THE UTAH GUIDE FOR THE SEISMIC IMPROVEMENT OF **UNREINFORCED MASONRY DWELLINGS**

**Utah Seismic Safety Commission
Existing Buildings Committee
Second Edition
2016**

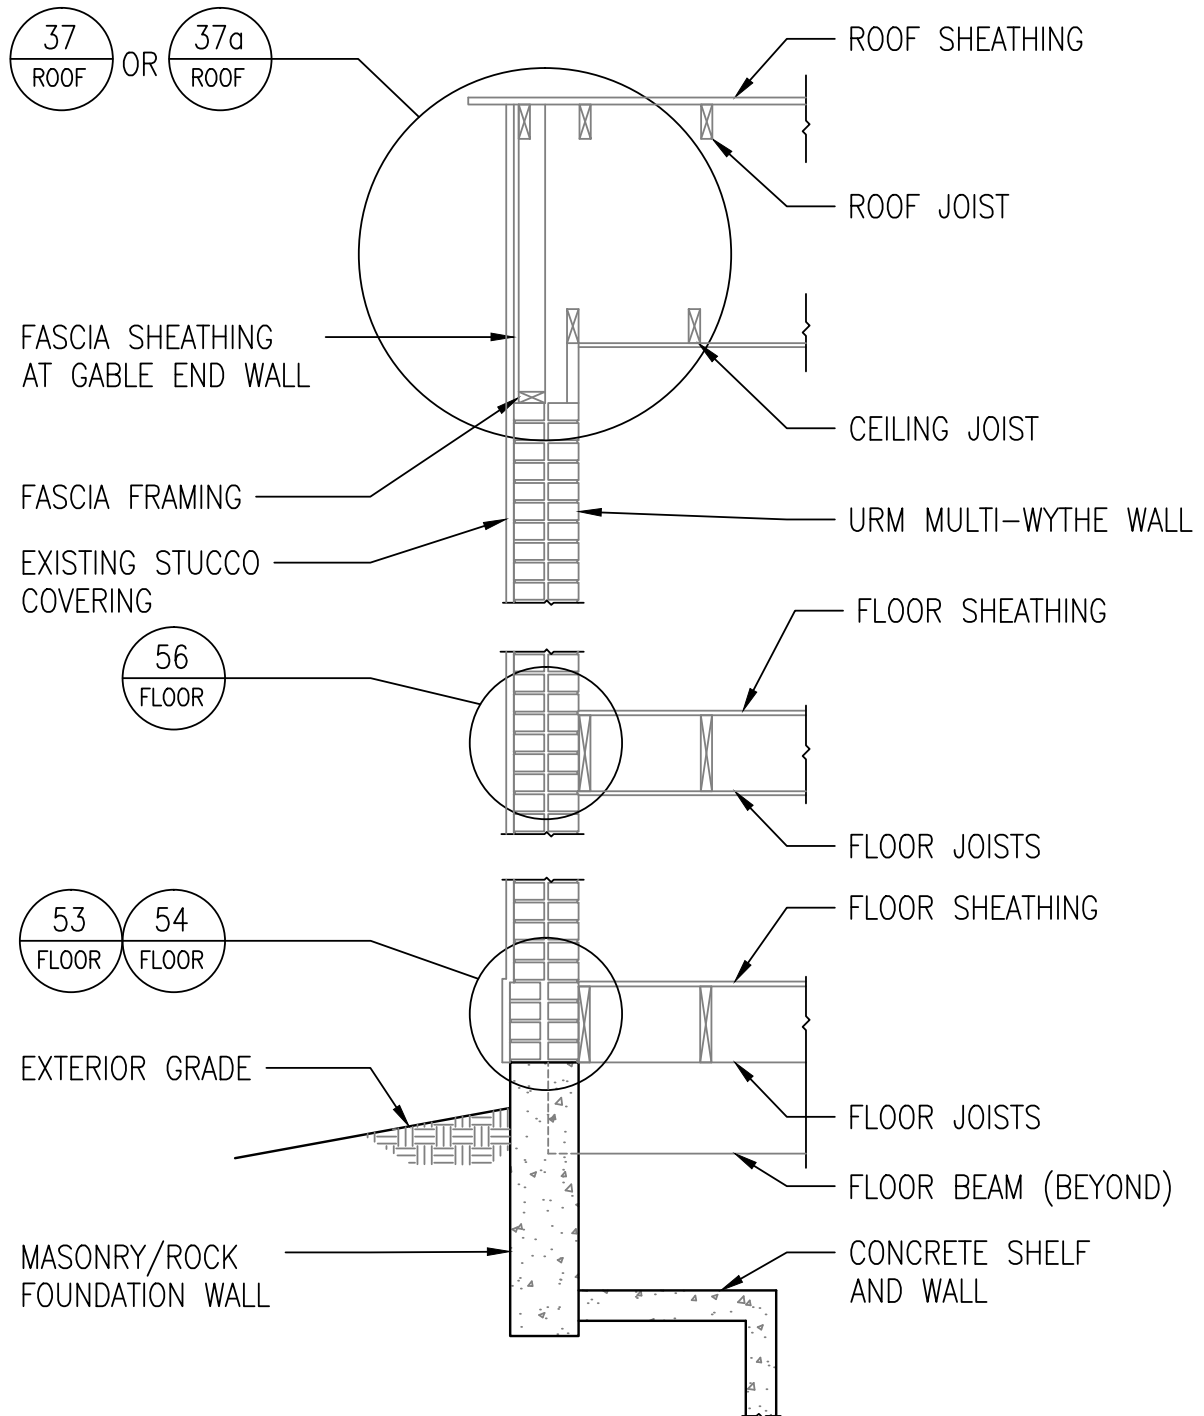
Model Home Seismic Deficiencies	HOME TYPE: MODEL C	Exterior Wall Sections	DETAIL: 6
------------------------------------	-----------------------	---------------------------	--------------

SECTION W/ JOIST FRAMING PARALLEL TO WALL

Details 5 and 6 show two different existing exterior walls sections for Model C. Reference circles have been superimposed onto the details showing the area of the wall where seismic deficiencies normally occur. The details for improvements to strengthen these deficiencies are found in Chapter 6. Table 1 and the additional details in Chapters 6 and 7 also recommend other improvements, although not illustrated in these exterior wall details.

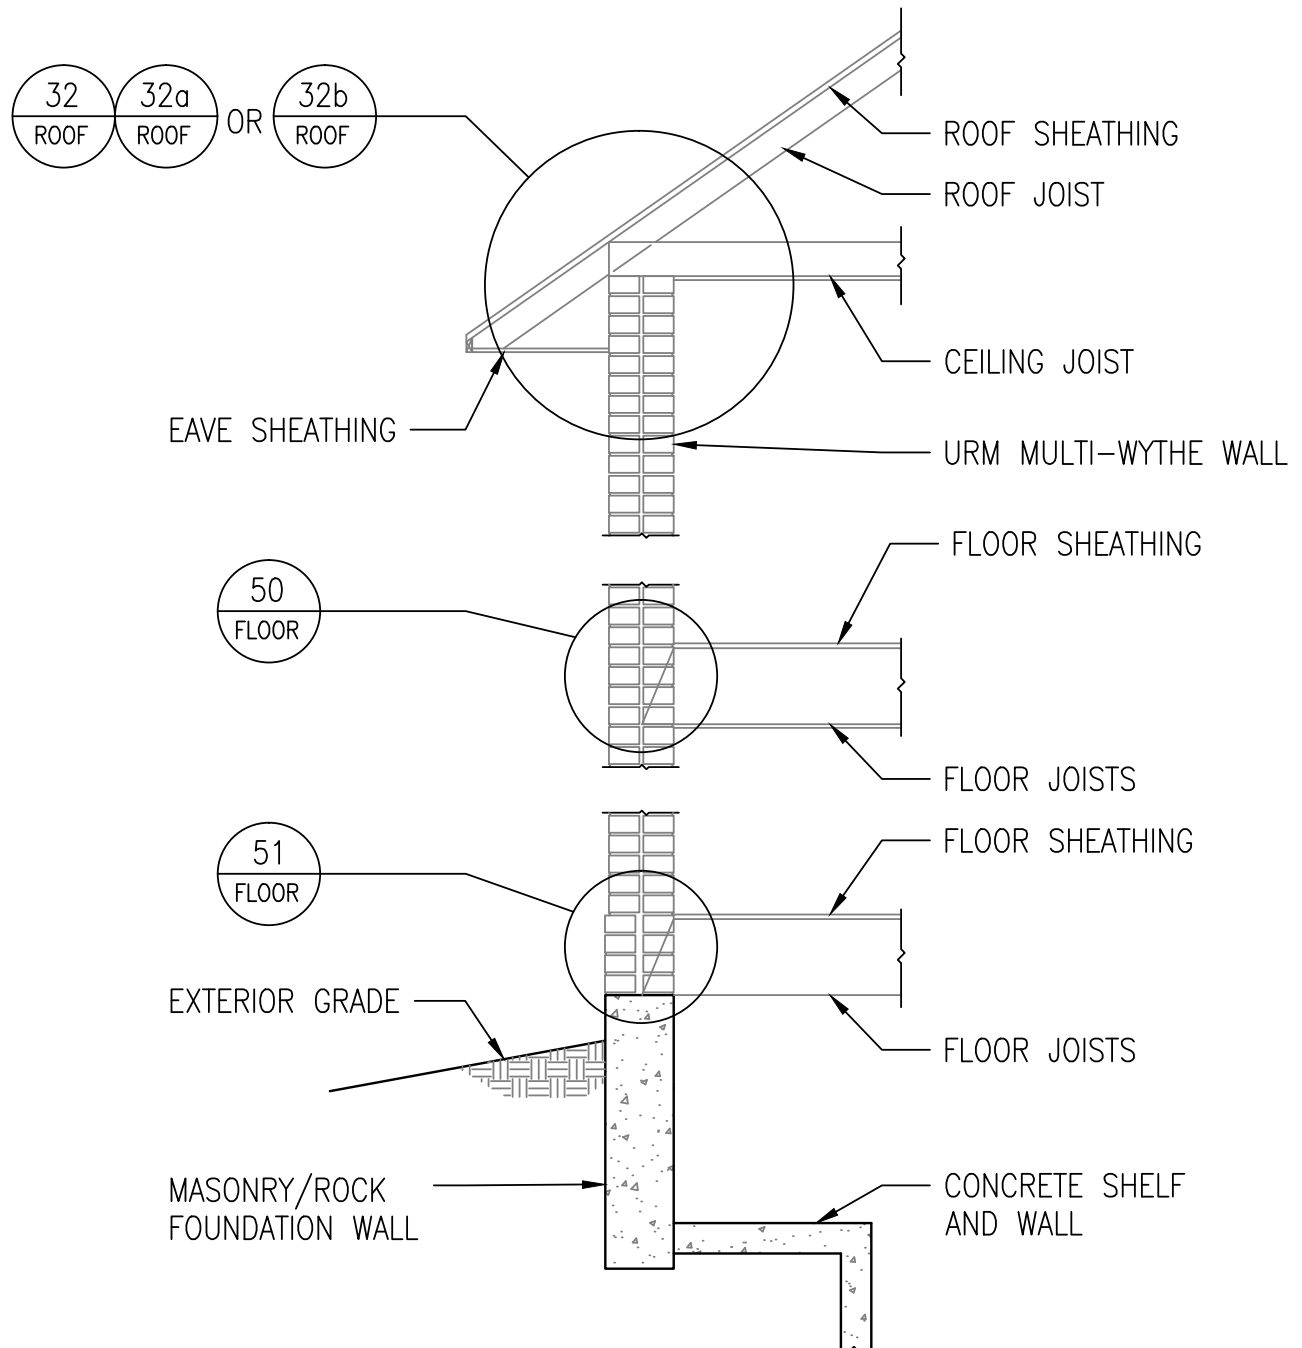
Model Home Seismic Deficiencies	HOME TYPE: MODEL D	Exterior Wall Sections	DETAIL: 7
------------------------------------	-----------------------	---------------------------	--------------

SECTION W/ JOIST FRAMING PERPENDICULAR TO WALL

Details 7 and 8 show two different existing exterior wall sections for Model D. Reference circles have been superimposed into these details showing the area of the wall where seismic deficiencies normally occur. The details for improvements to strengthen these deficiencies are found in Chapter 6. Table 1 and the additional details in Chapters 6 and 7 also recommend other improvements, although not illustrated in these exterior wall details.

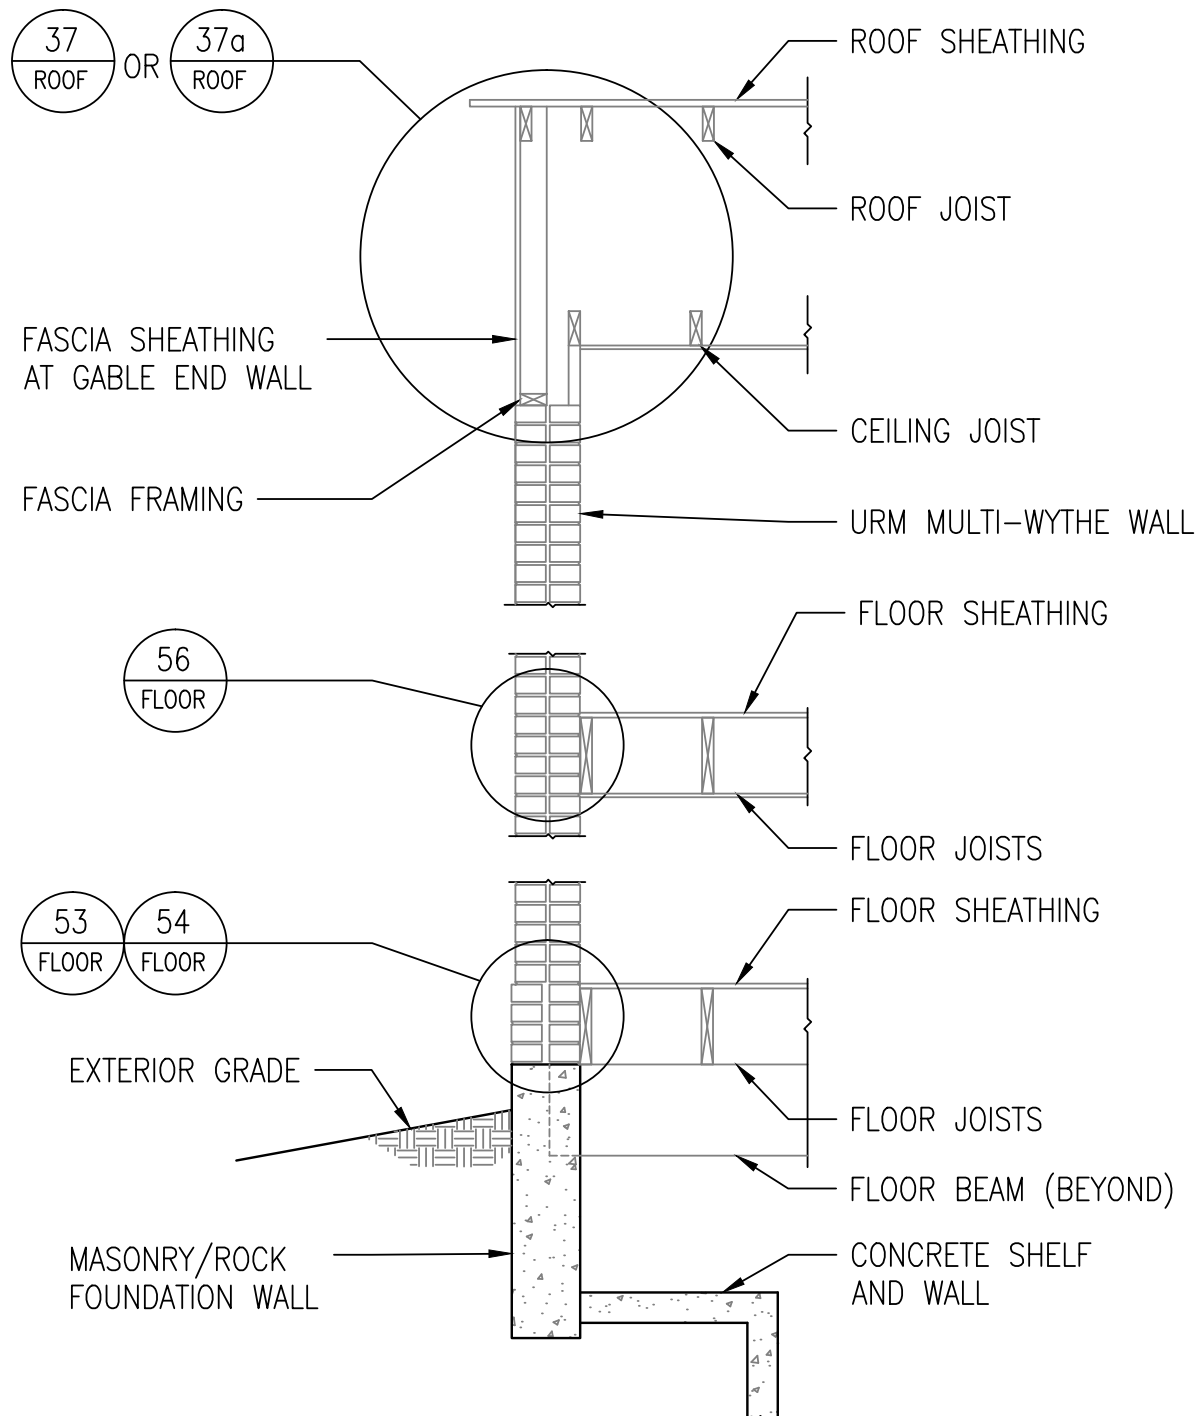
Model Home Seismic Deficiencies	HOME TYPE: MODEL D	Exterior Wall Sections	DETAIL: 8
------------------------------------	-----------------------	---------------------------	--------------

8 SECTION W/ JOIST FRAMING
PARALLEL TO WALL

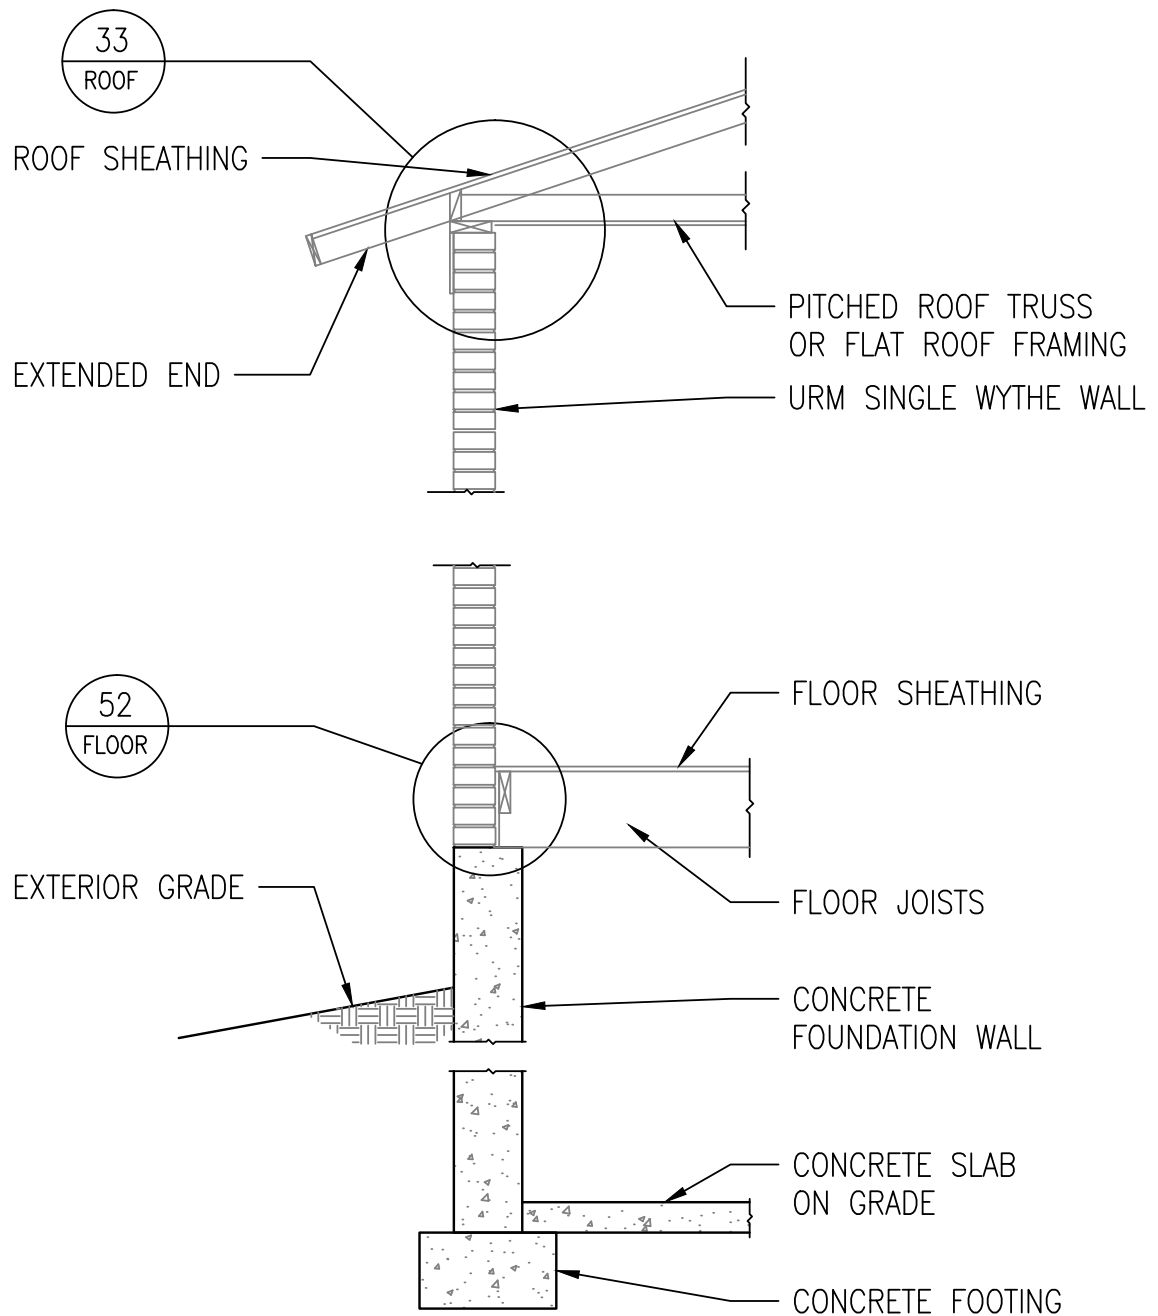
Model Home Seismic Deficiencies	HOME TYPE: MODEL E	Exterior Wall Sections	DETAIL: 9
------------------------------------	-----------------------	---------------------------	--------------

SECTION W/ JOIST FRAMING
PERPENDICULAR TO WALL

Details 9 and 10 show two different existing exterior wall sections for Model E. Reference circles have been superimposed into these details showing the area of the wall where seismic deficiencies normally occur. The details for improvements to strengthen these deficiencies are found in Chapter 6. Table 1 and the additional details in Chapters 6 and 7 also recommend other improvements, although not illustrated in these exterior wall details.

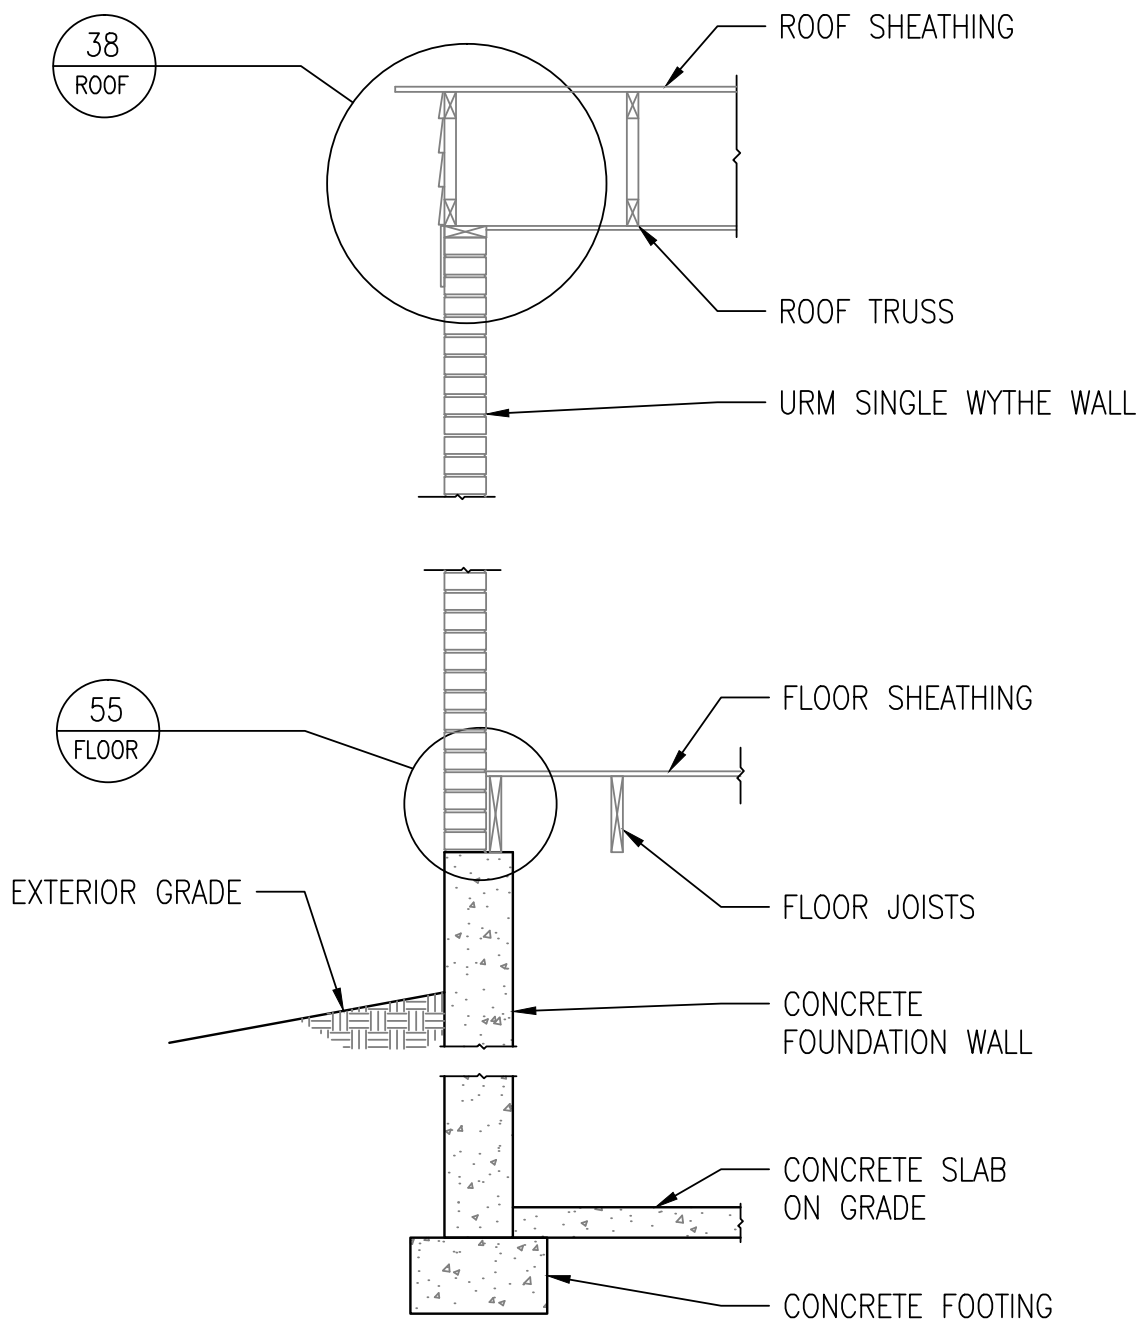
Model Home Seismic Deficiencies	HOME TYPE: MODEL E	Exterior Wall Sections	DETAIL: 10
------------------------------------	-----------------------	---------------------------	---------------

10 SECTION
SECTION W/ JOIST FRAMING
PARALLEL TO WALL

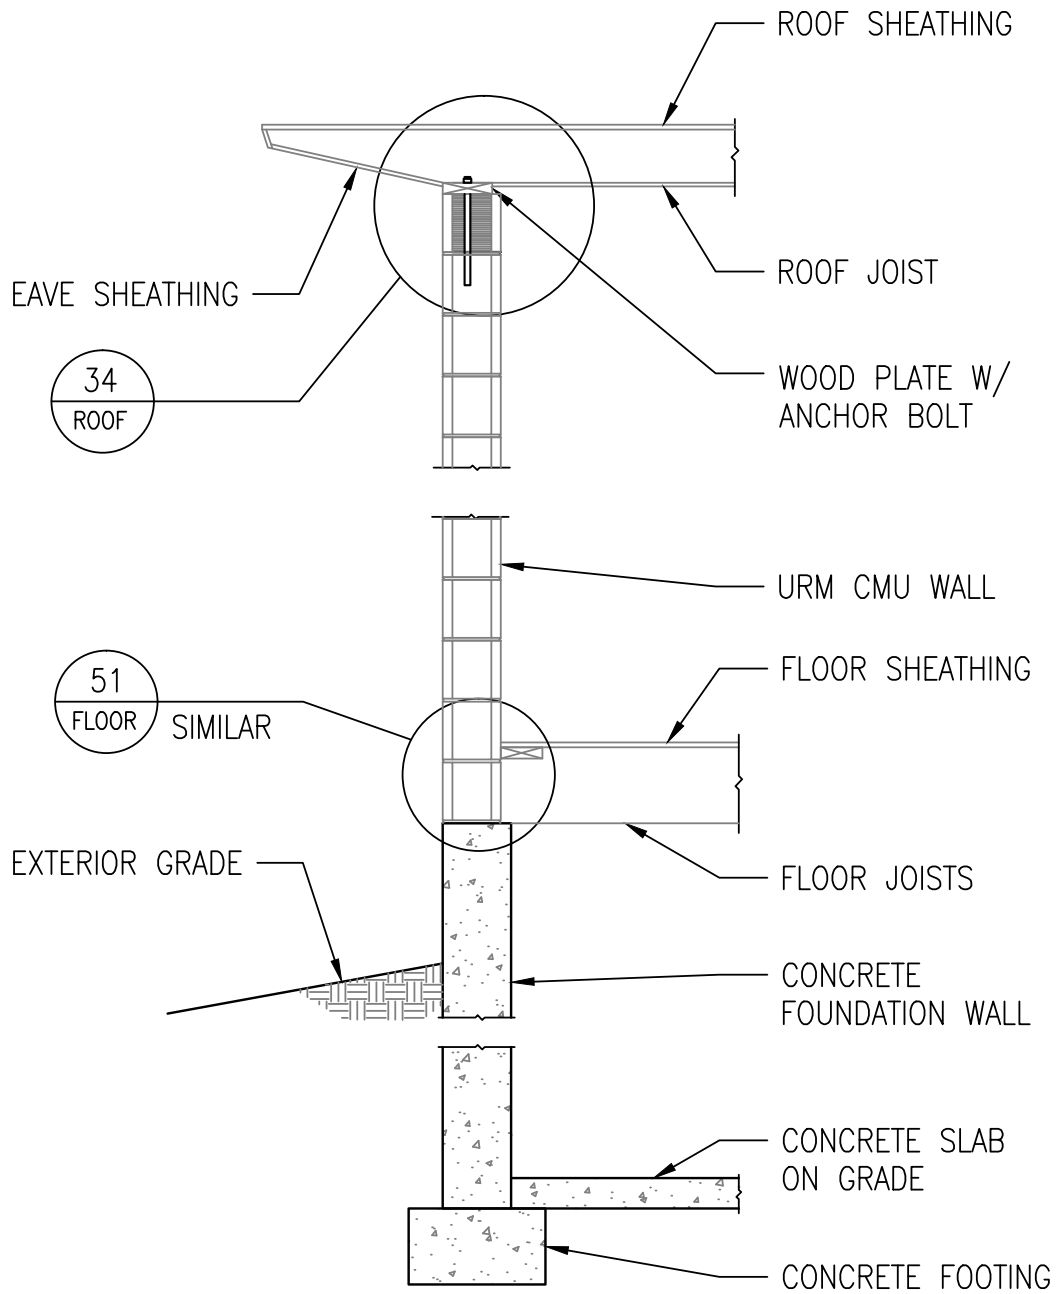
Model Home Seismic Deficiencies	HOME TYPE: MODEL F	Exterior Wall Sections	DETAIL: 11
------------------------------------	-----------------------	---------------------------	---------------

SECTION W/ JOIST FRAMING
PERPENDICULAR TO WALL

Detail 11 shows an existing exterior wall section for Model F. Reference circles have been superimposed into this detail showing the area of the wall where seismic deficiencies normally occur. The details for improvements to

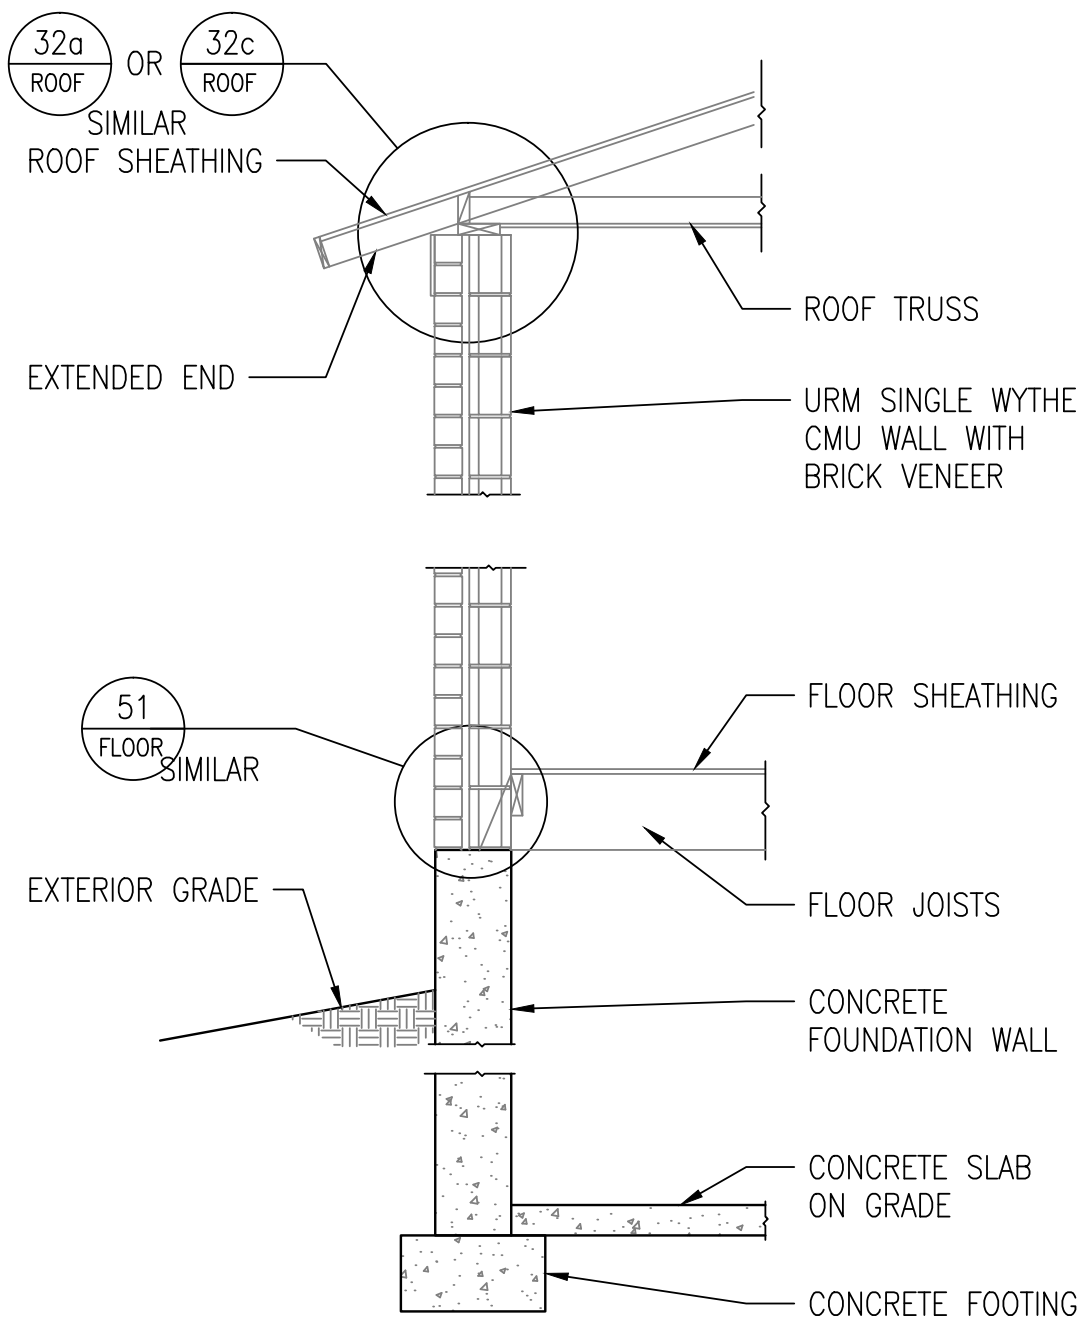
Model Home Seismic Deficiencies	HOME TYPE: MODEL G	Exterior Wall Sections	DETAIL: 12
------------------------------------	-----------------------	---------------------------	---------------

SECTION W/ JOIST FRAMING
PERPENDICULAR TO WALL

Details 12 and 13 show different existing exterior wall sections for Model G. Reference circles have been superimposed into these details showing the areas of the wall where seismic deficiencies normally occur. The details for improvements to strengthen these deficiencies are found in Chapter 6. Table 1 and the additional details in Chapters 6 and 7 also recommend other improvements, although not illustrated in these exterior wall details

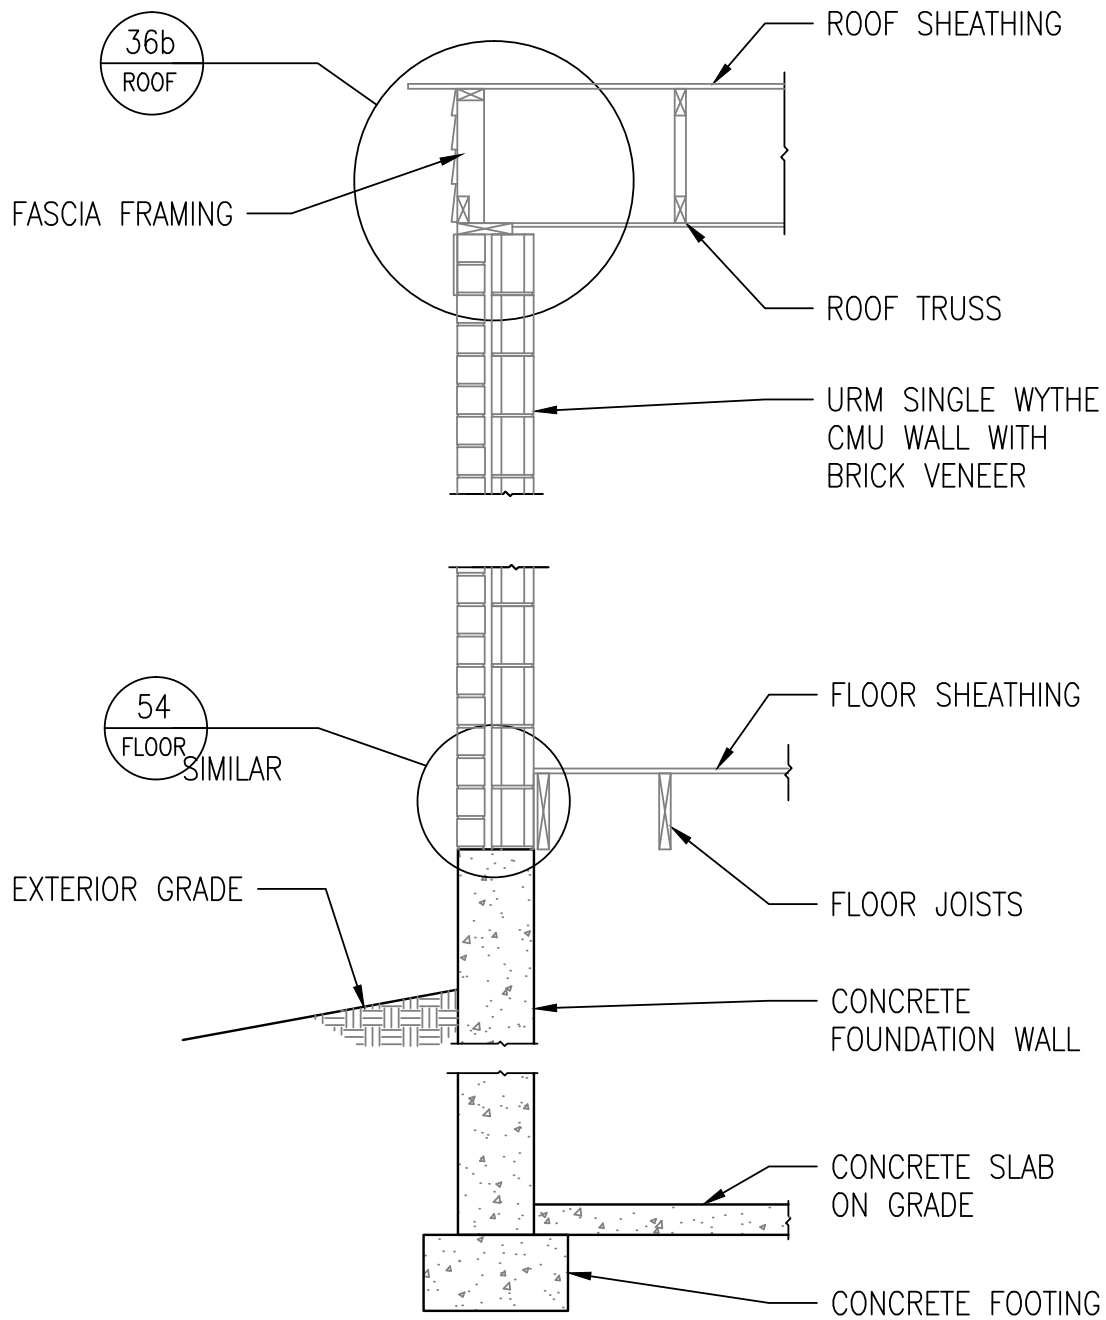
Model Home Seismic Deficiencies	HOME TYPE: MODEL G	Exterior Wall Sections	DETAIL: 13
------------------------------------	-----------------------	---------------------------	---------------

SECTION W/ JOIST FRAMING PARALLEL TO WALL

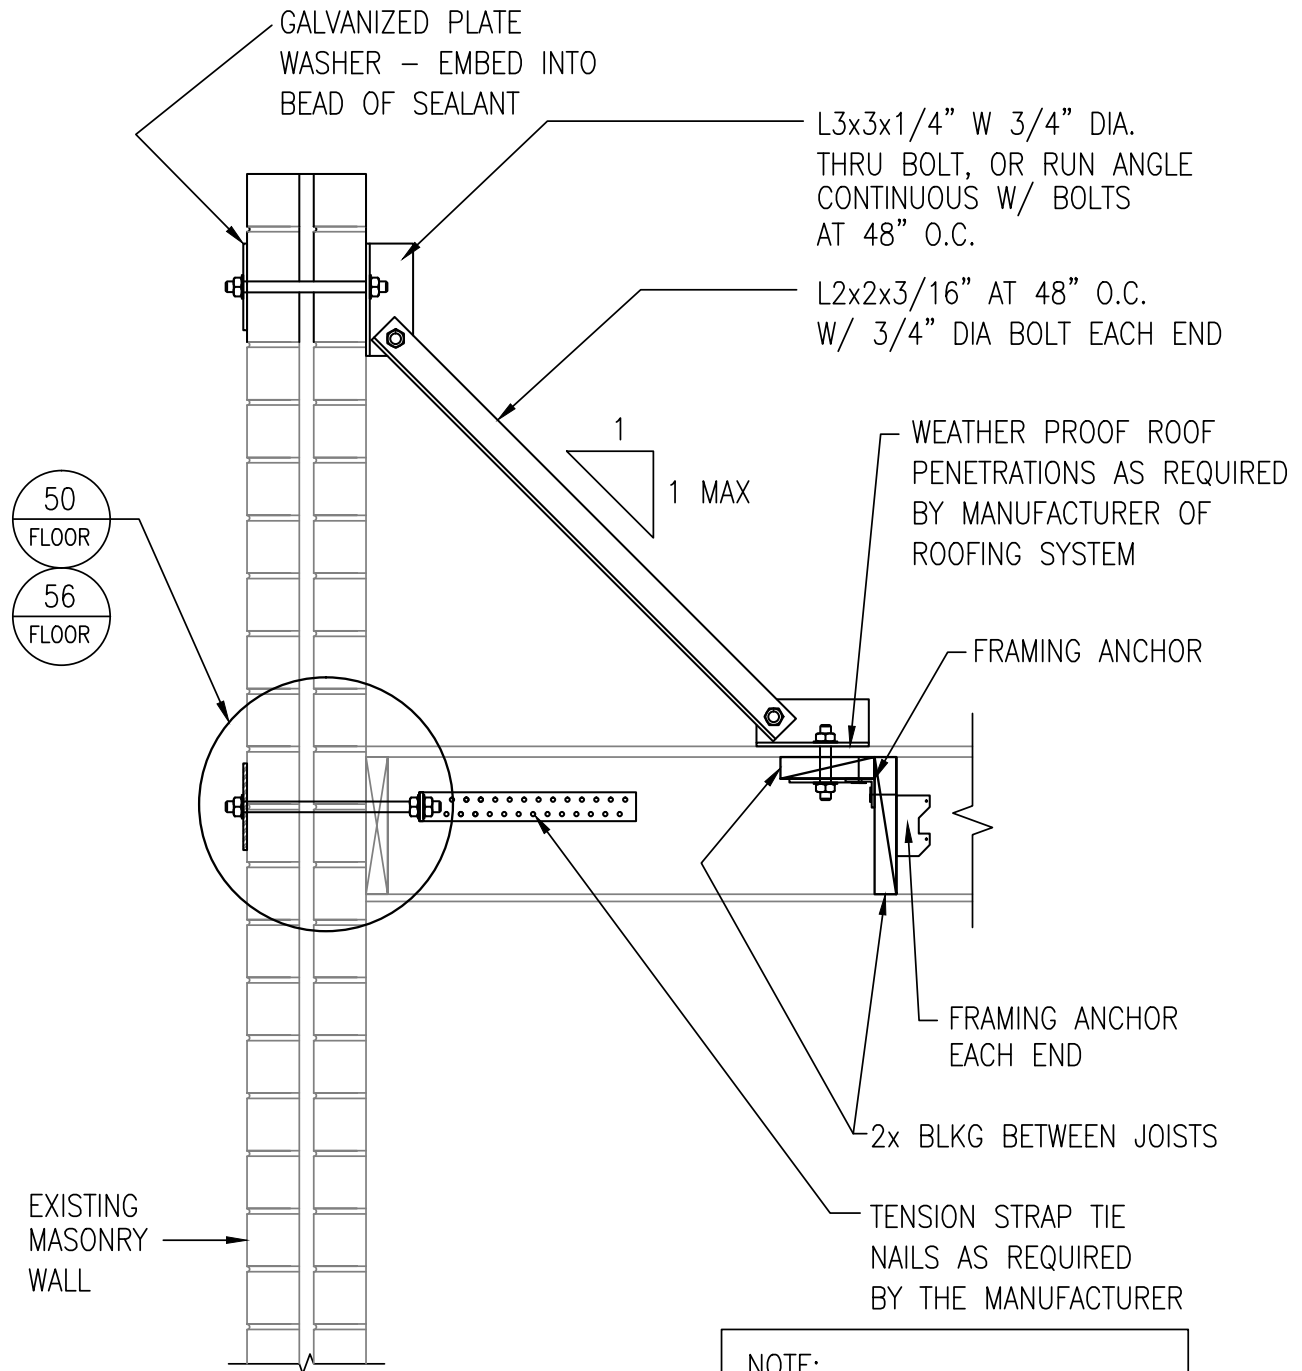
Seismic Improvement Structural Detail	HOME TYPE: VARIES	Structural Bracing	DETAIL: 20
--	----------------------	-----------------------	---------------

PARAPET BRACING

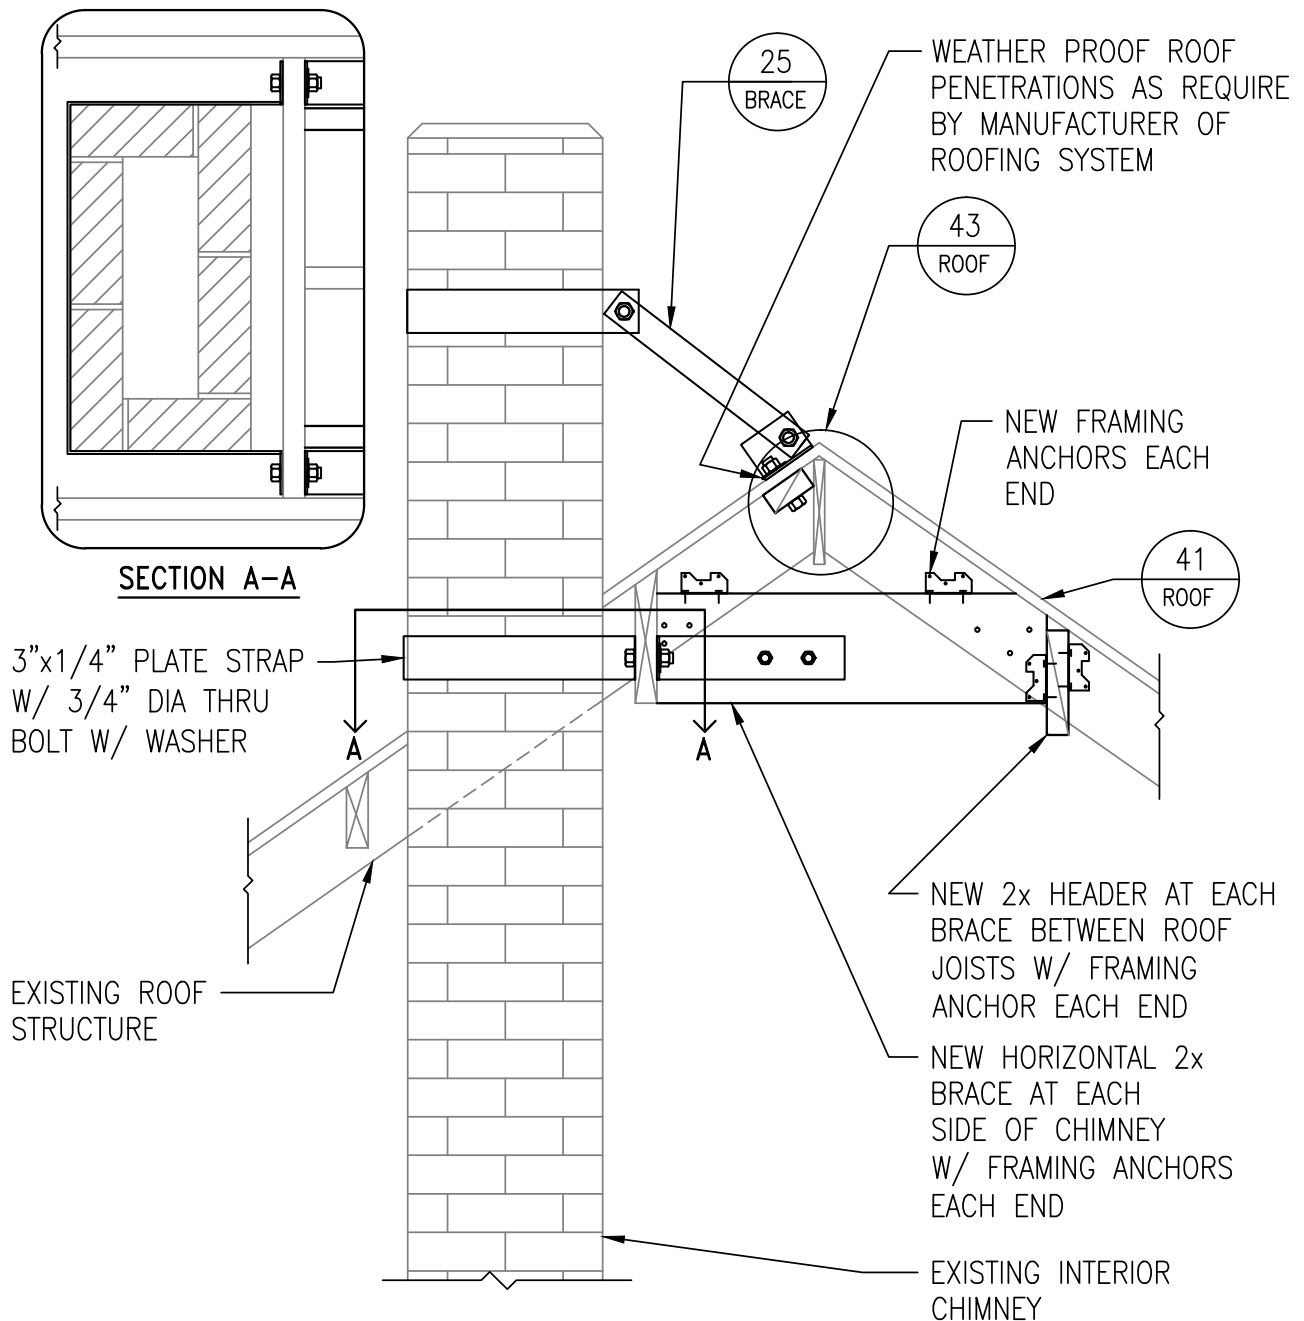
Seismic Improvement Structural Detail	HOME TYPE: VARIES	Structural Bracing	DETAIL: 21
--	----------------------	-----------------------	---------------

URM GABLE BRACING

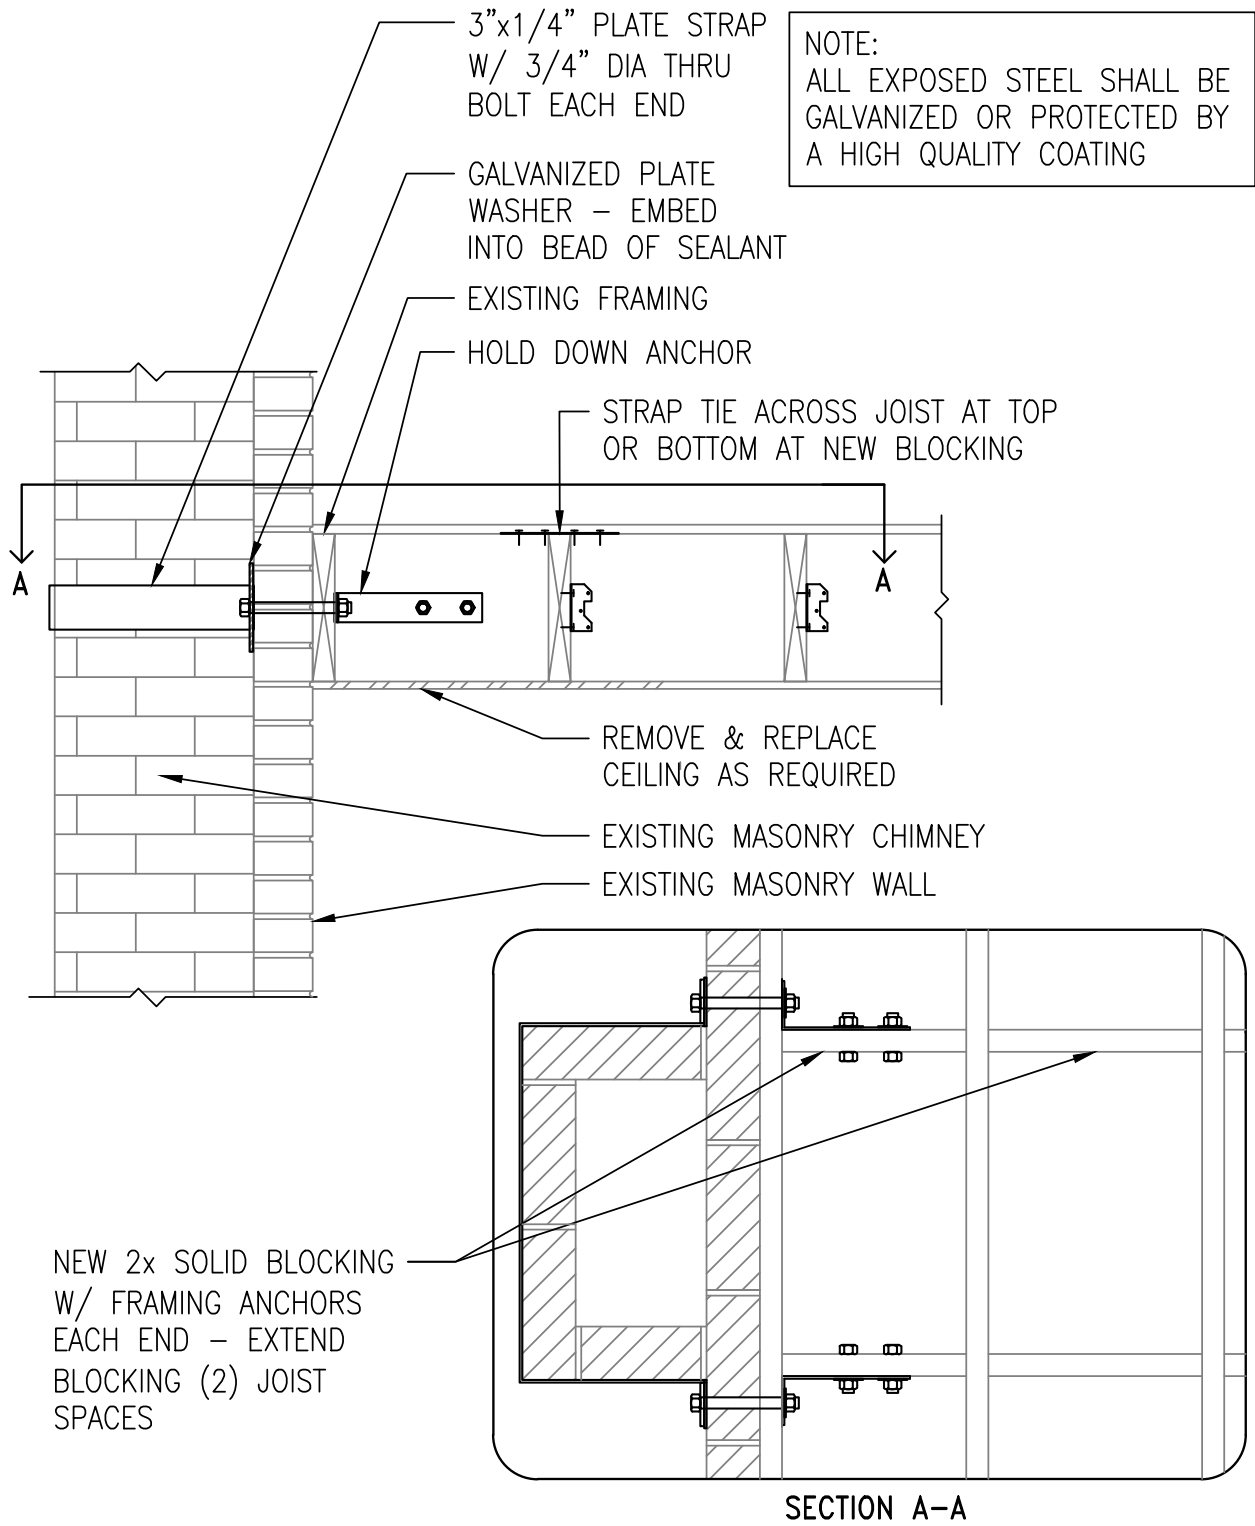
Seismic Improvement Structural Detail	HOME TYPE: VARIES	Structural Bracing	DETAIL: 22
--	----------------------	-----------------------	---------------

INTERIOR CHIMNEY BRACING W/ HEADER AT JOIST

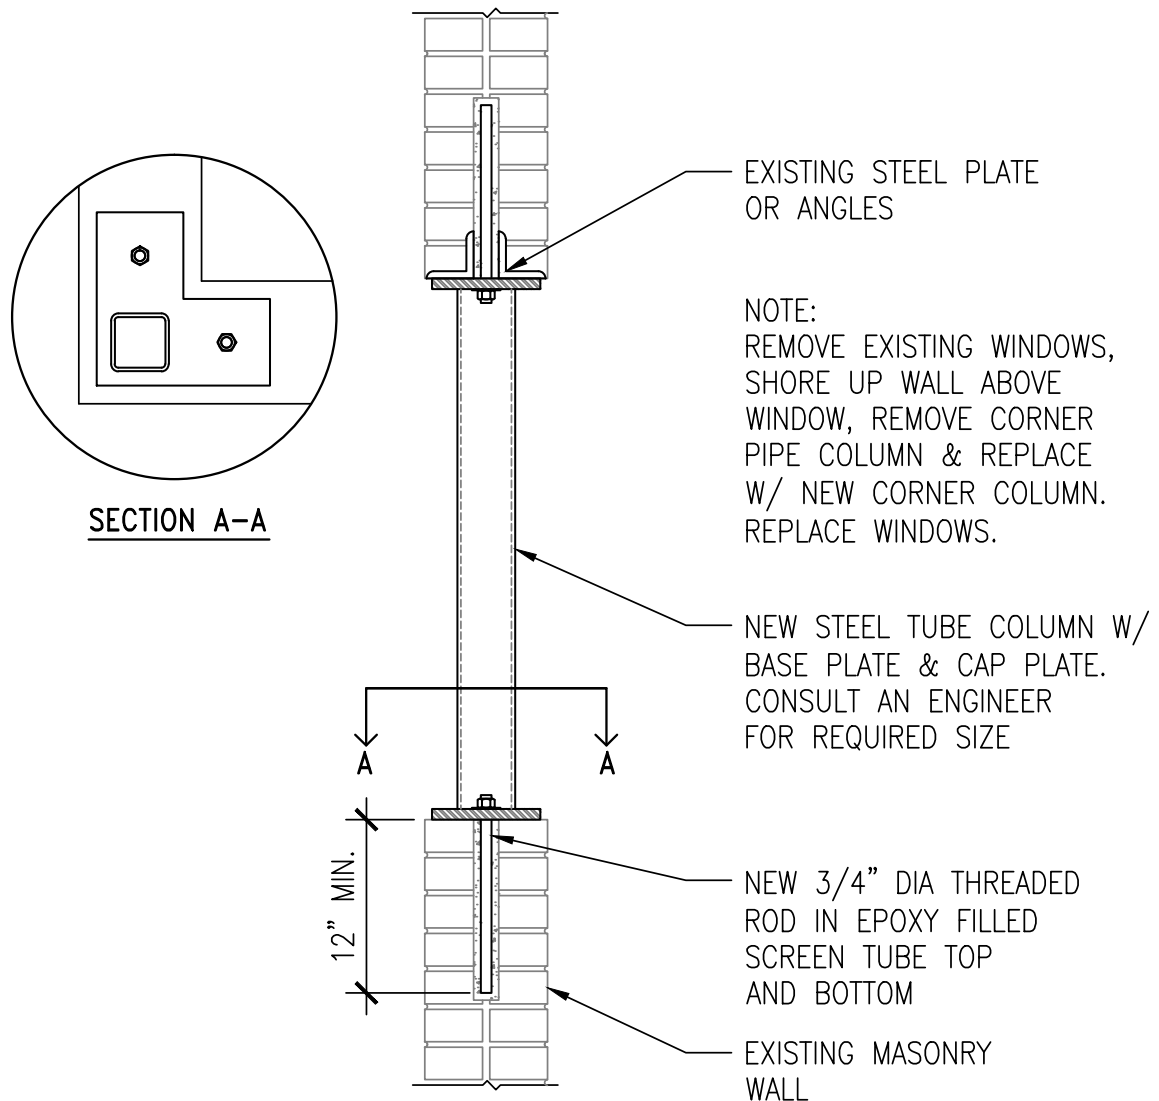
Seismic Improvement Structural Detail	HOME TYPE: VARIES	Structural Bracing	DETAIL: 26a
--	----------------------	-----------------------	----------------

CORNER WINDOW STRENGTHENING

masonry wall above or the wall above may be on a cantilevered steel angle to avoid a corner post (figure 42). When used, the steel pipe may or may not be connected to the steel lintel. This feature may create a weakness in the shear wall. If the steel pipe was to become displaced, partial collapse of the dwelling could take place. See details 26 and 26a to help strengthen this deficiency.

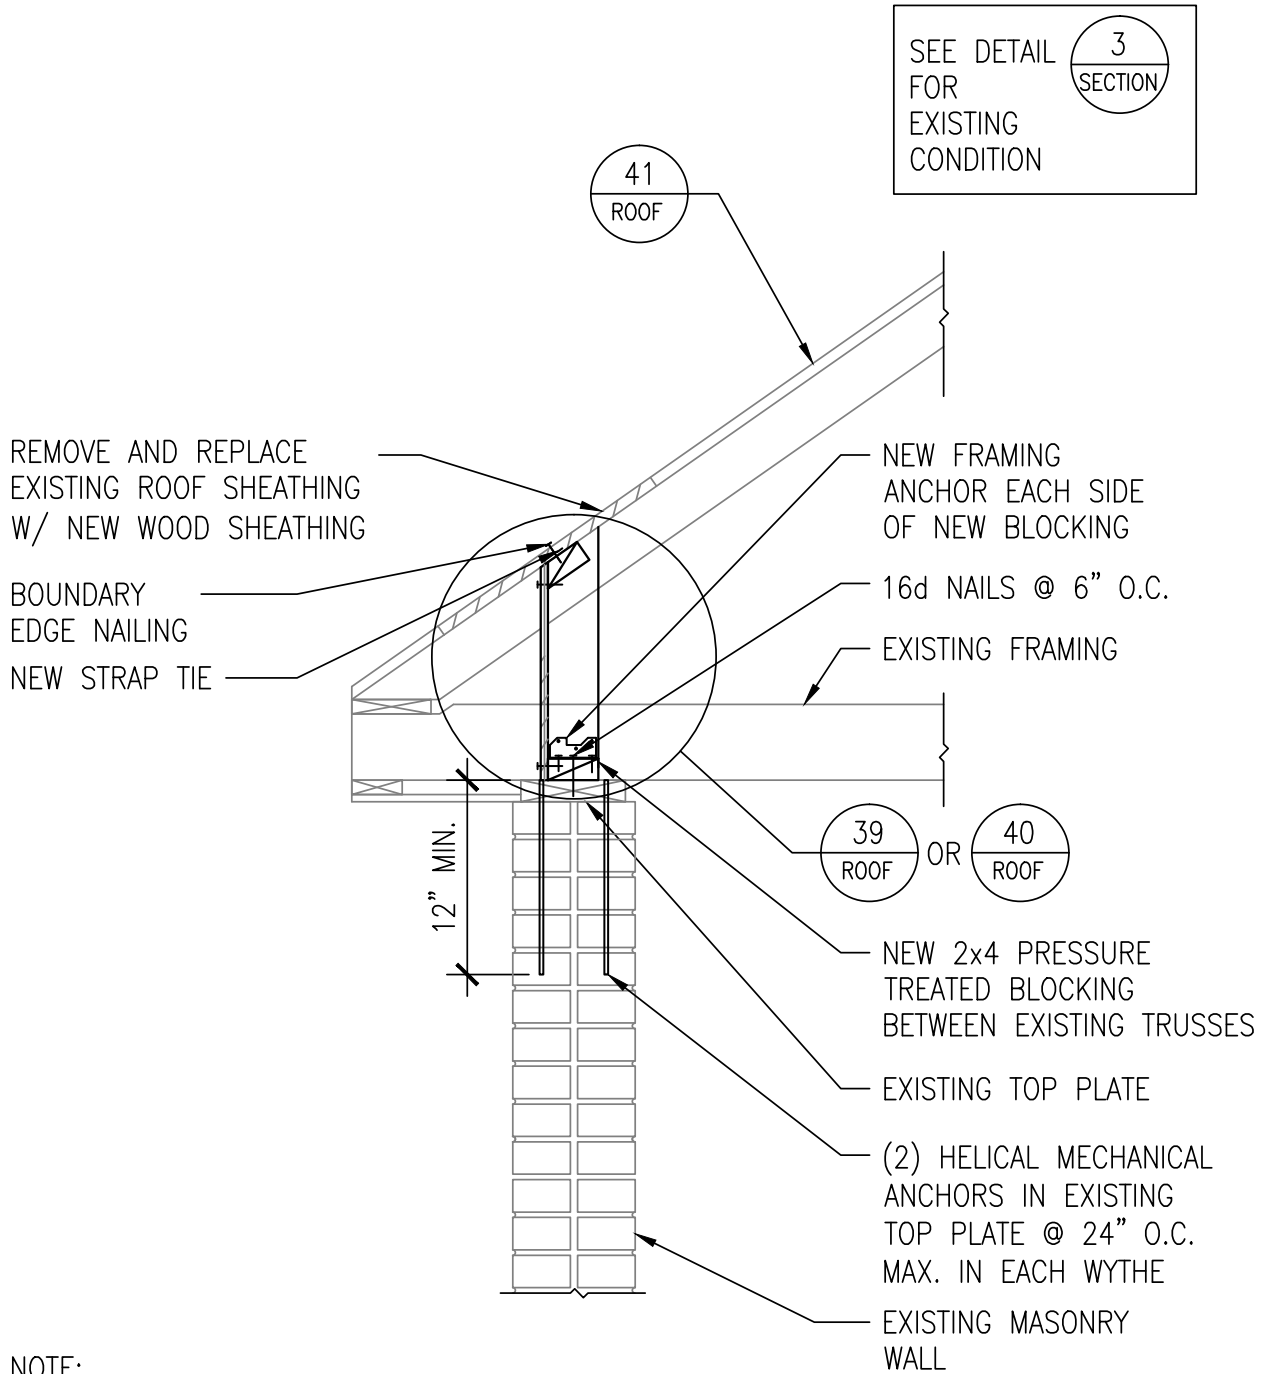
Seismic Improvement Structural Detail	HOME TYPE: MODEL A	Roof to URM Wall Anchorage	DETAIL: 30a
--	-----------------------	-------------------------------	----------------

ROOF TO URM WALL ANCHORAGE W/ JOISTS PERPENDICULAR TO WALL
