THE UTAH GUIDE FOR THE SEISMIC IMPROVEMENT OF **UNREINFORCED MASONRY DWELLINGS**

**Utah Seismic Safety Commission
Existing Buildings Committee
Second Edition
2016**

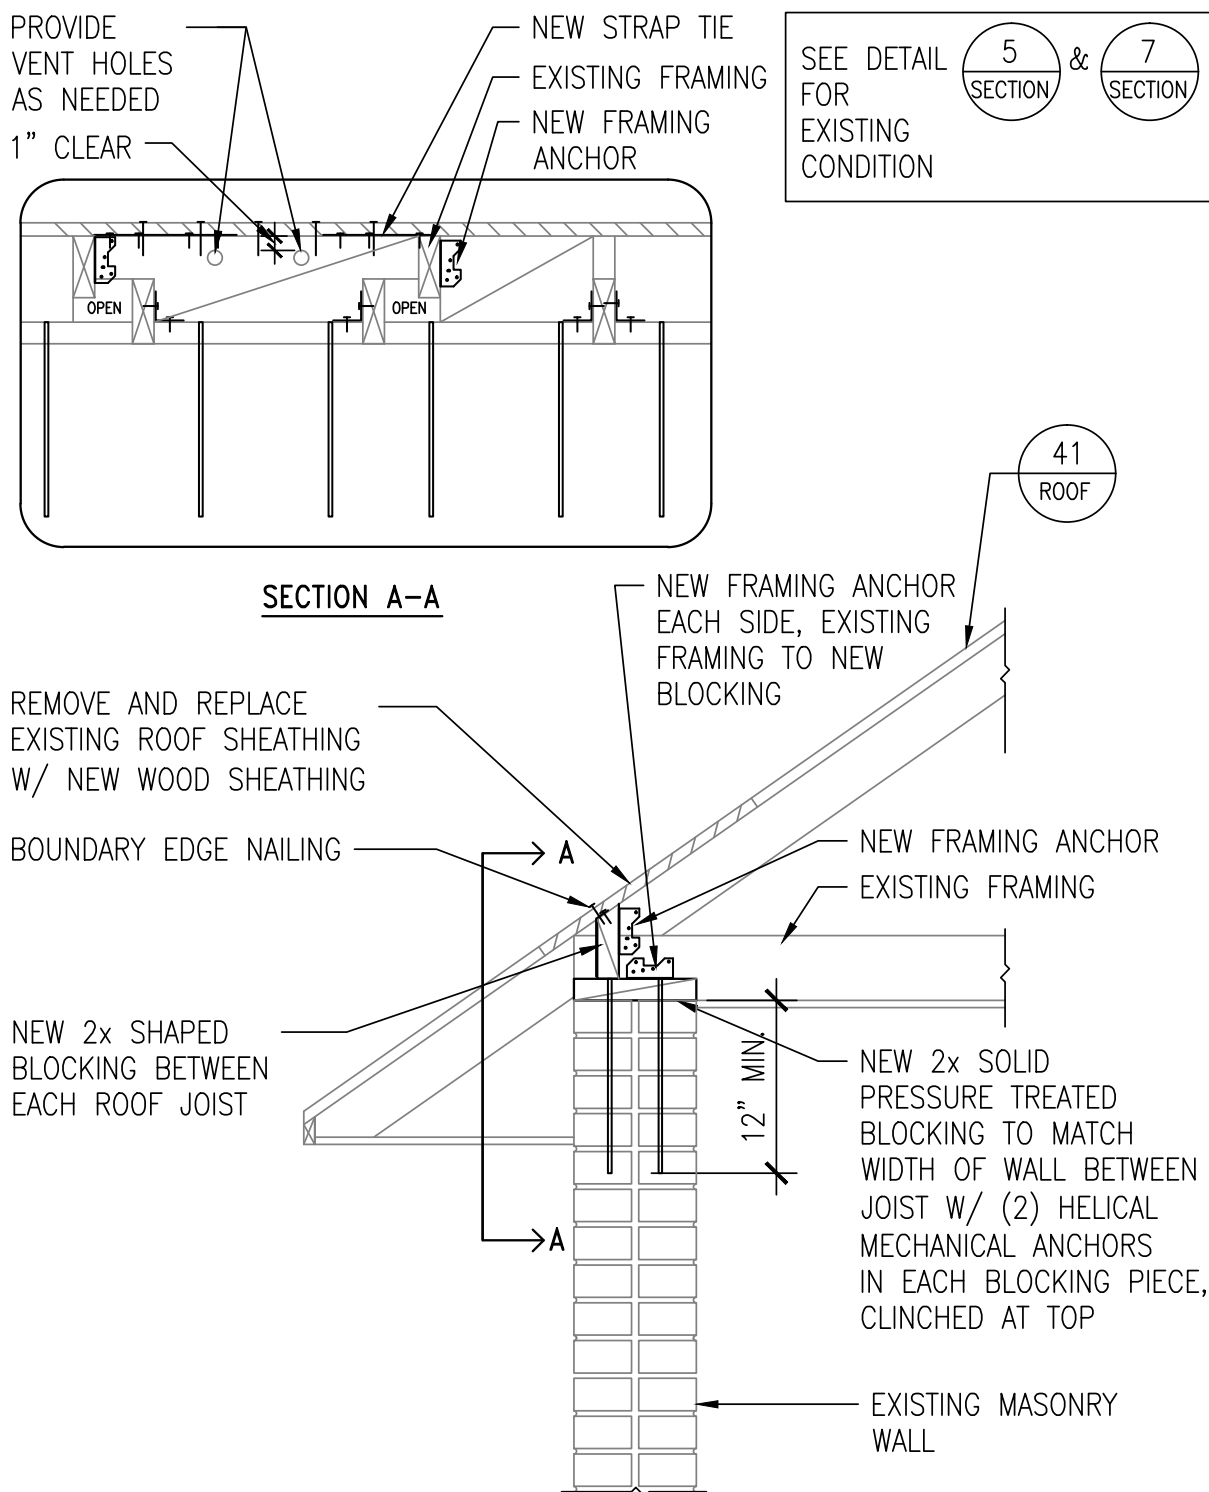
Seismic Improvement Structural Detail	HOME TYPE: MODEL B	Roof to URM Wall Anchorage	DETAIL: 31a
--	-----------------------	-------------------------------	----------------

ROOF TO URM WALL ANCHORAGE W/ JOISTS PERPENDICULAR TO WALL

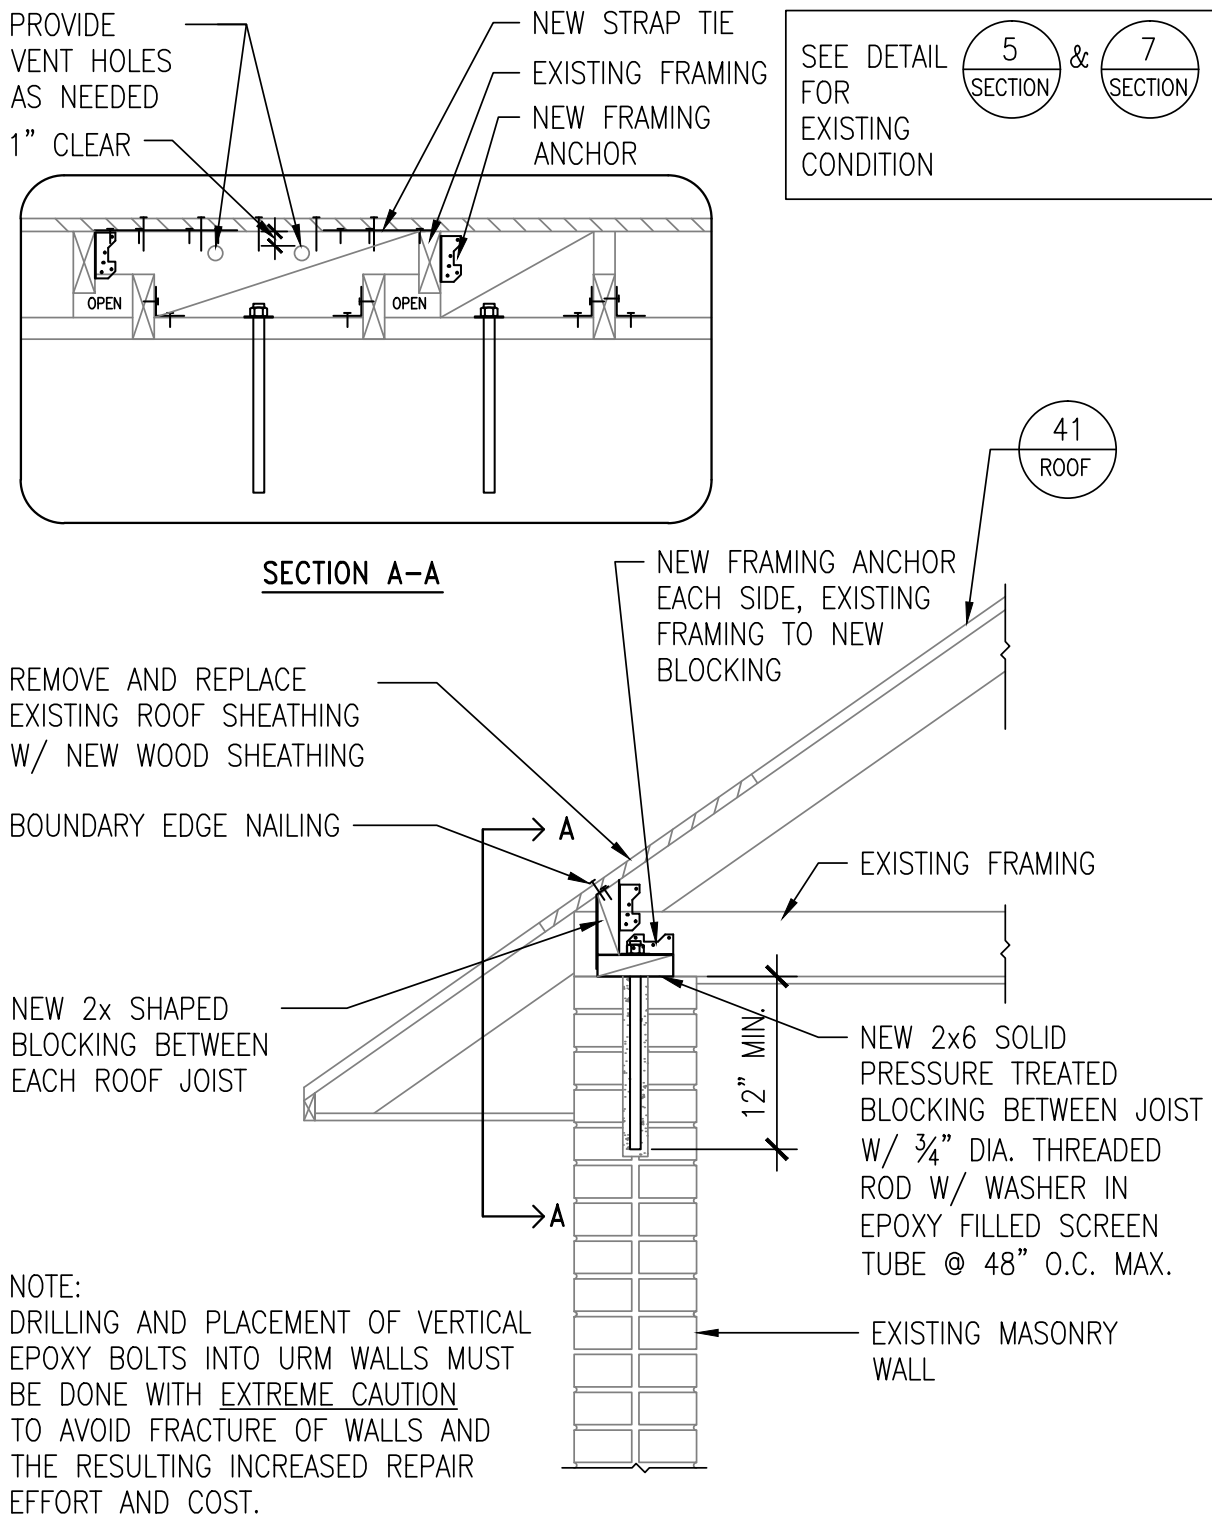
Seismic Improvement Structural Detail	HOME TYPE: MODEL C & D	Roof to URM Wall Anchorage	DETAIL: 32
--	---------------------------	-------------------------------	---------------

ROOF TO URM WALL ANCHORAGE W/ JOISTS PERPENDICULAR TO WALL

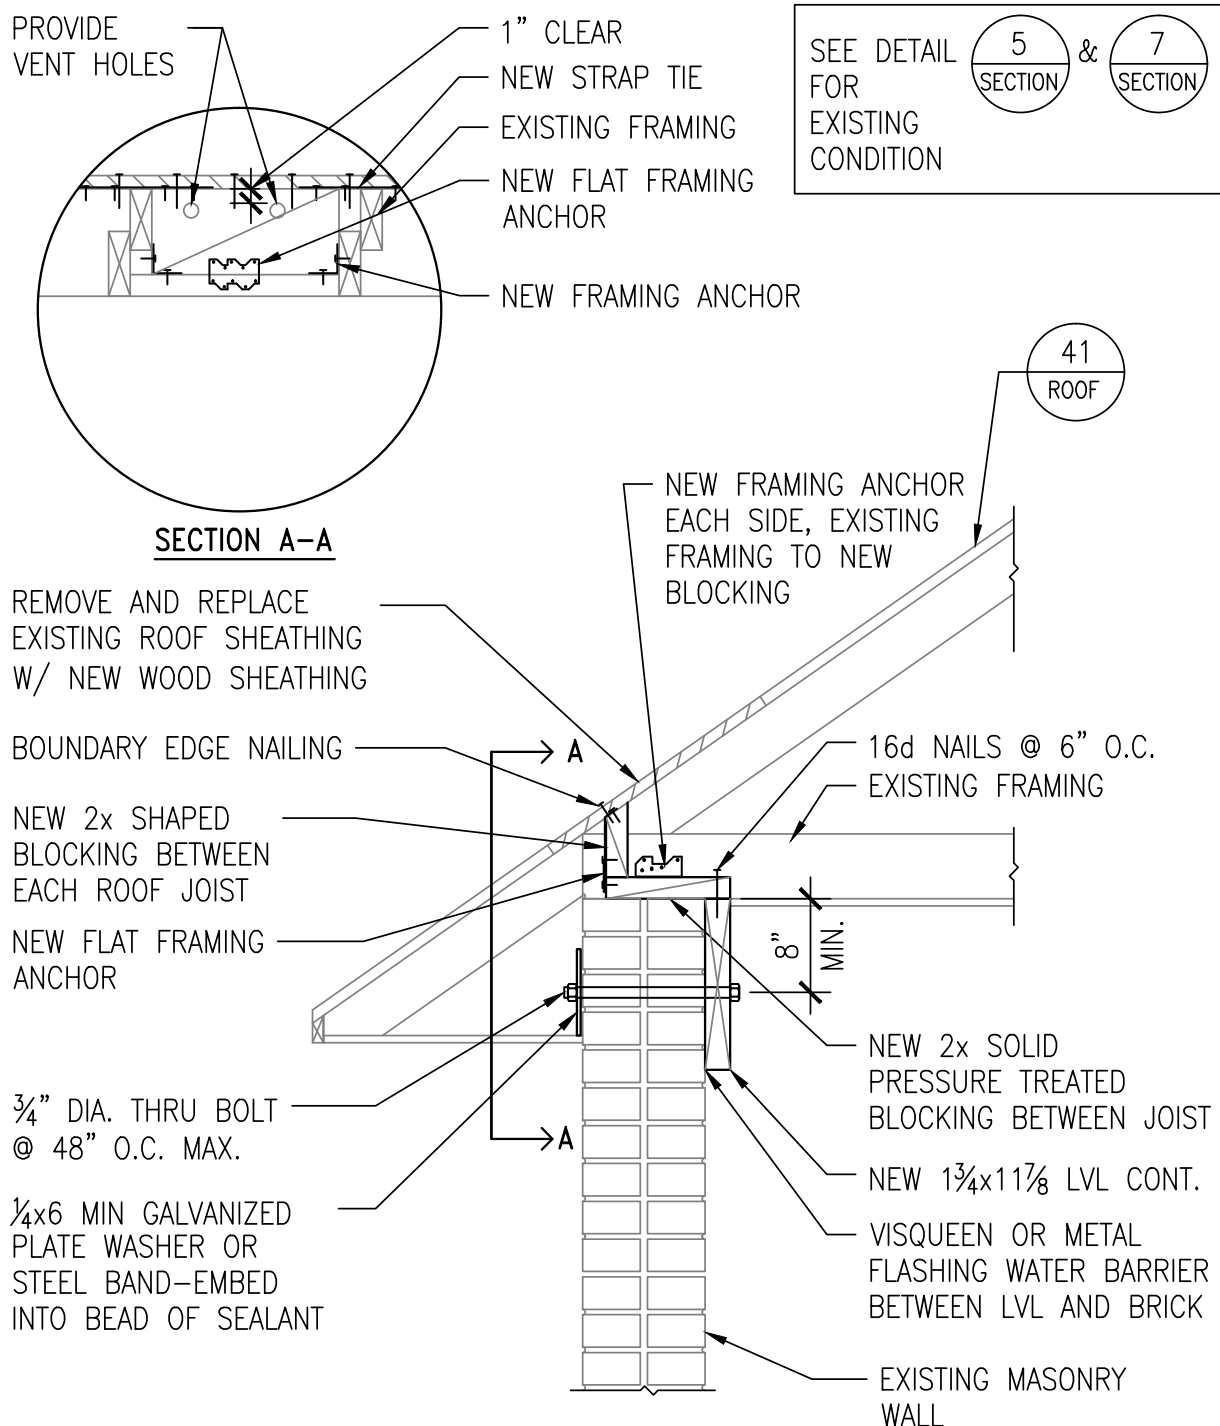
Seismic Improvement Structural Detail	HOME TYPE: MODEL C & D	Roof to URM Wall Anchorage	DETAIL: 32a
--	---------------------------	-------------------------------	----------------

ROOF TO URM WALL ANCHORAGE W/ JOISTS PERPENDICULAR TO WALL

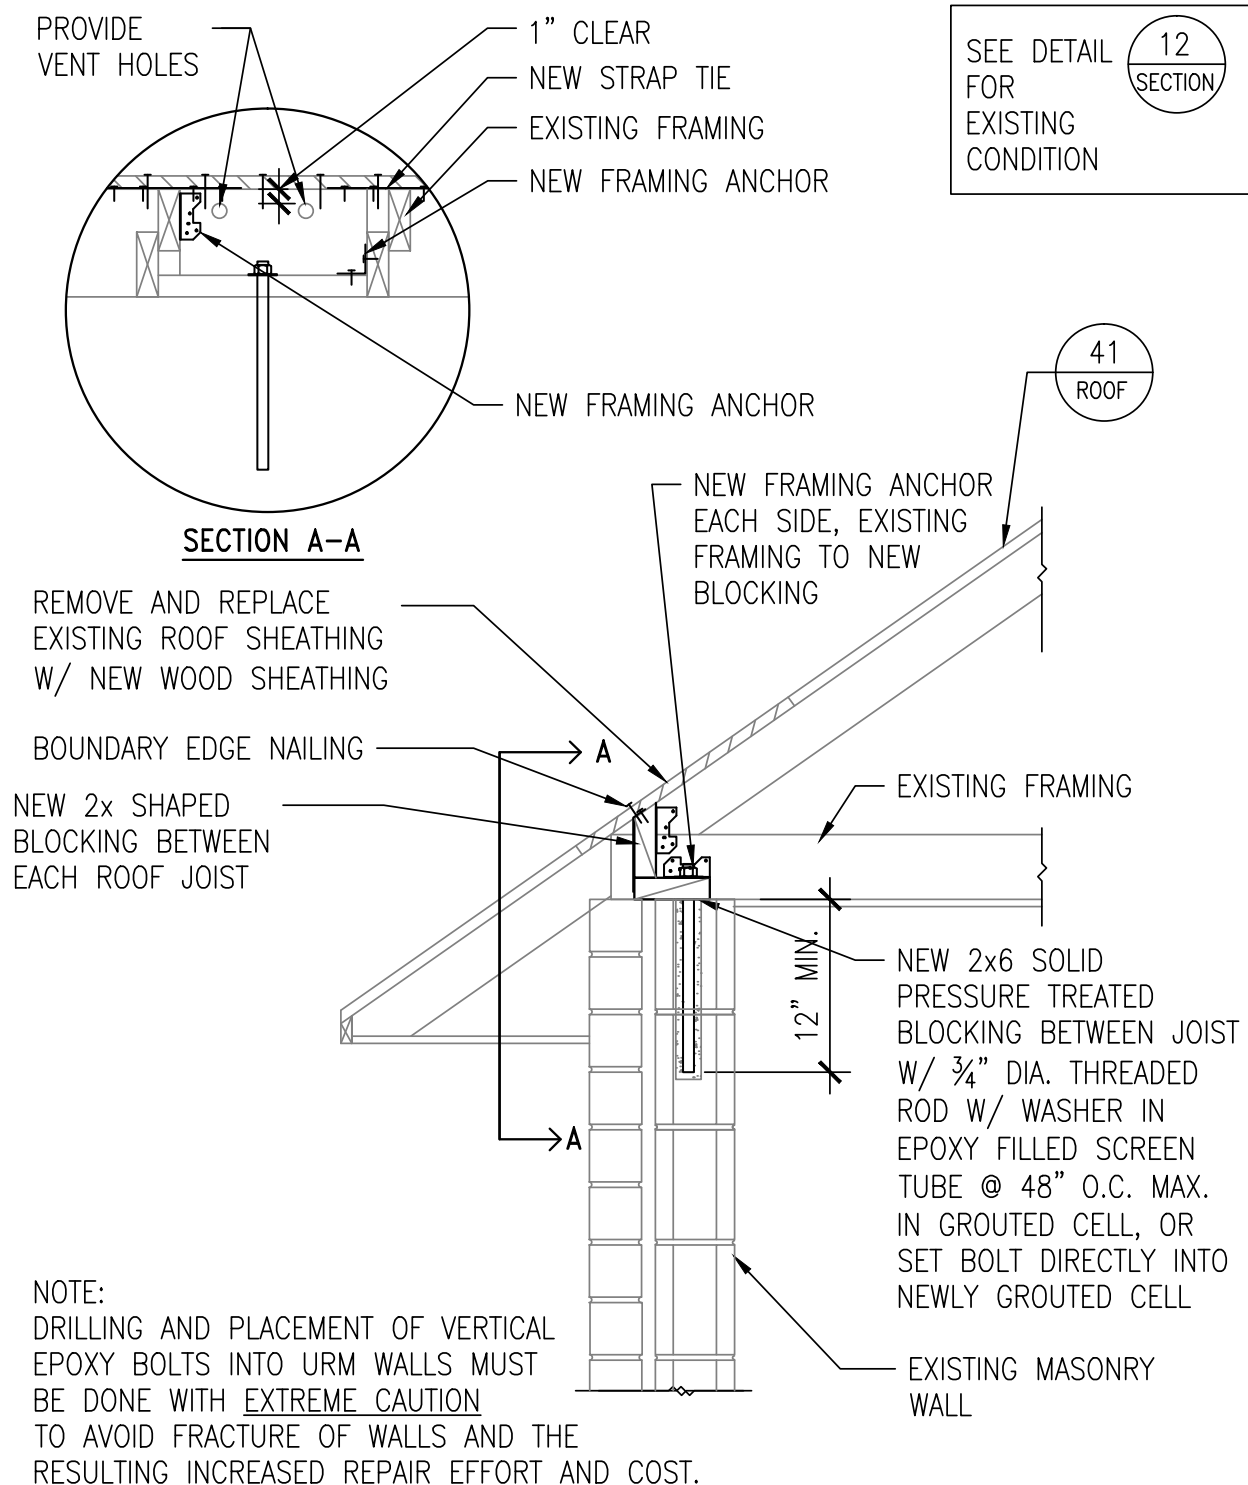
Seismic Improvement Structural Detail	HOME TYPE: MODEL C & D	Roof to URM Wall Anchorage	DETAIL: 32b
--	---------------------------	-------------------------------	----------------

ROOF TO URM WALL ANCHORAGE W/ JOISTS PERPENDICULAR TO WALL

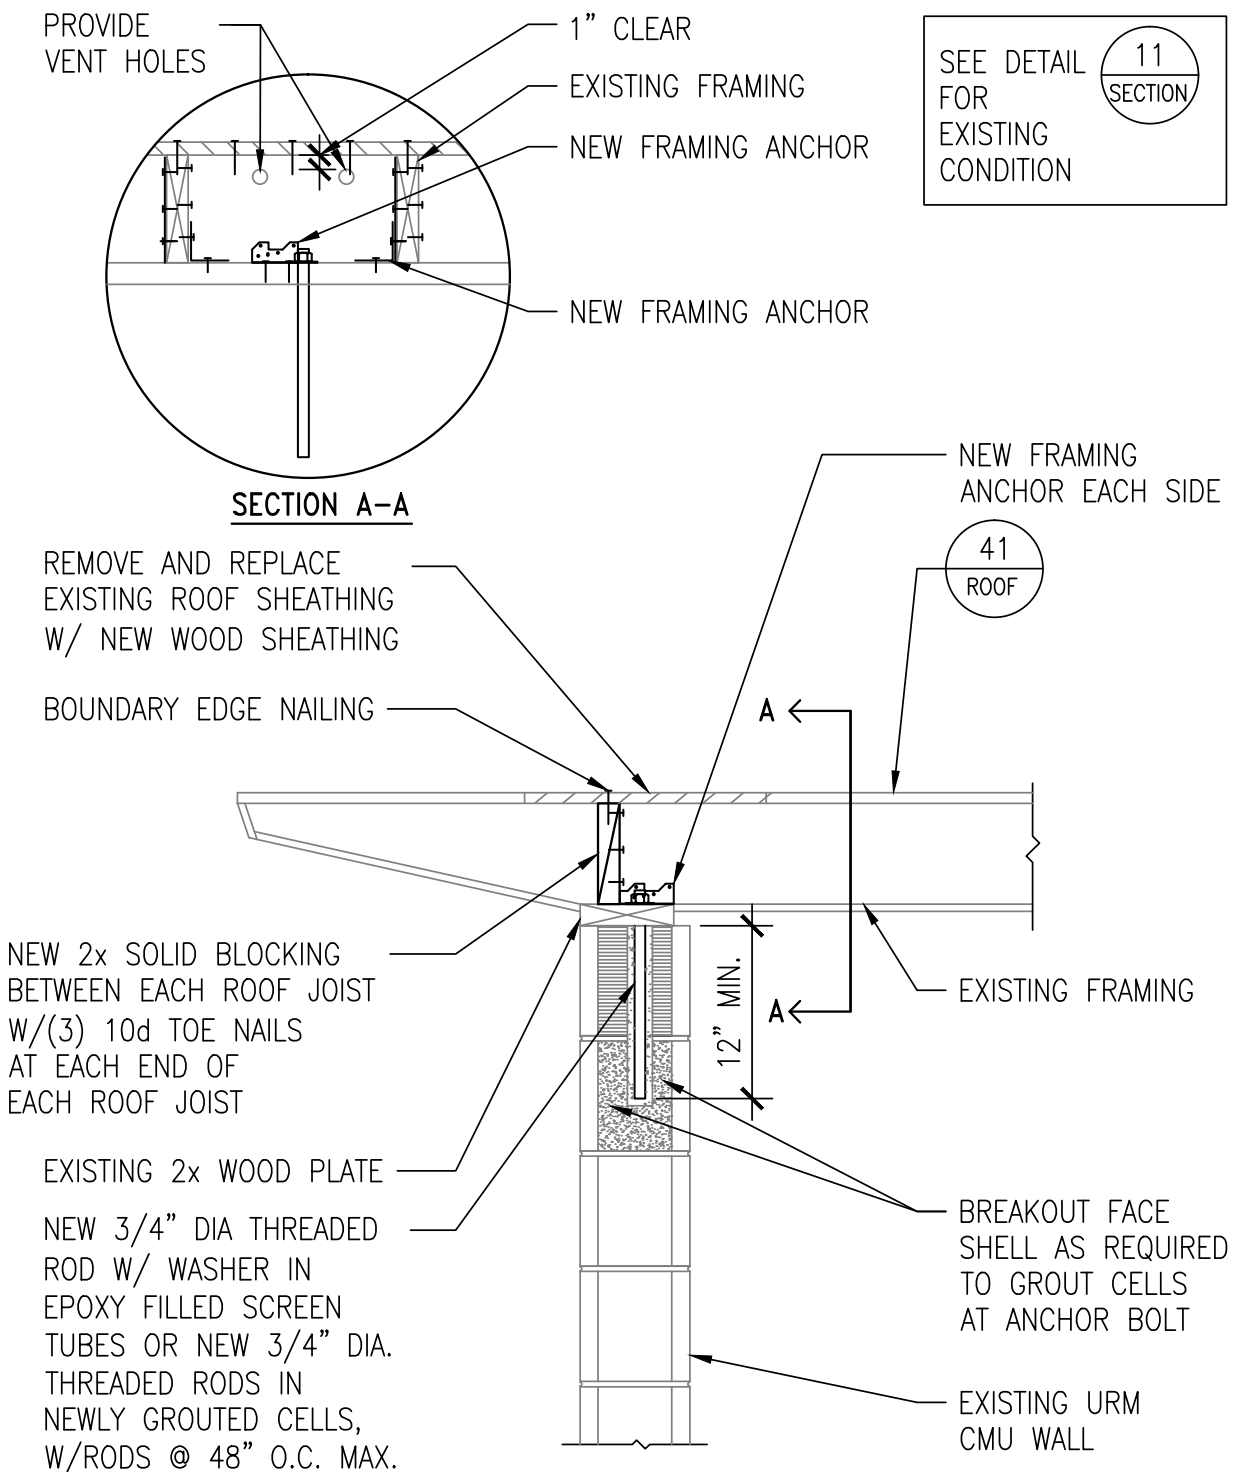
Seismic Improvement Structural Detail	HOME TYPE: MODEL E	Roof to URM Wall Anchorage	DETAIL: 33a
--	-----------------------	-------------------------------	----------------

ROOF TO URM WALL ANCHORAGE W/ JOISTS PERPENDICULAR TO WALL

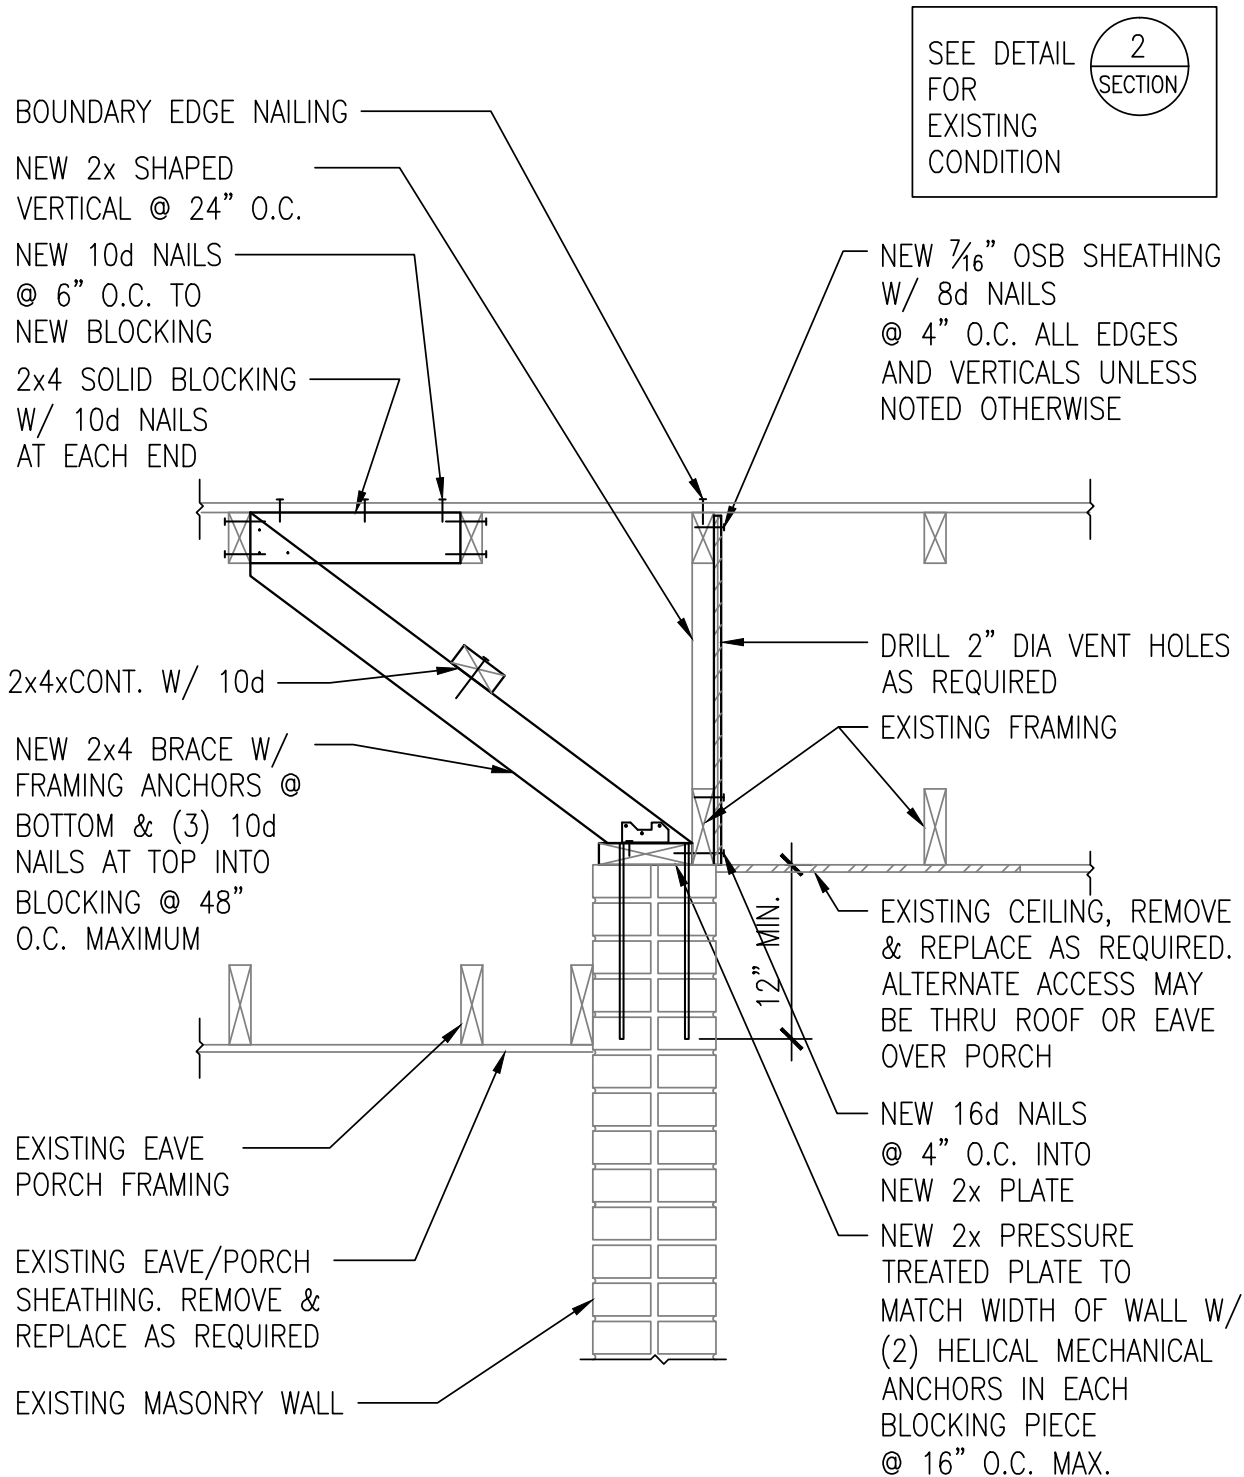
Seismic Improvement Structural Detail	HOME TYPE: MODEL F	Roof to URM Wall Anchorage	DETAIL: 34
---------------------------------------	-----------------------	----------------------------	---------------

ROOF TO URM WALL ANCHORAGE W/ JOISTS PERPENDICULAR TO WALL

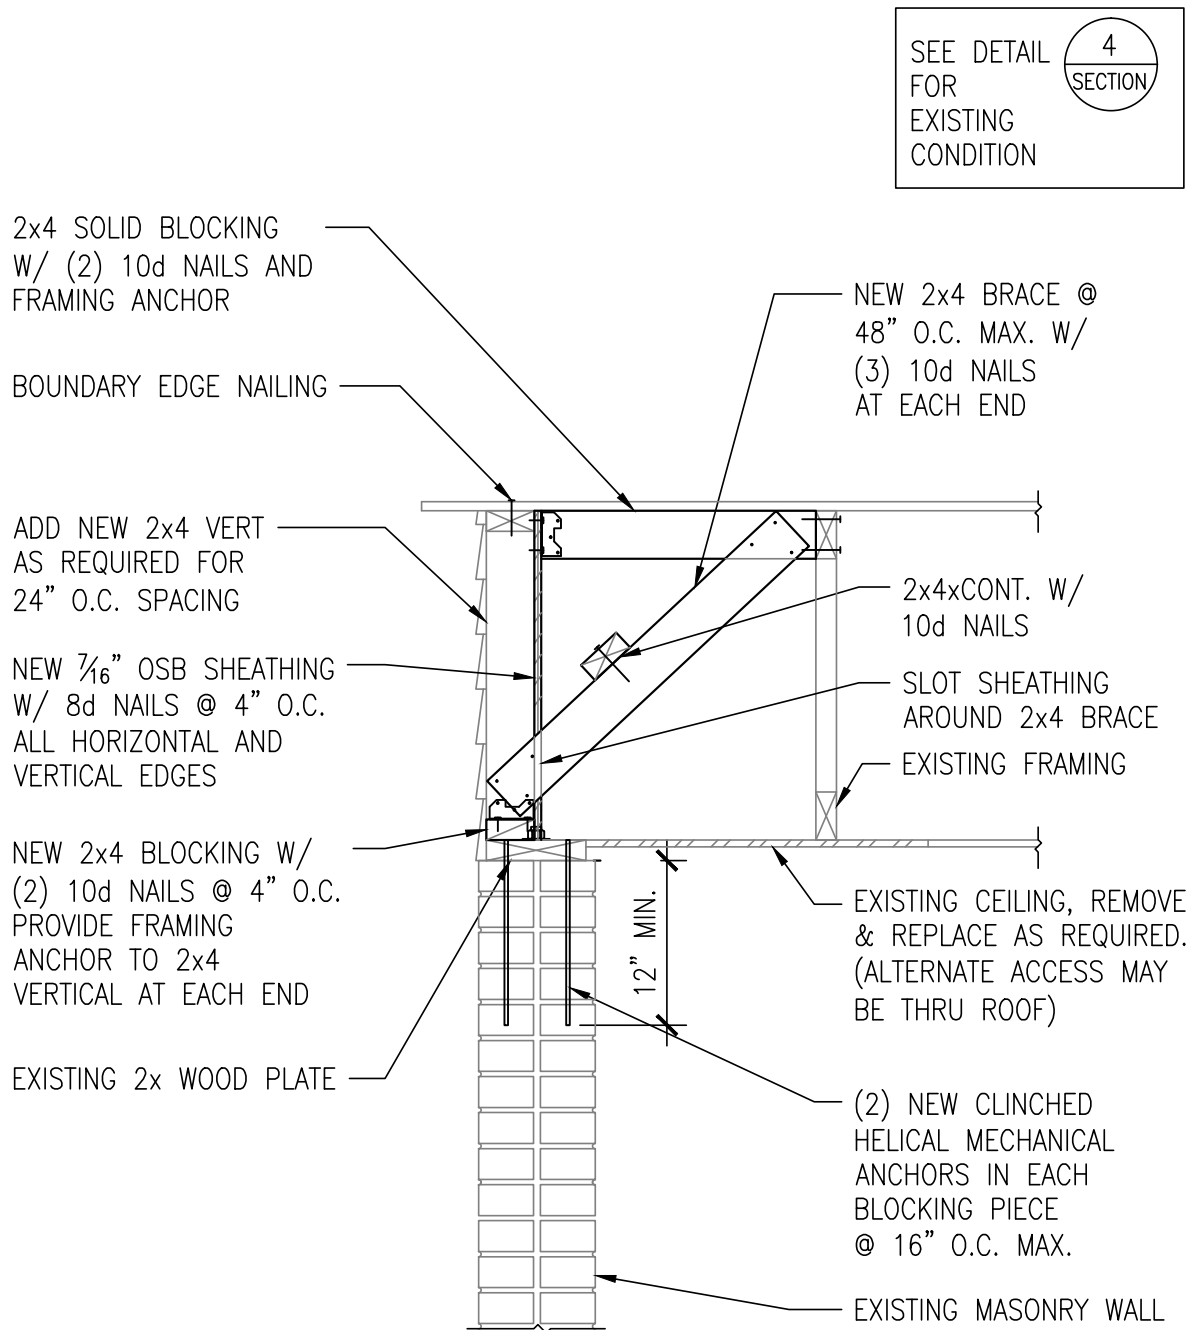
Seismic Improvement Structural Detail	HOME TYPE: MODEL A	Roof to URM Wall Anchorage	DETAIL: 35a
--	-----------------------	-------------------------------	----------------

ROOF TO URM WALL ANCHORAGE W/ JOISTS PARALLEL TO WALL

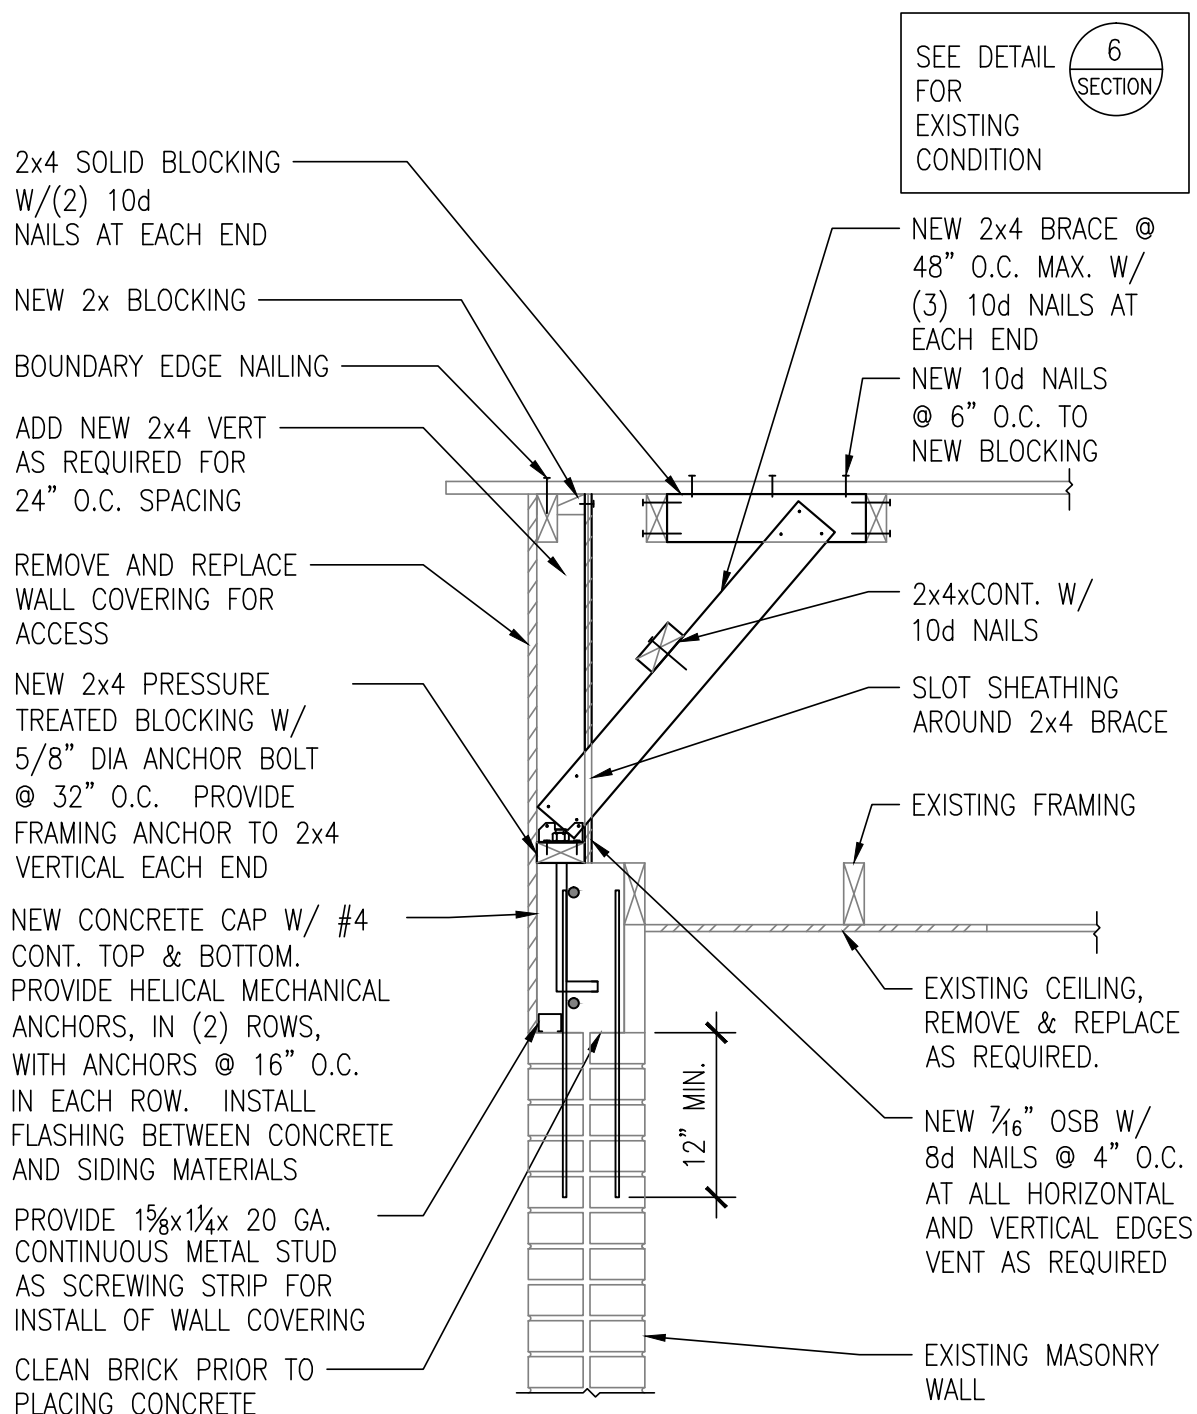
Seismic Improvement Structural Detail	HOME TYPE: MODEL G	Roof to URM Wall Anchorage	DETAIL: 36b
--	-----------------------	-------------------------------	----------------

ROOF TO URM WALL ANCHORAGE W/ JOISTS PARALLEL TO WALL

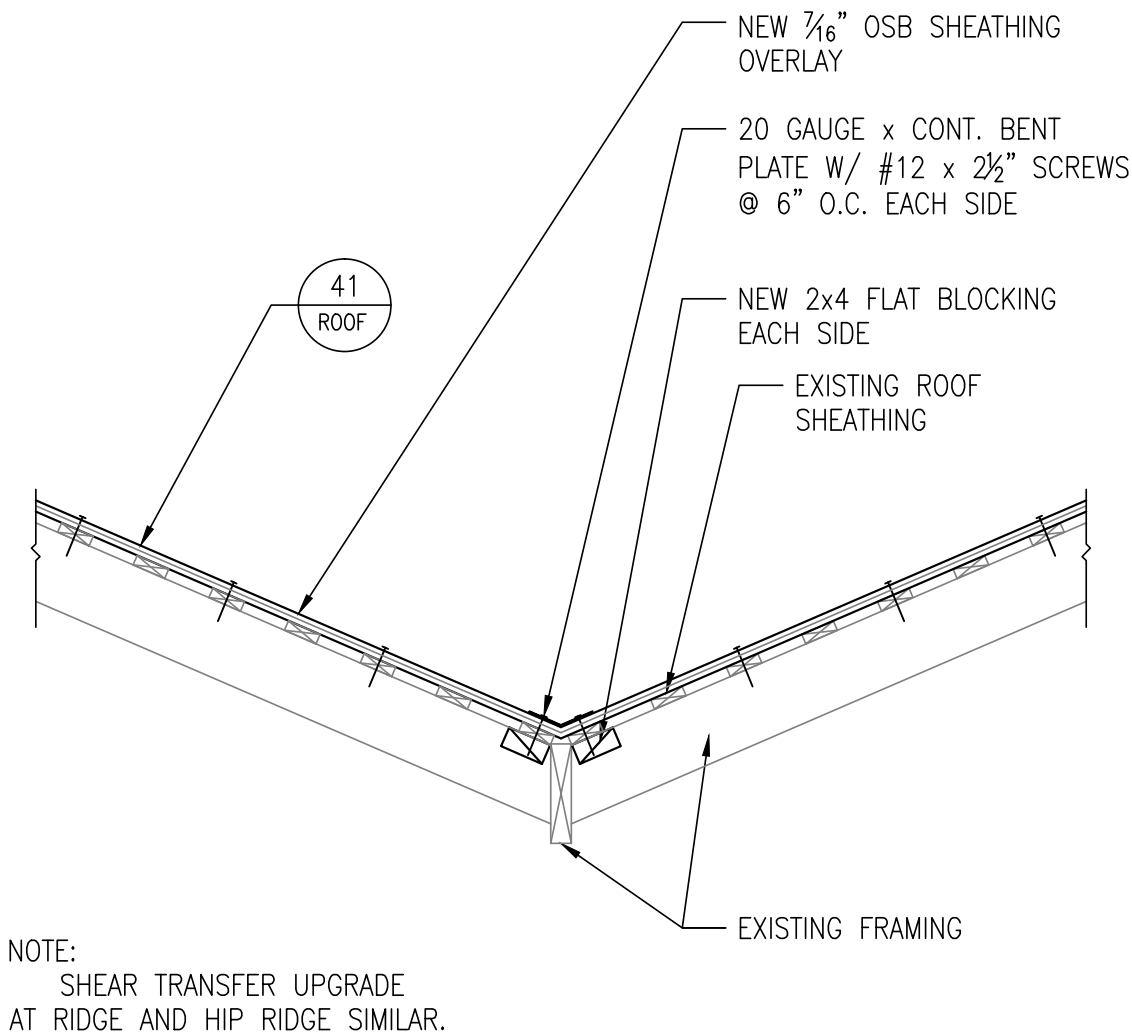
Seismic Improvement Structural Detail	HOME TYPE: ALL MODELS	Roof Diaphragm Strengthening	DETAIL: 41
--	--------------------------	---------------------------------	---------------

ROOF DIAPHRAGM STRENGTHENING

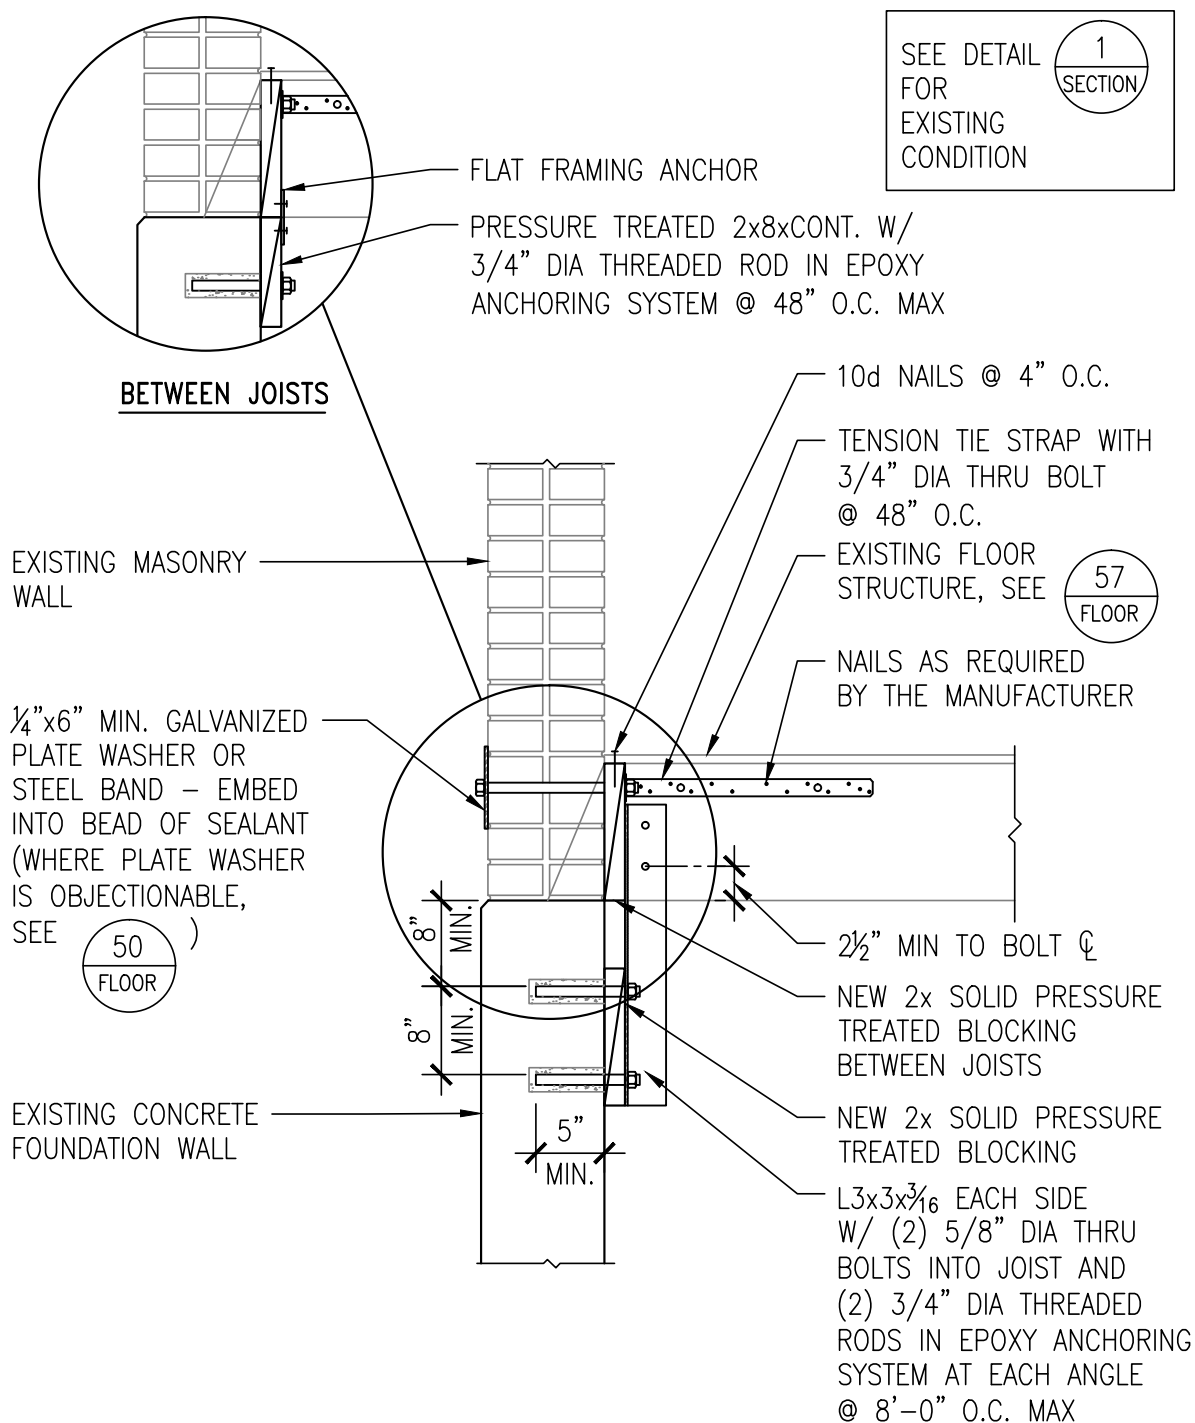
Seismic Improvement Structural Detail	HOME TYPE: MODEL C & D	Floor to URM Wall Anchorage	DETAIL: 50
--	---------------------------	--------------------------------	---------------

**FLOOR TO URM WALL ANCHORAGE
WITH JOISTS PERPENDICULAR TO WALL**

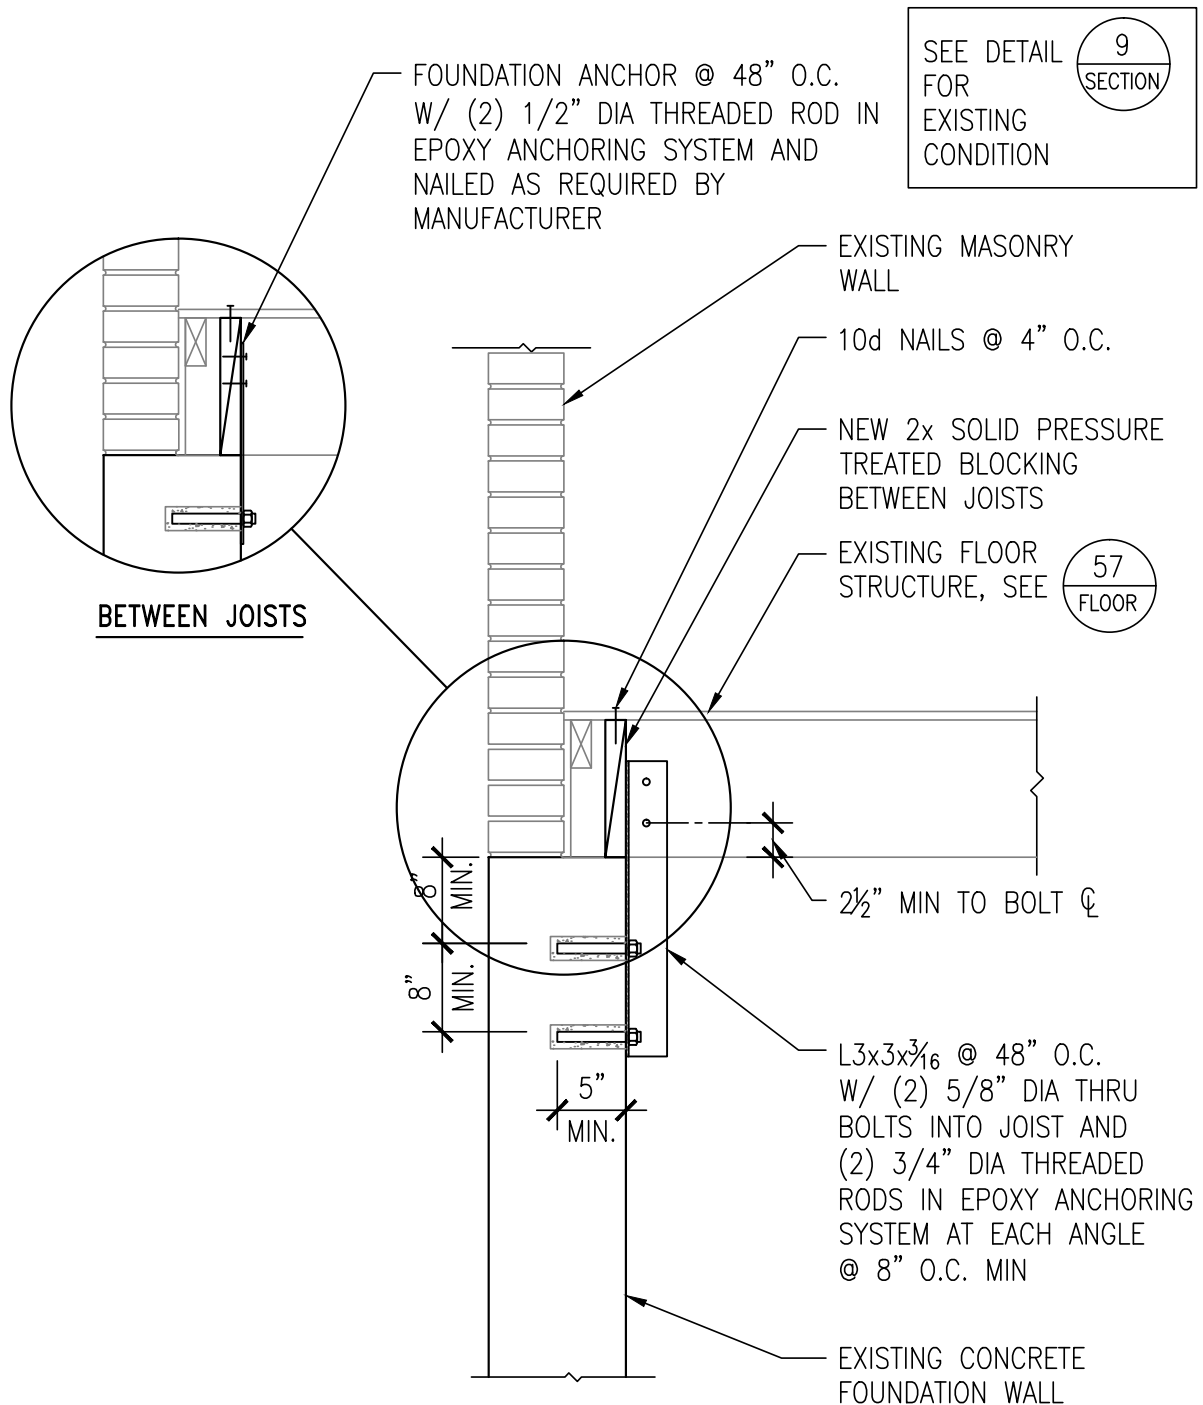
Seismic Improvement Structural Detail	HOME TYPE: MODEL A,B,C,D,&F	Floor to URM Wall Anchorage	DETAIL: 51
--	--------------------------------	--------------------------------	---------------

FLOOR TO URM WALL & FOUNDATION WALL
ANCHORAGE W/JOISTS PERPENDICULAR TO WALL

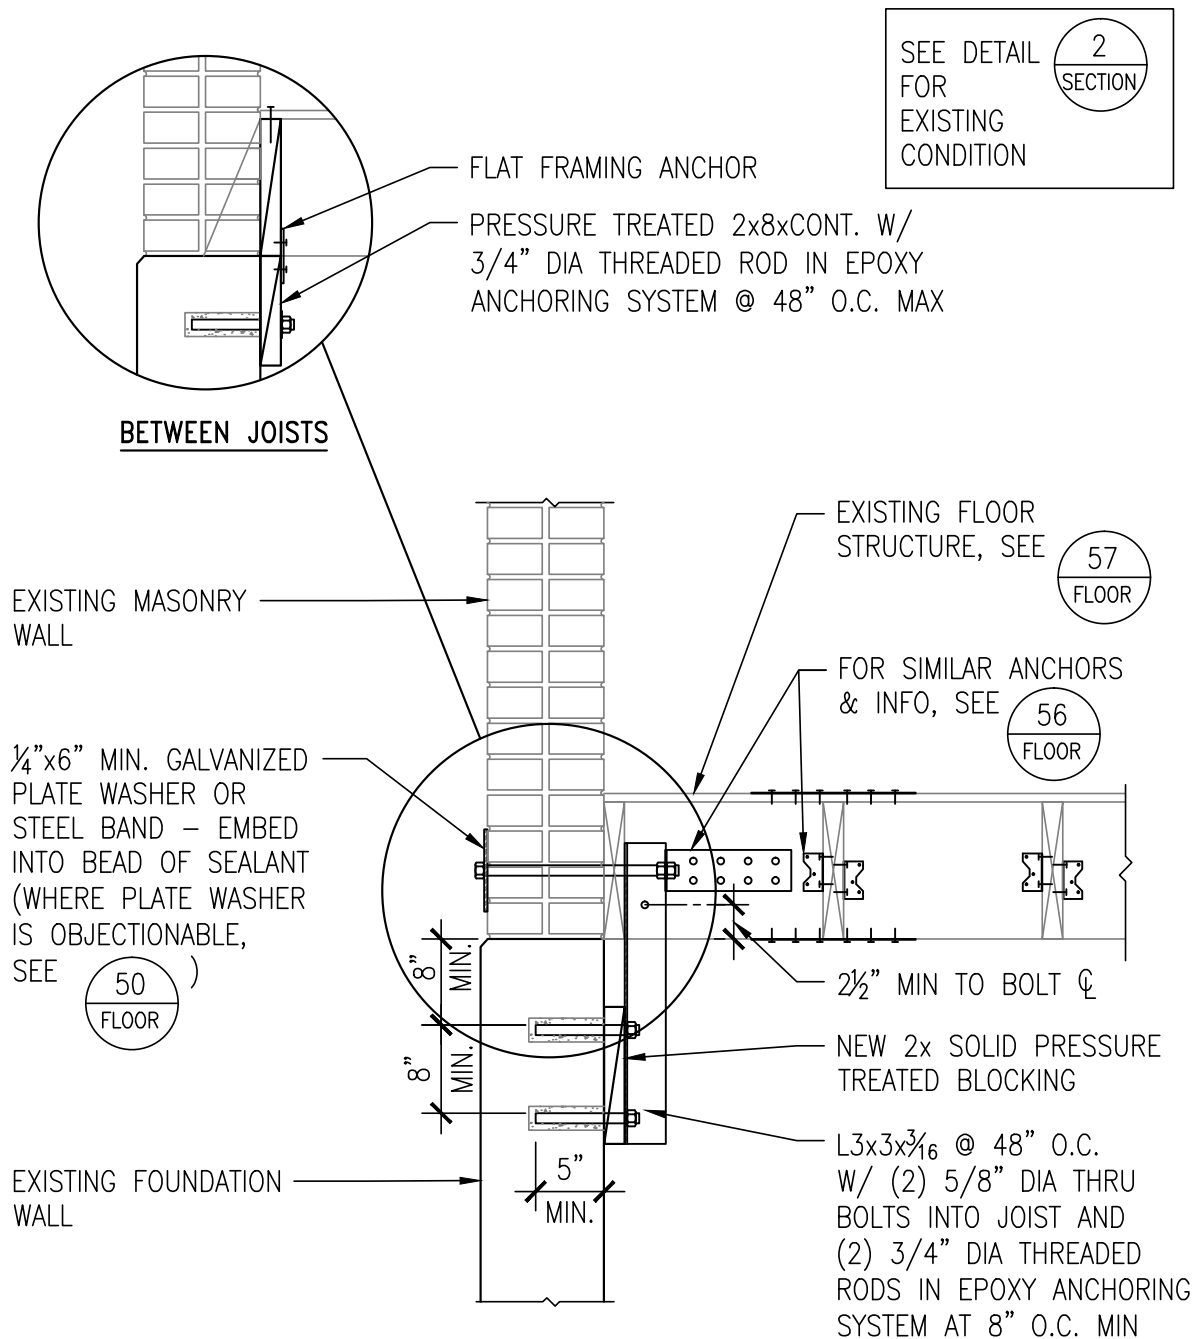
Seismic Improvement Structural Detail	HOME TYPE: MODEL A,B,C,&D	Floor to URM Wall Anchorage	DETAIL: 53
---------------------------------------	---------------------------	-----------------------------	------------

FLOOR BEAM TO FOUNDATION WALL ANCHORAGE

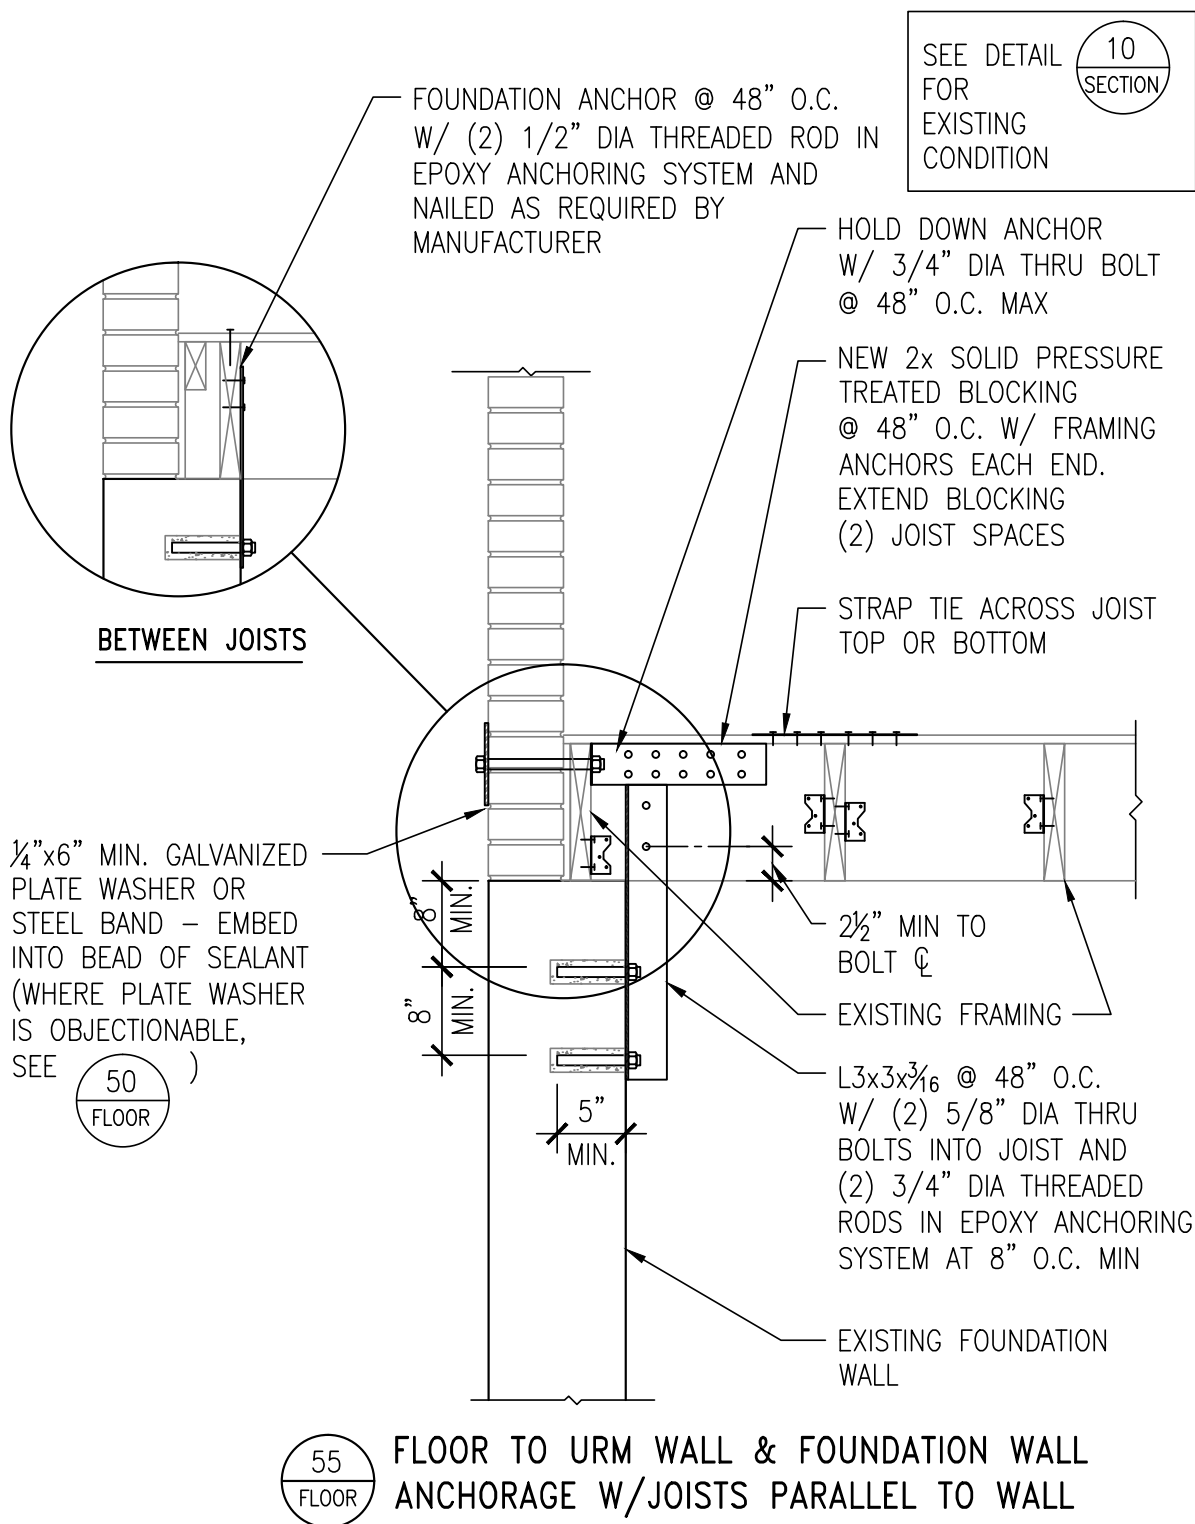
FLOOR TO URM WALL & FOUNDATION WALL ANCHORAGE W/JOISTS PARALLEL TO WALL

Seismic Improvement Structural Detail	HOME TYPE: MODEL A,B,C,&D	Floor to URM Wall Anchorage	DETAIL: 54
---------------------------------------	------------------------------	-----------------------------	---------------
