THE UTAH GUIDE FOR THE SEISMIC IMPROVEMENT OF **UNREINFORCED MASONRY DWELLINGS**

**Utah Seismic Safety Commission
Existing Buildings Committee
Second Edition
2016**

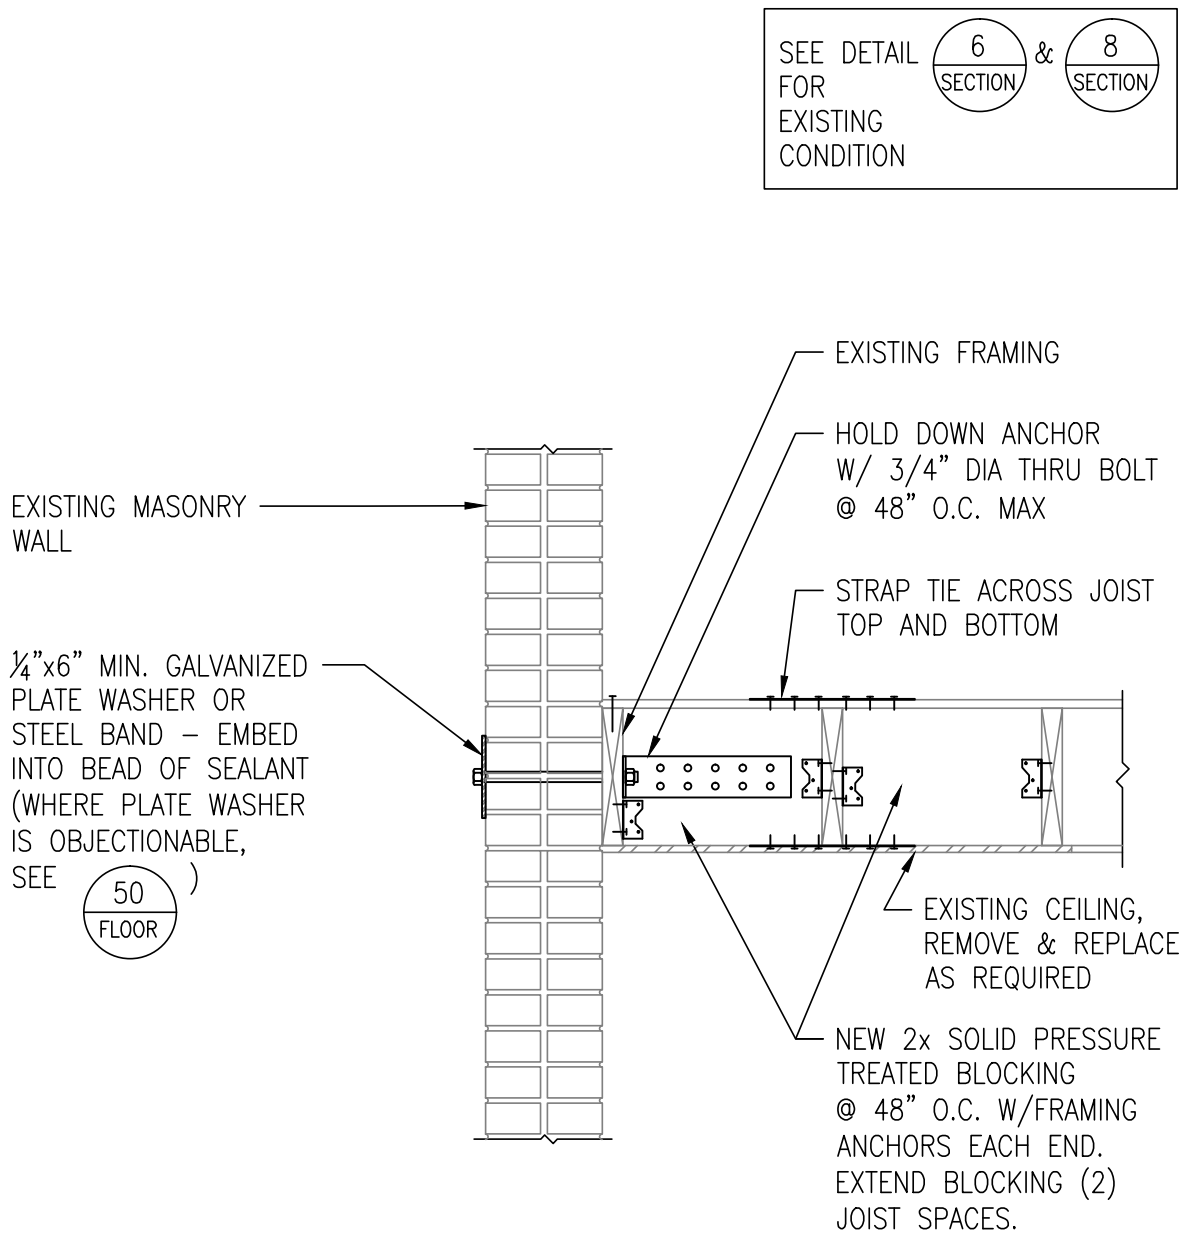
Seismic Improvement Structural Detail	HOME TYPE: MODEL E	Floor to URM Wall Anchorage	DETAIL: 55
--	-----------------------	--------------------------------	---------------

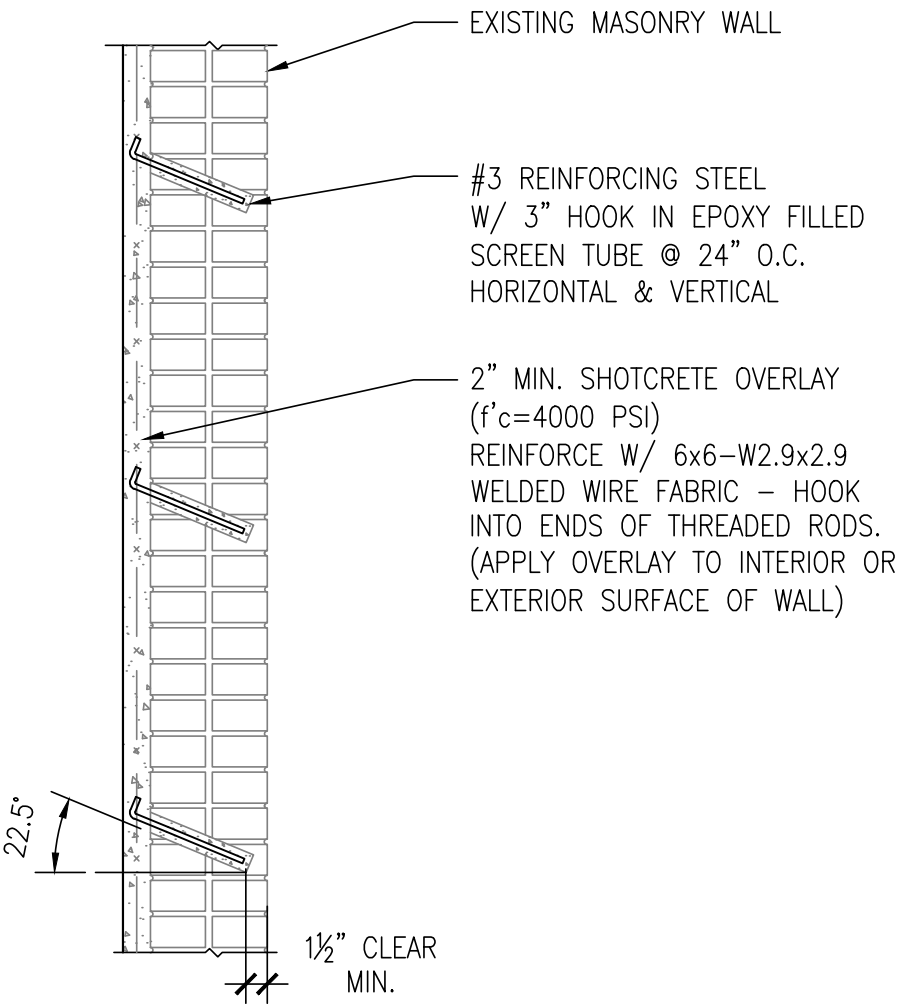
URM WALL STRENGTHENING

Seismic Improvement Structural Detail	HOME TYPE: VARIES	URM Wall Strengthening	DETAIL: 72
--	----------------------	---------------------------	---------------

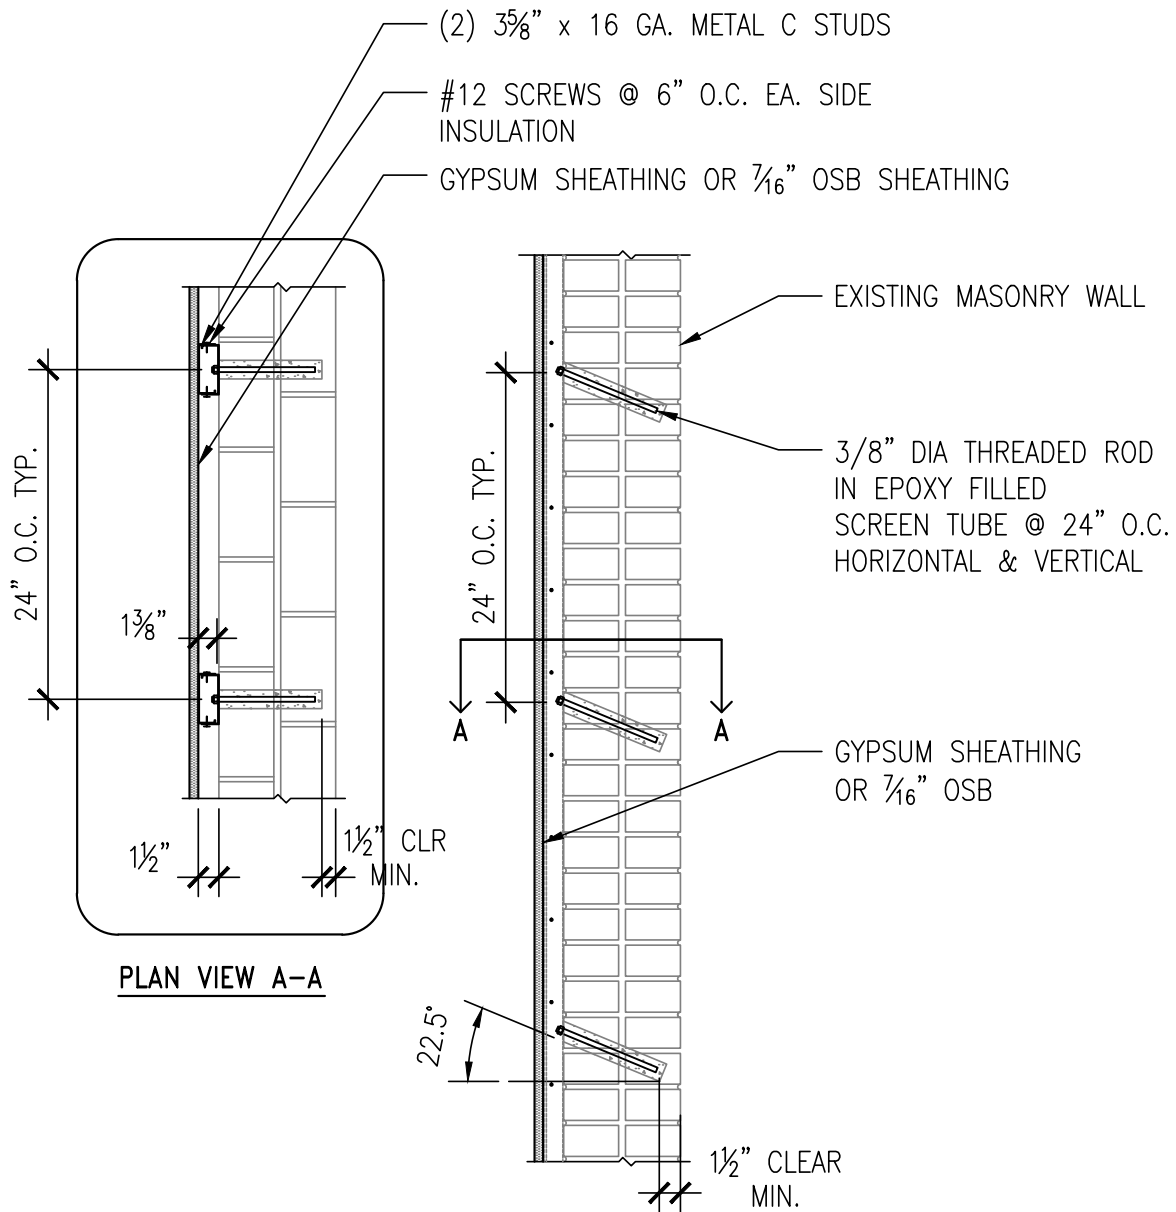
URM WALL STRENGTHENING

Seismic Improvement Structural Detail	HOME TYPE: VARIES	URM Wall Strengthening	DETAIL: 73
--	----------------------	---------------------------	---------------

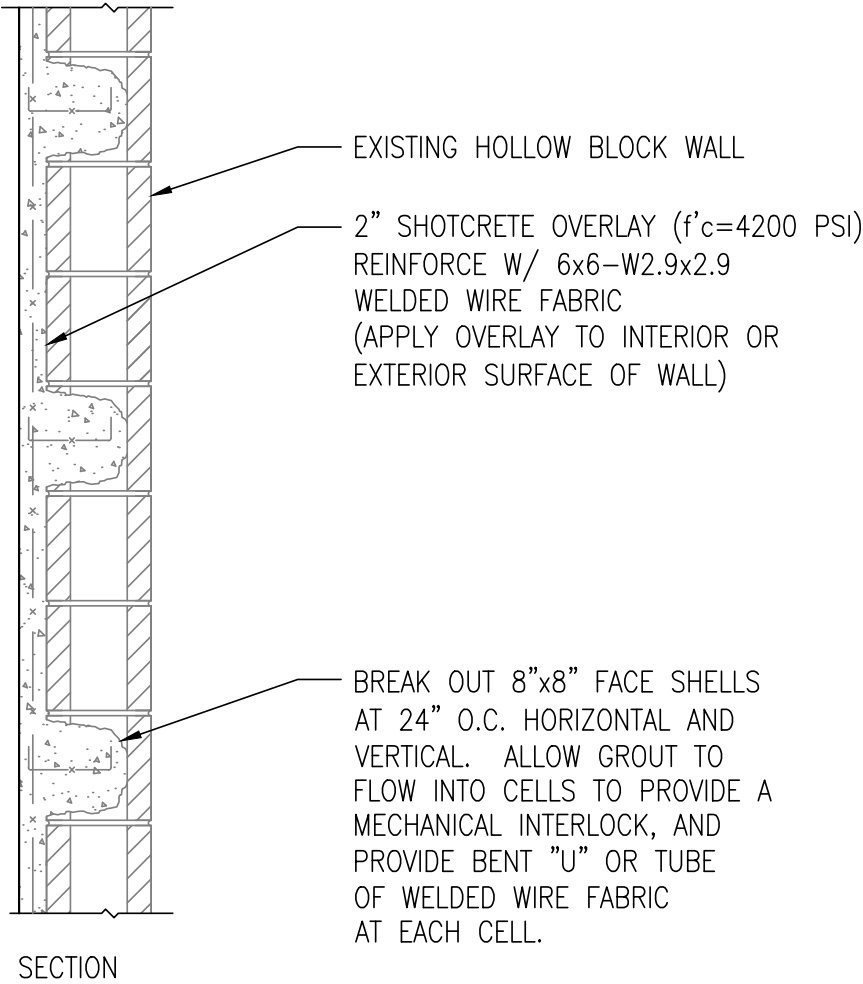
URM WALL STRENGTHENING

Seismic Improvement Structural Detail	HOME TYPE: VARIES	URM Wall Strengthening	DETAIL: 74
--	----------------------	---------------------------	---------------

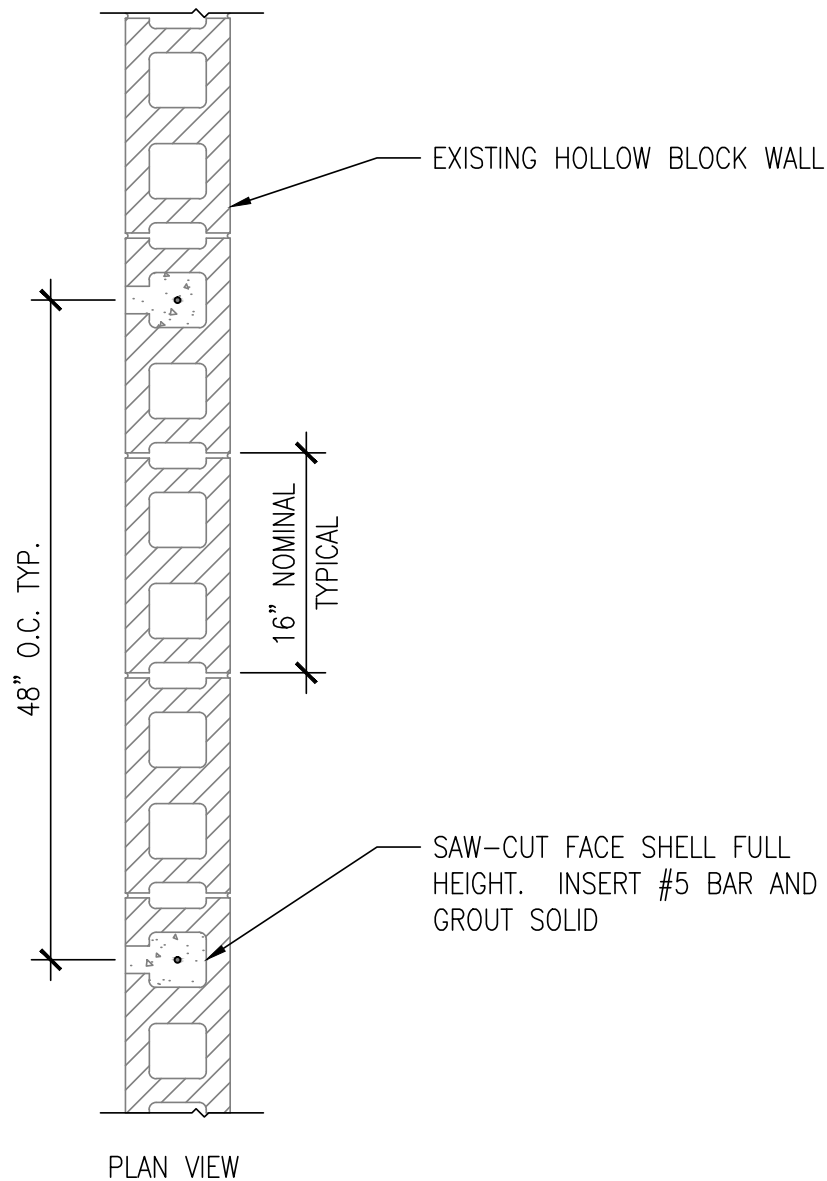
URM WALL STRENGTHENING

Seismic Improvement Structural Detail	HOME TYPE: MODEL F	URM Wall Strengthening	DETAIL: 75
--	-----------------------	---------------------------	---------------

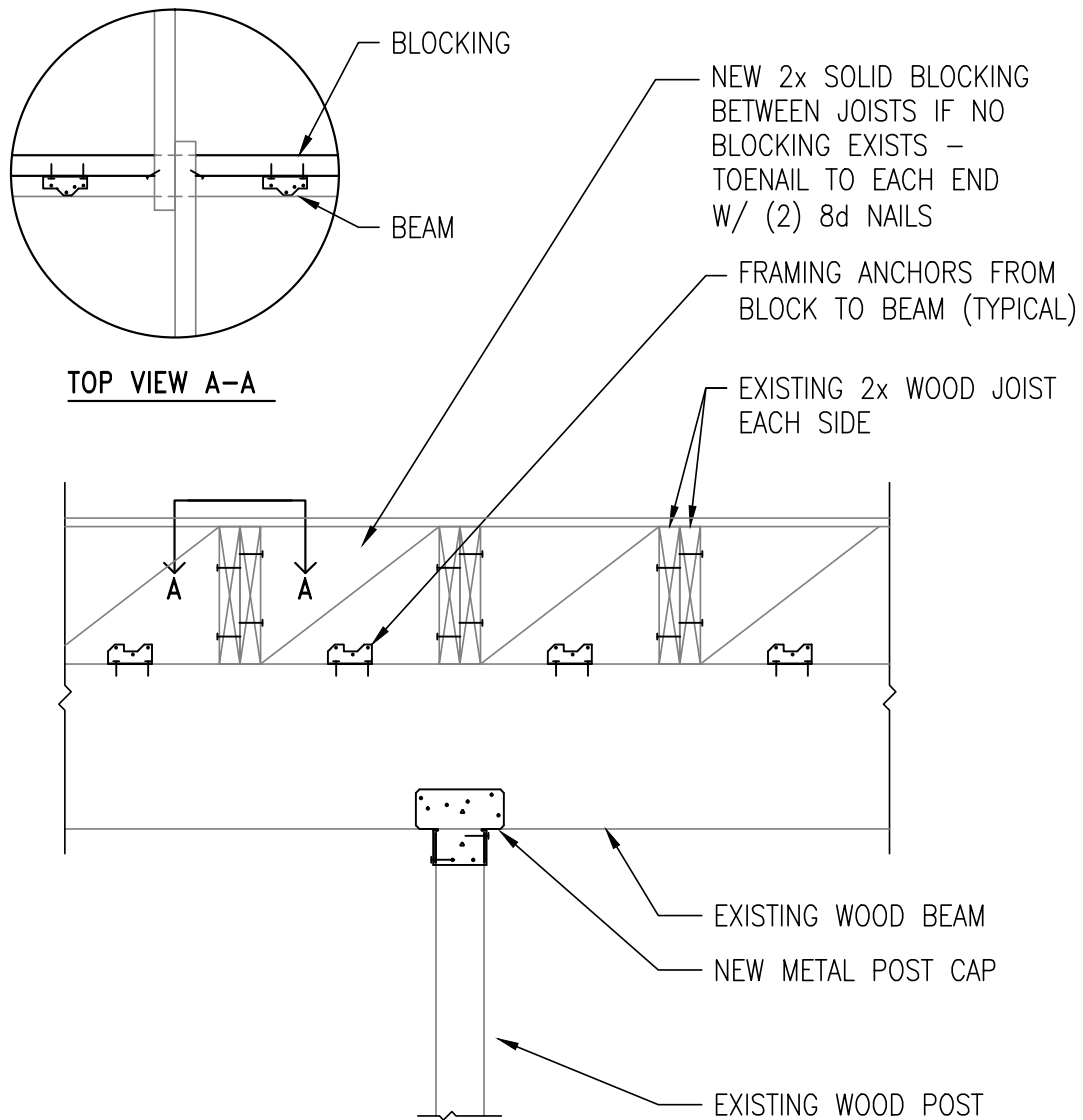
WOOD JOIST TO INTERIOR BEARING WALL AT CEILING JOISTS

Seismic Improvement Structural Detail	HOME TYPE: VARIES	Interior Bearing Strengthening	DETAIL: 81
--	----------------------	-----------------------------------	---------------

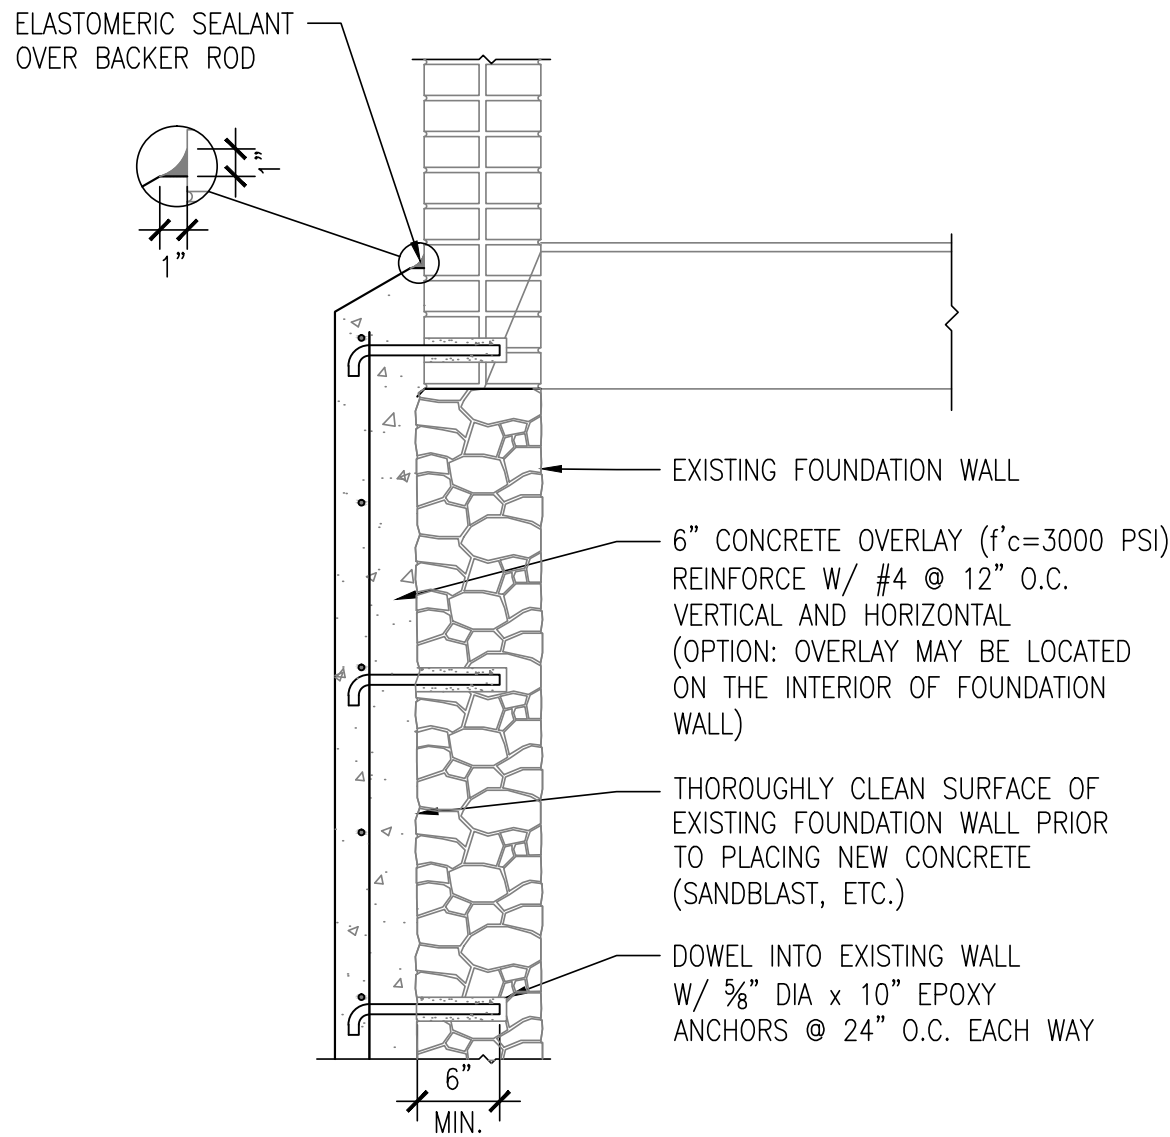
FOUNDATION WALL STRENGTHENING

Seismic Improvement Structural Detail	HOME TYPE: VARIES	Foundation Wall Strengthening	DETAIL: 90
--	----------------------	----------------------------------	---------------

Foundation anchorage and strengthening: Detail 90

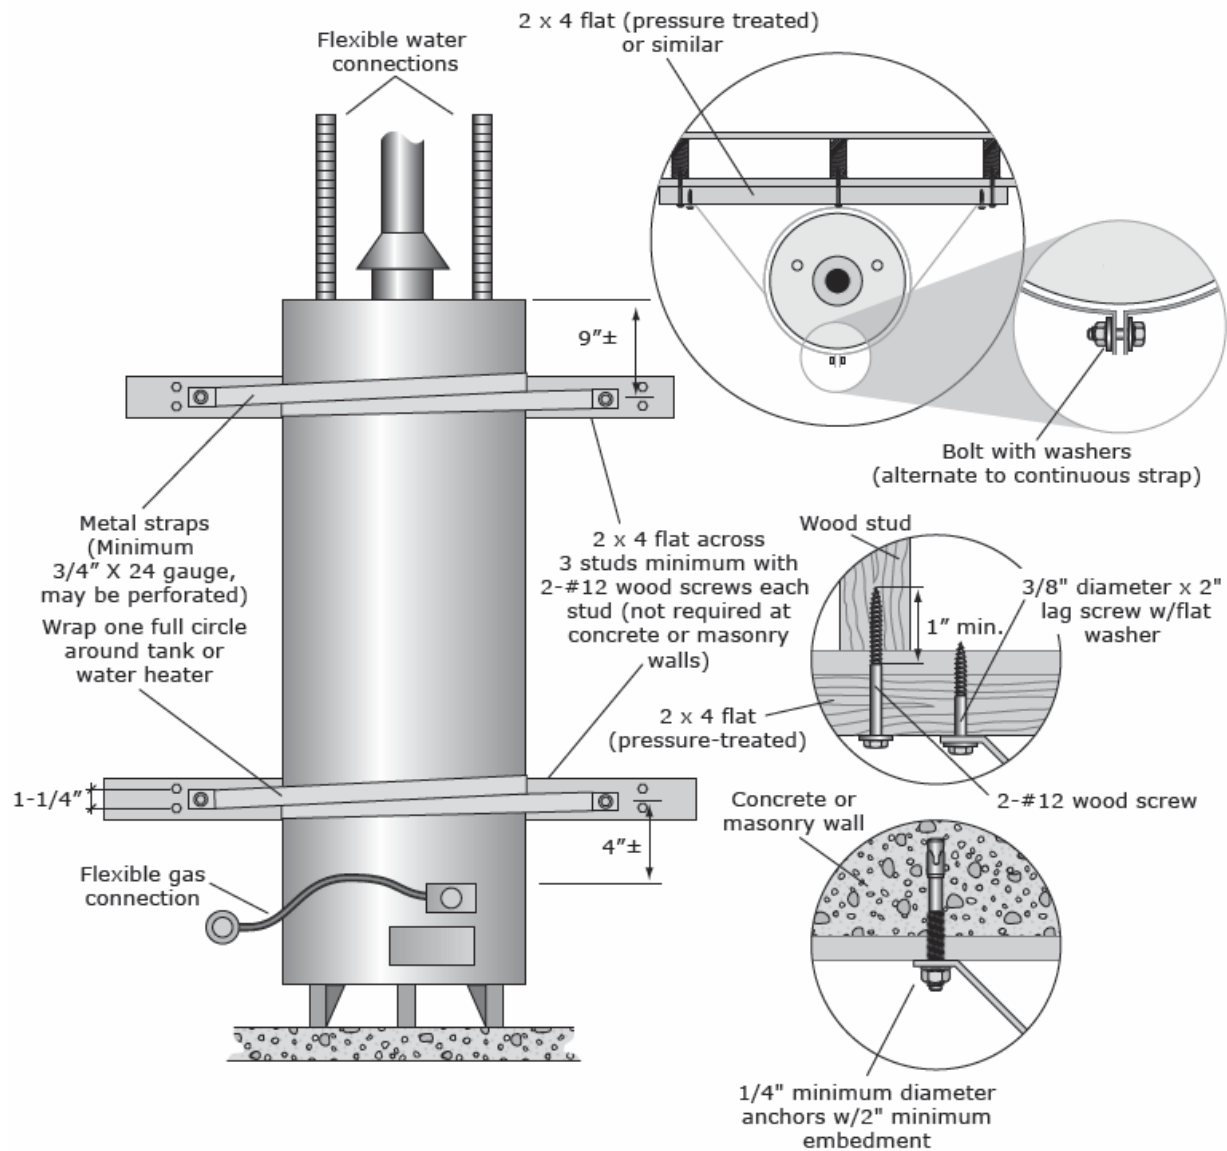
Water heater bracing: Details 100–101

Seismic Improvement Non-Structural Detail	HOME TYPE: VARIES	Water Heater Bracing	DETAIL: 100
--	----------------------	-------------------------	----------------

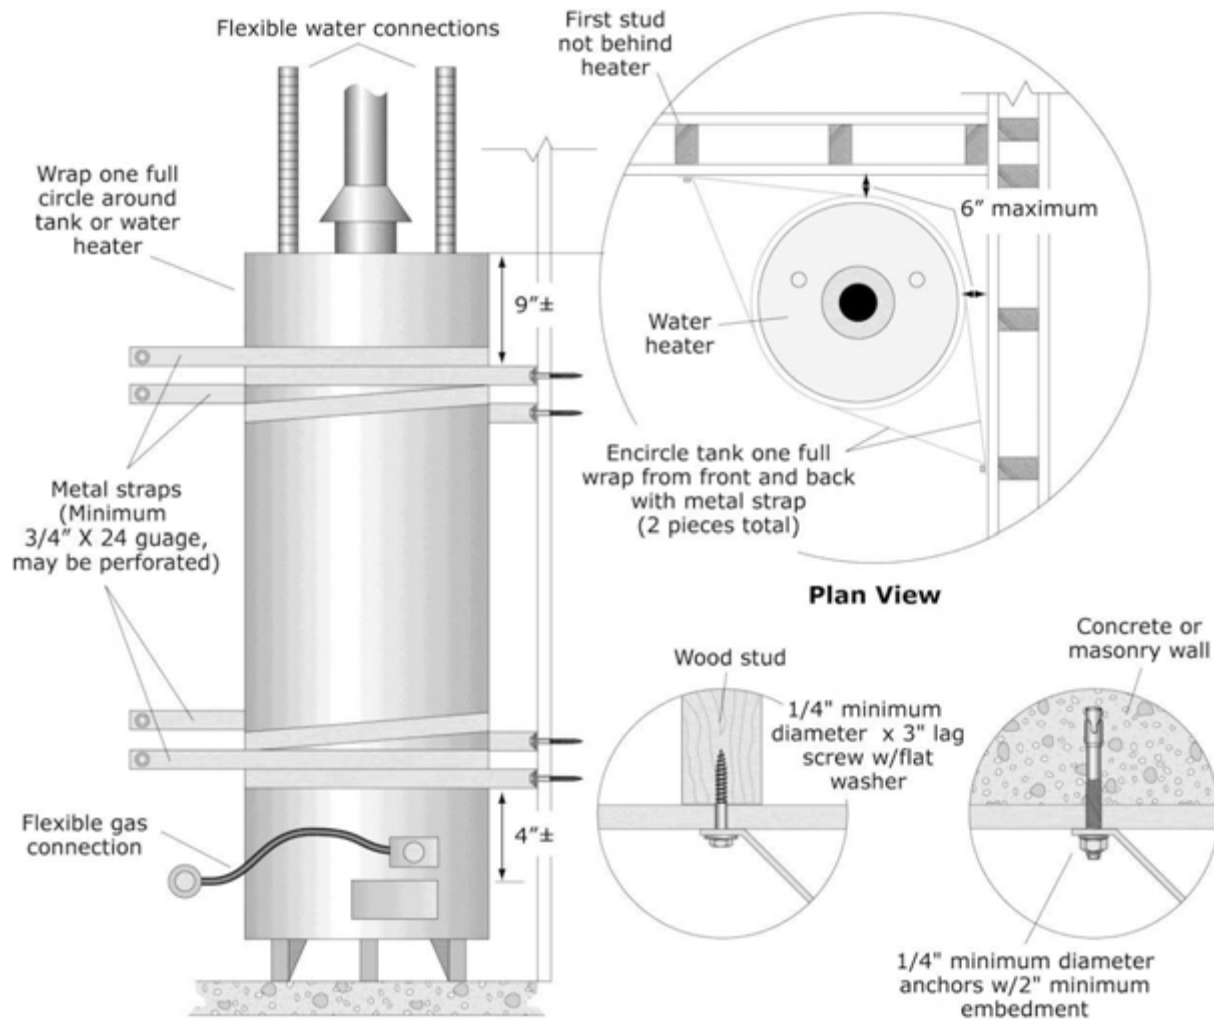
Seismic Improvement Non-Structural Detail	HOME TYPE: VARIES	Water Heater Bracing	DETAIL: 10'
--	----------------------	-------------------------	----------------

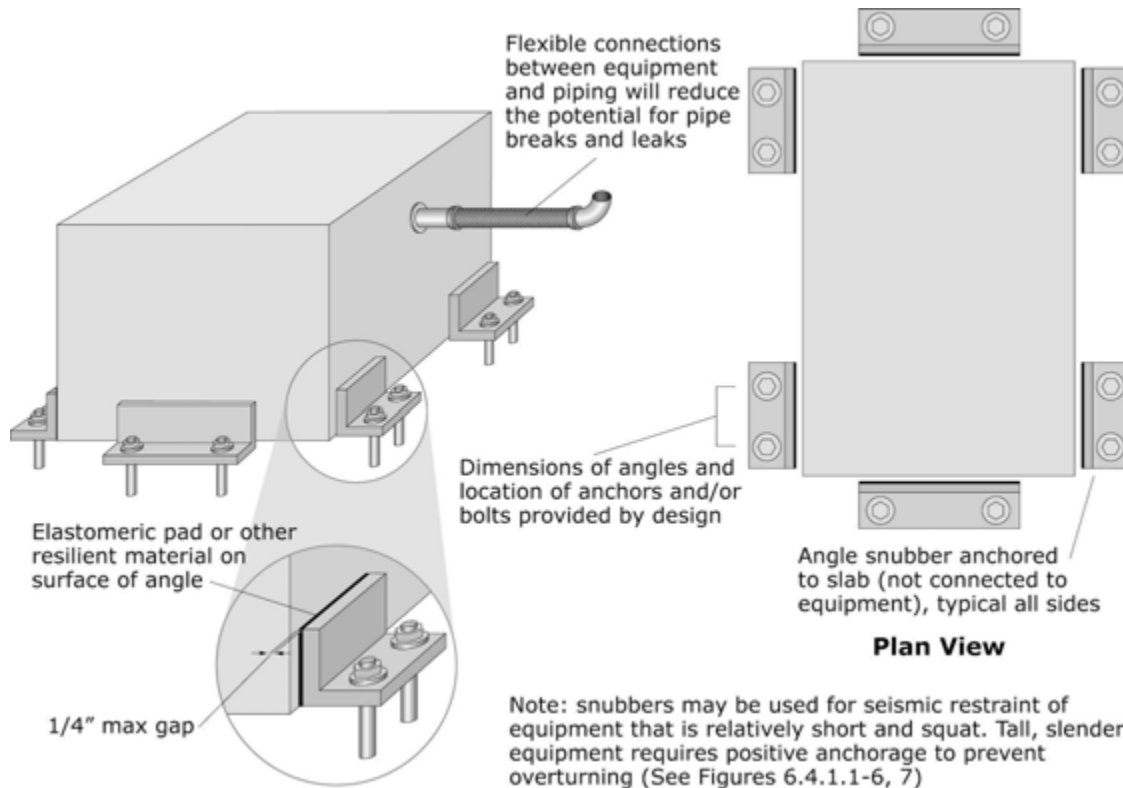
Floor-mounted equipment: Detail 102

Seismic Improvement Non-Structural Detail	HOME TYPE: VARIES	Floor Mounted Equipment	DETAIL: 102
--	----------------------	----------------------------	----------------

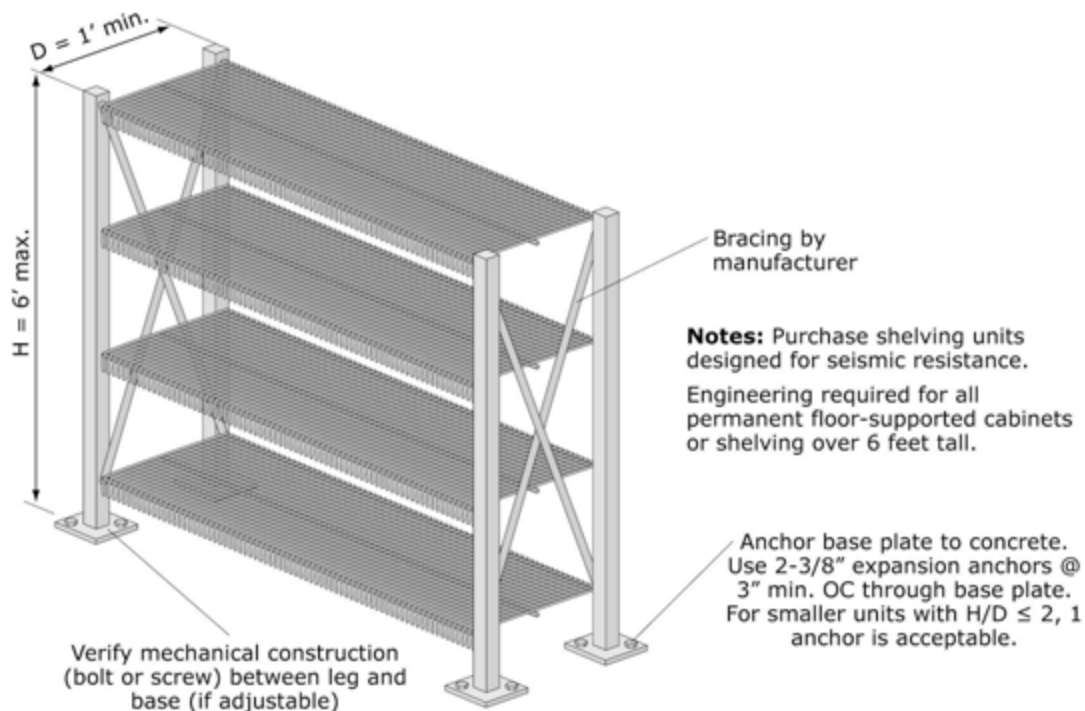
Light-duty shelving: Detail 103

Seismic Improvement Non-Structural Detail	HOME TYPE: VARIES	Light Duty Shelving	DETAIL: 103
--	----------------------	------------------------	----------------

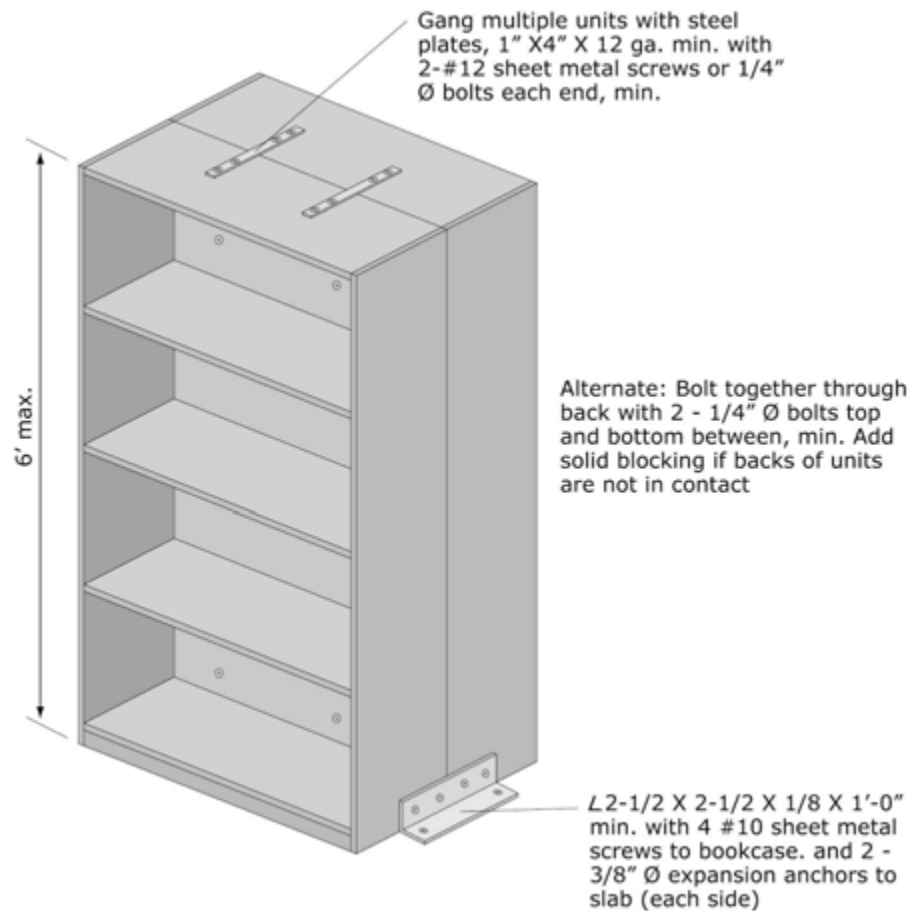
Anchoring freestanding bookcase: Detail 105

Note: Engineering required for all permanent floor-supported cabinets or shelving over 6 feet tall. Details shown are adequate for typical shelving 6 feet or less in height.

Seismic Improvement Non-Structural Detail	HOME TYPE: VARIES	Anchoring Free- Standing Bookcase	DETAIL: 105
--	----------------------	--------------------------------------	----------------

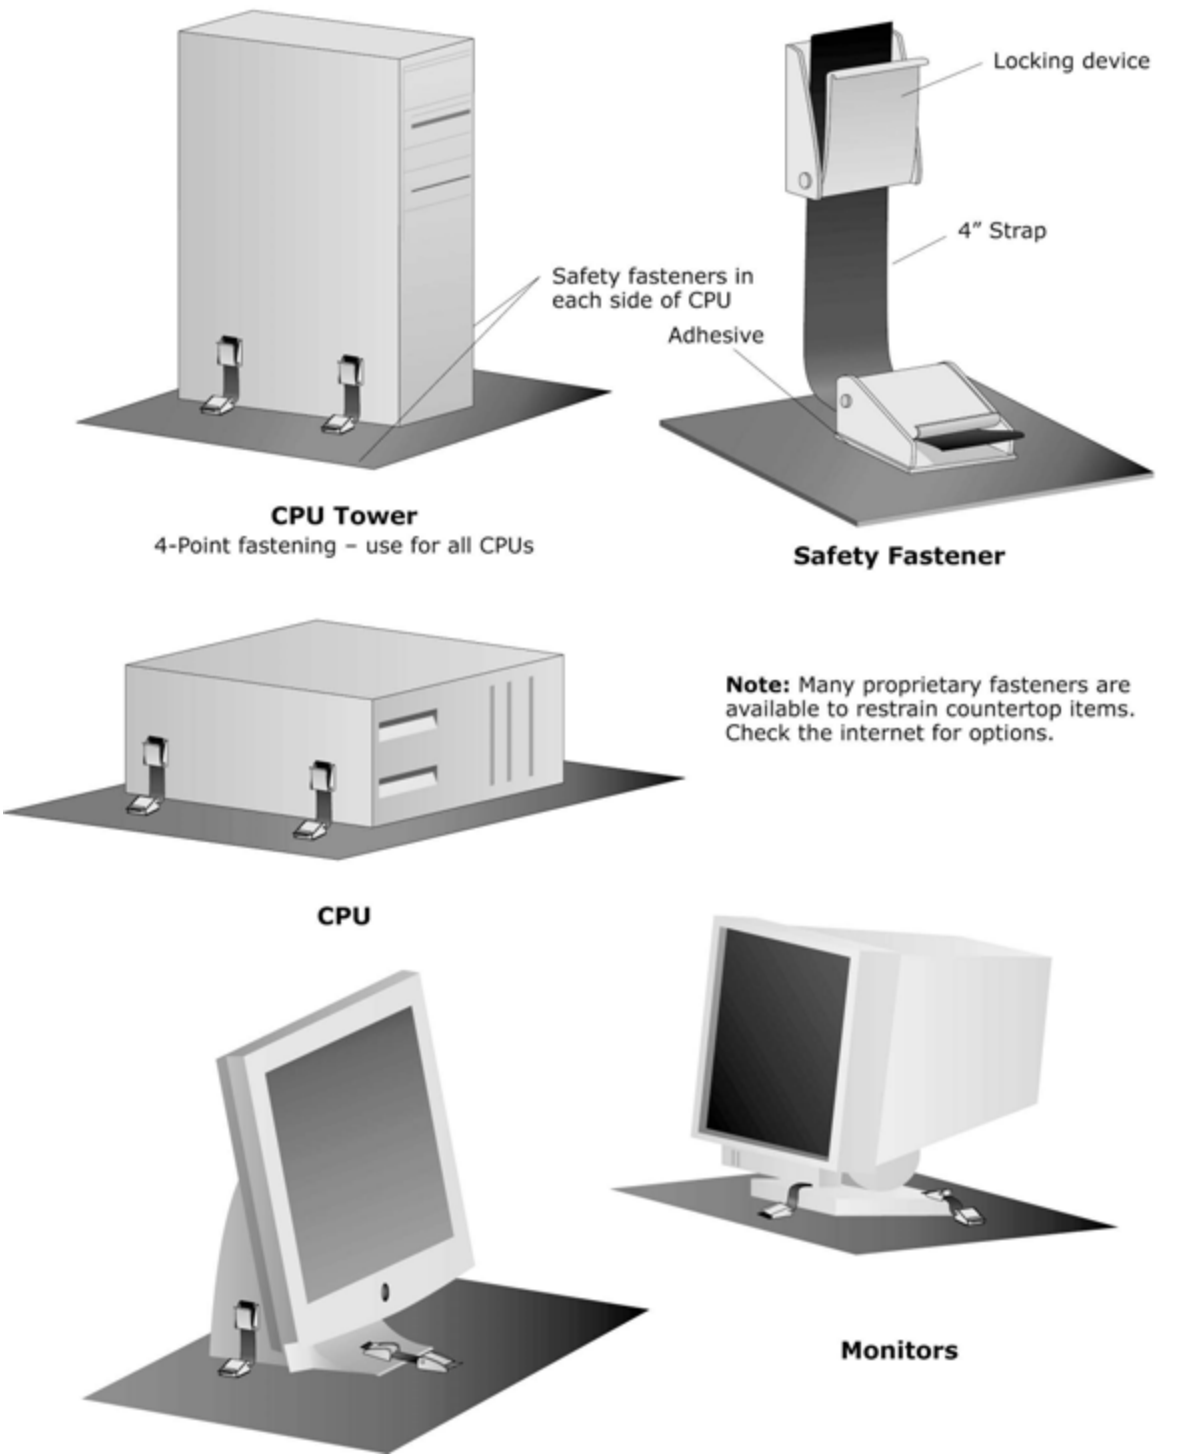
Computers and accessories: Detail 106

Seismic Improvement Non-Structural Detail	HOME TYPE: VARIES	Computers and Accessories	DETAIL 106
--	----------------------	------------------------------	---------------

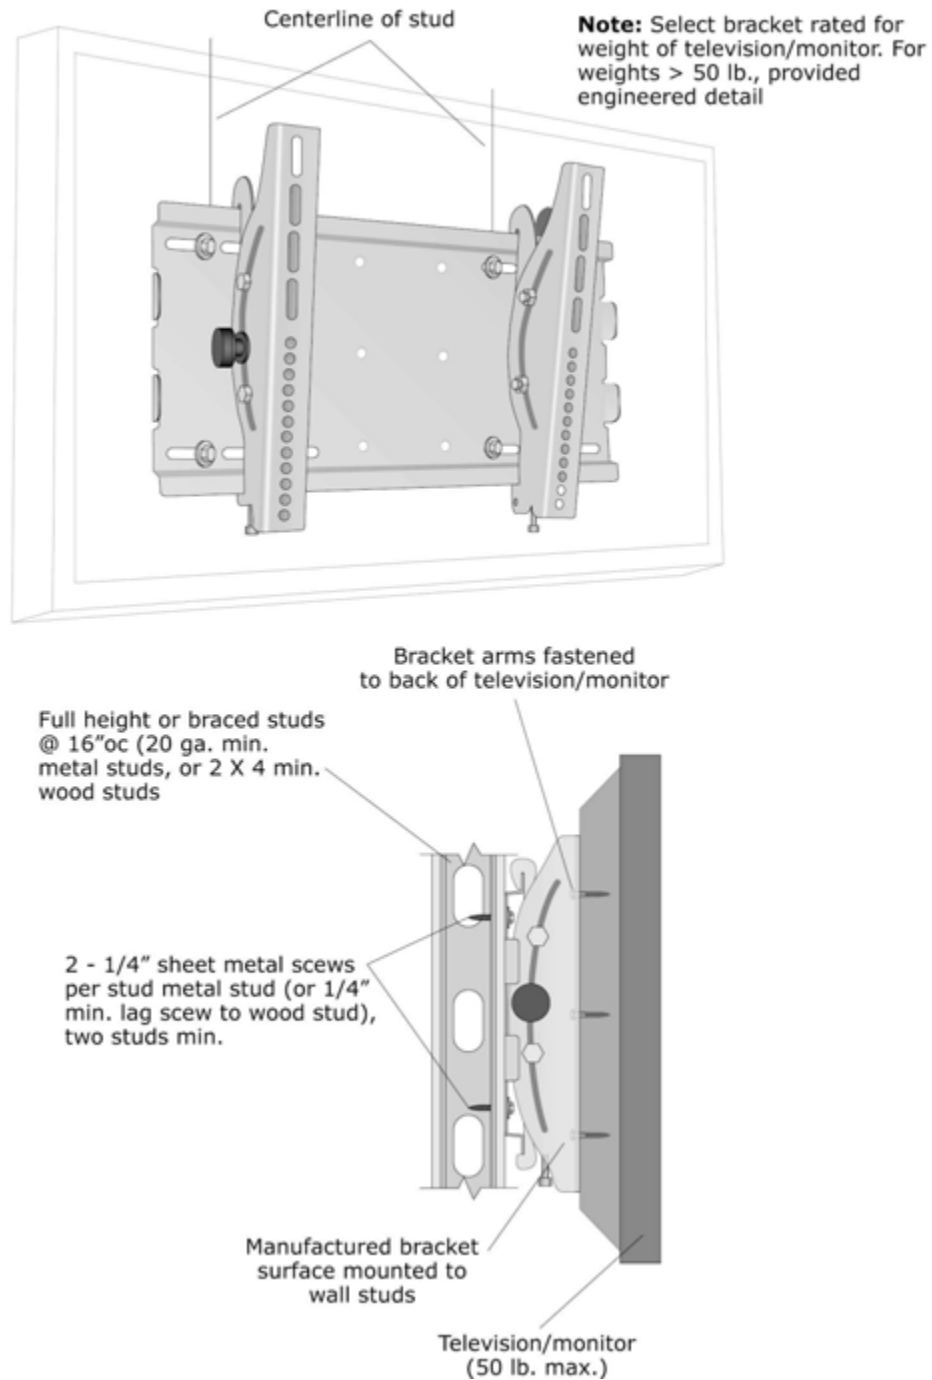
Wall-mounted televisions: Detail 107

Seismic Improvement Non-Structural Detail	HOME TYPE: VARIES	Wall-mounted Television	DETAIL: 107
--	----------------------	----------------------------	----------------

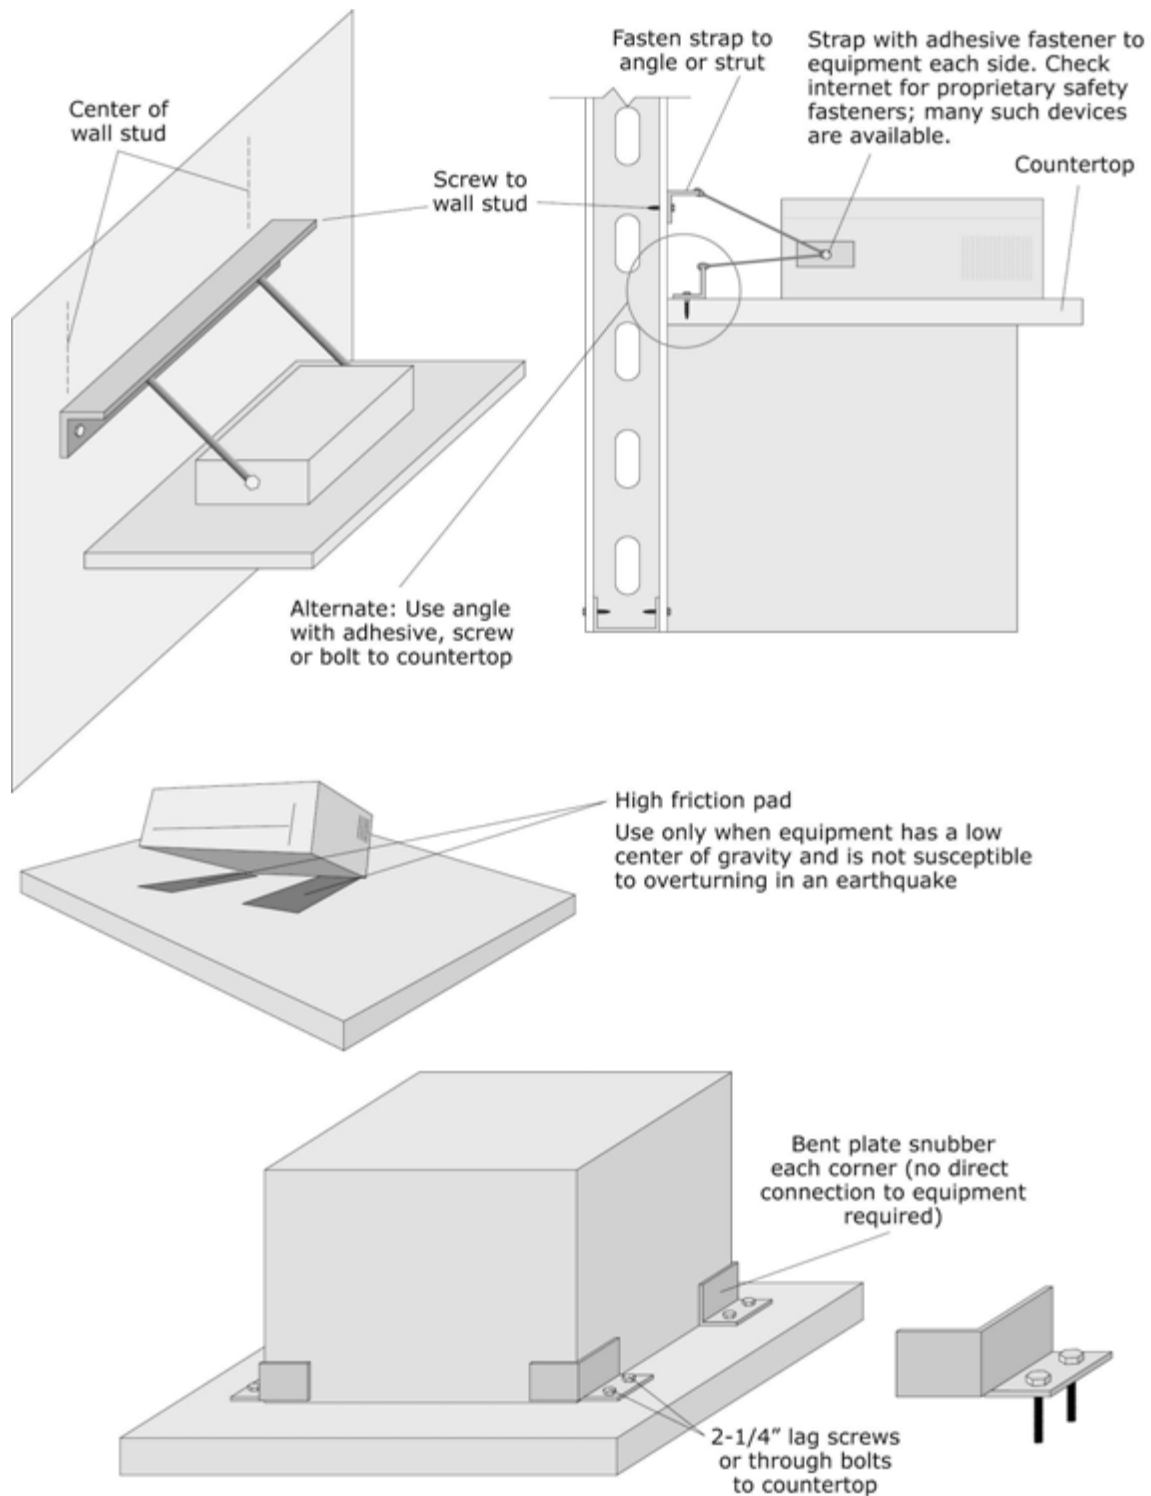
Desktop/counter equipment restraint: Detail 108

Seismic Improvement Non-Structural Detail	HOME TYPE: VARIES	Desktop/Counter Equipment Restraint	DETAIL: 108
--	----------------------	--	----------------

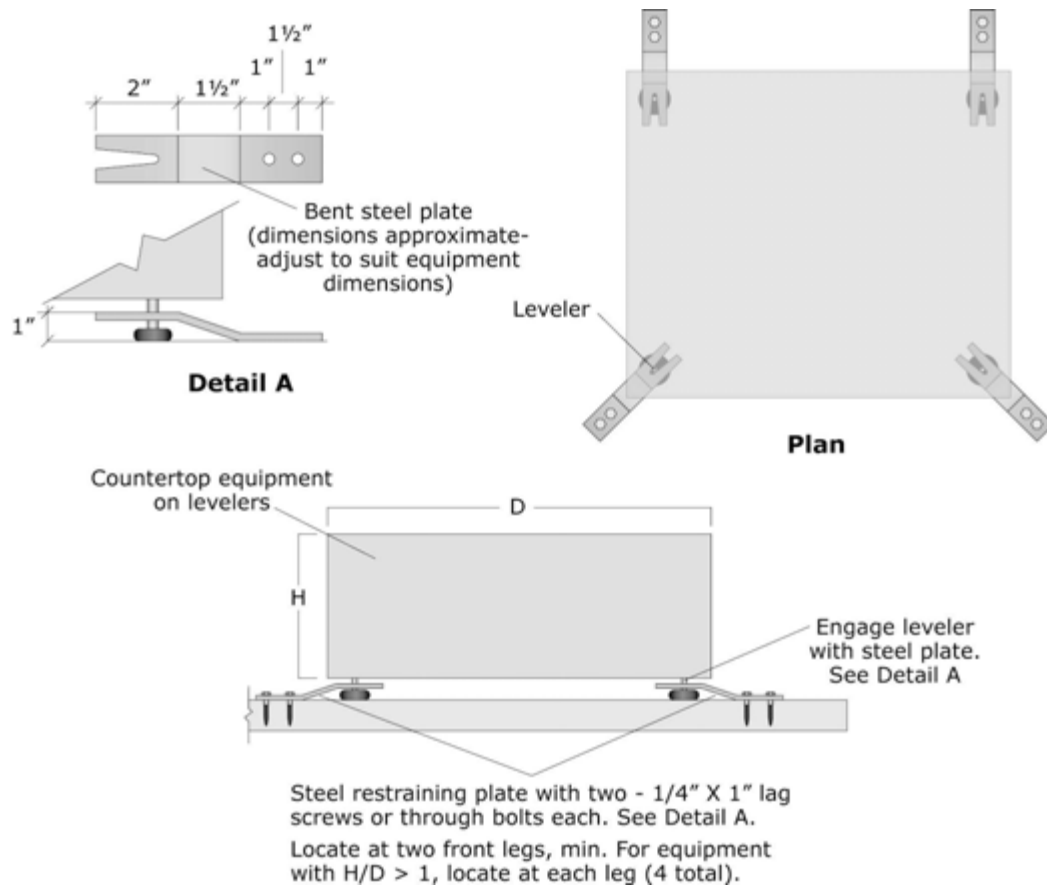
Figure 6.5.6.2-4 Desktop/countertop equipment restraining brackets (NE).

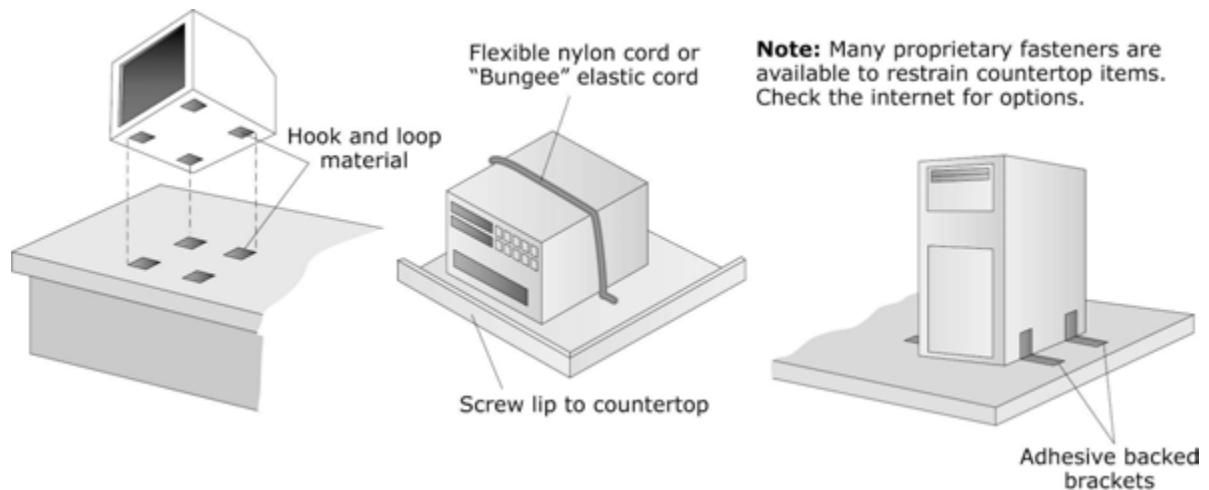
Restraining brackets/straps: Detail 109

Seismic Improvement Non-Structural Detail	HOME TYPE: VARIES	Restraining Brackets/Straps	DETAIL: 109
--	----------------------	--------------------------------	----------------

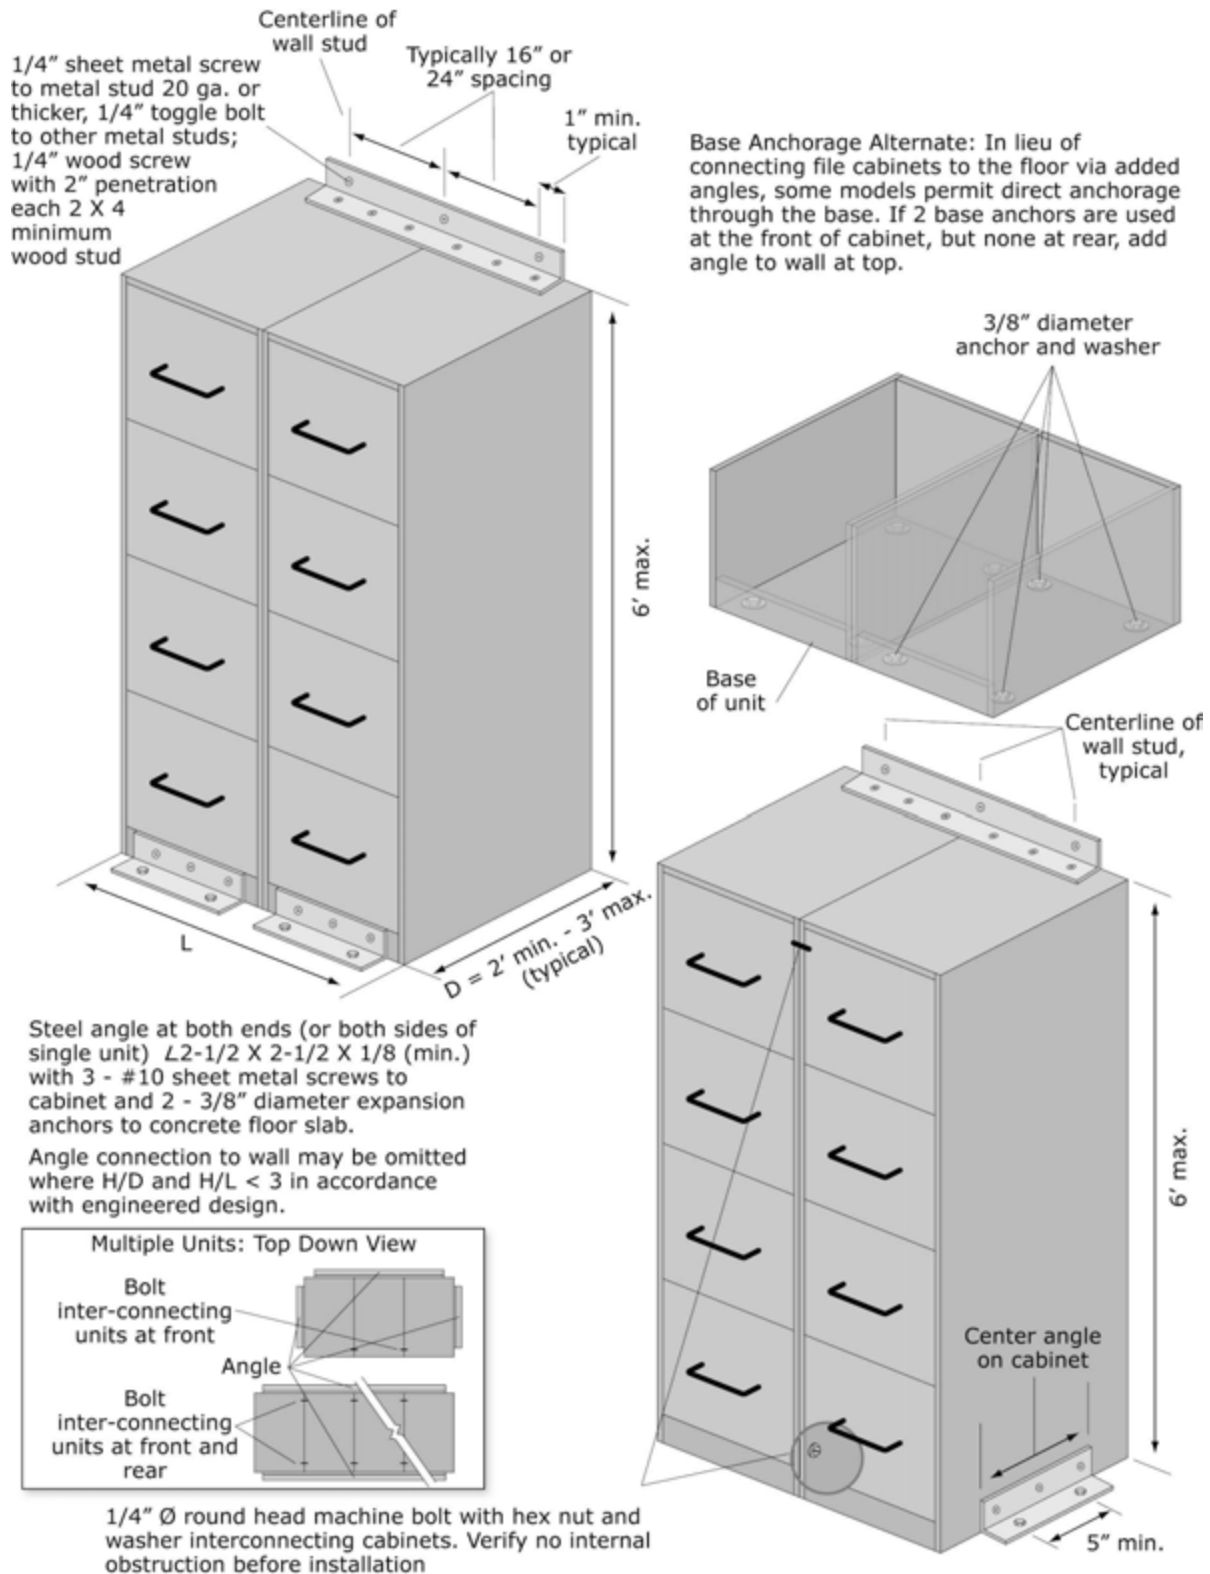
DETAIL:
110

Wall-mounted file cabinets: Detail 110
