THE UTAH GUIDE FOR THE SEISMIC IMPROVEMENT OF **UNREINFORCED MASONRY DWELLINGS**

**Utah Seismic Safety Commission
Existing Buildings Committee
Second Edition
2016**

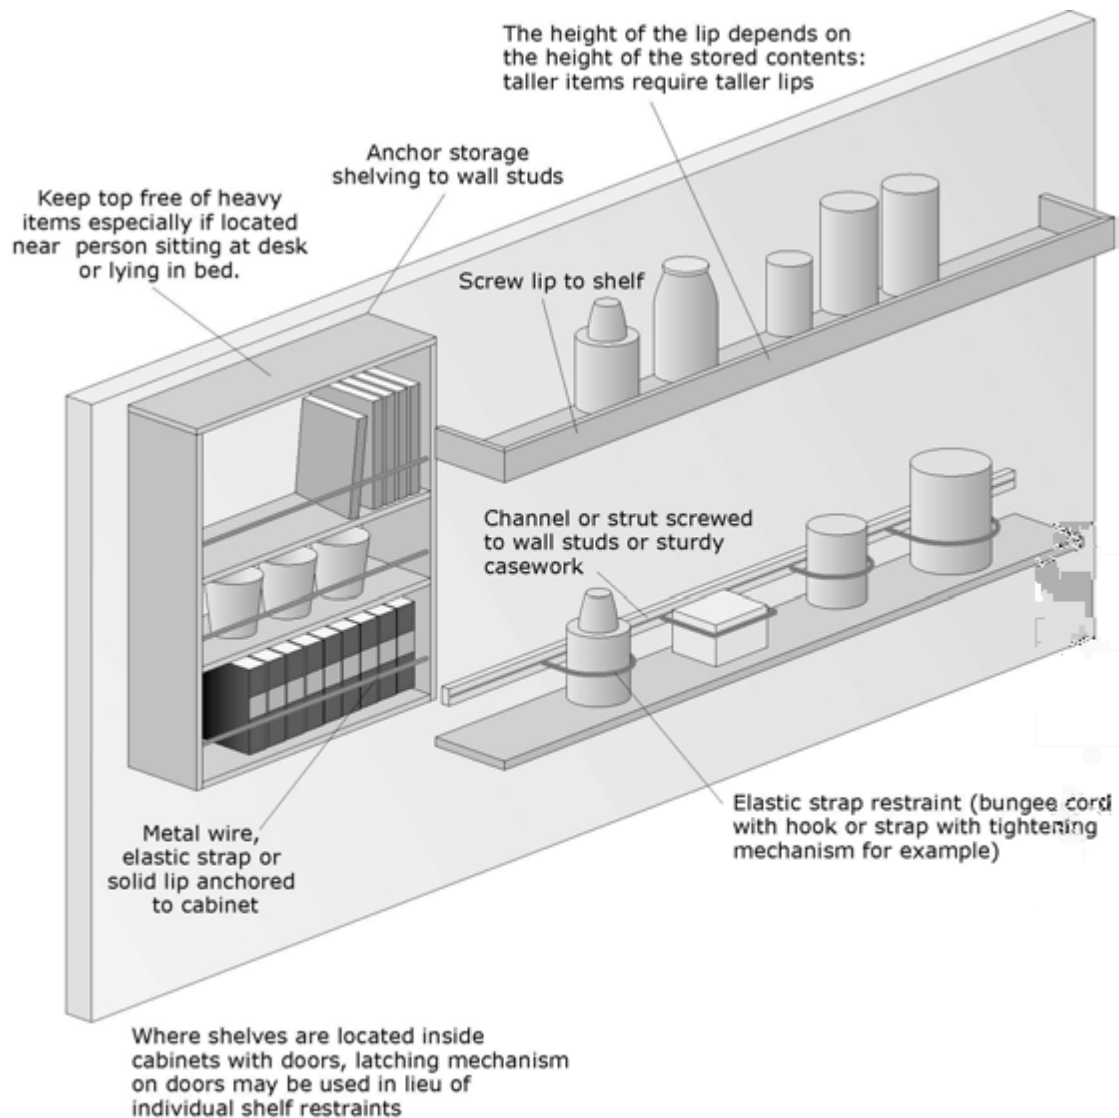
Shelf-mounted items: Detail 113

Seismic Improvement Non-Structural Detail	HOME TYPE: VARIES	Shelf-mounted Items	DETAIL 113
--	----------------------	------------------------	---------------

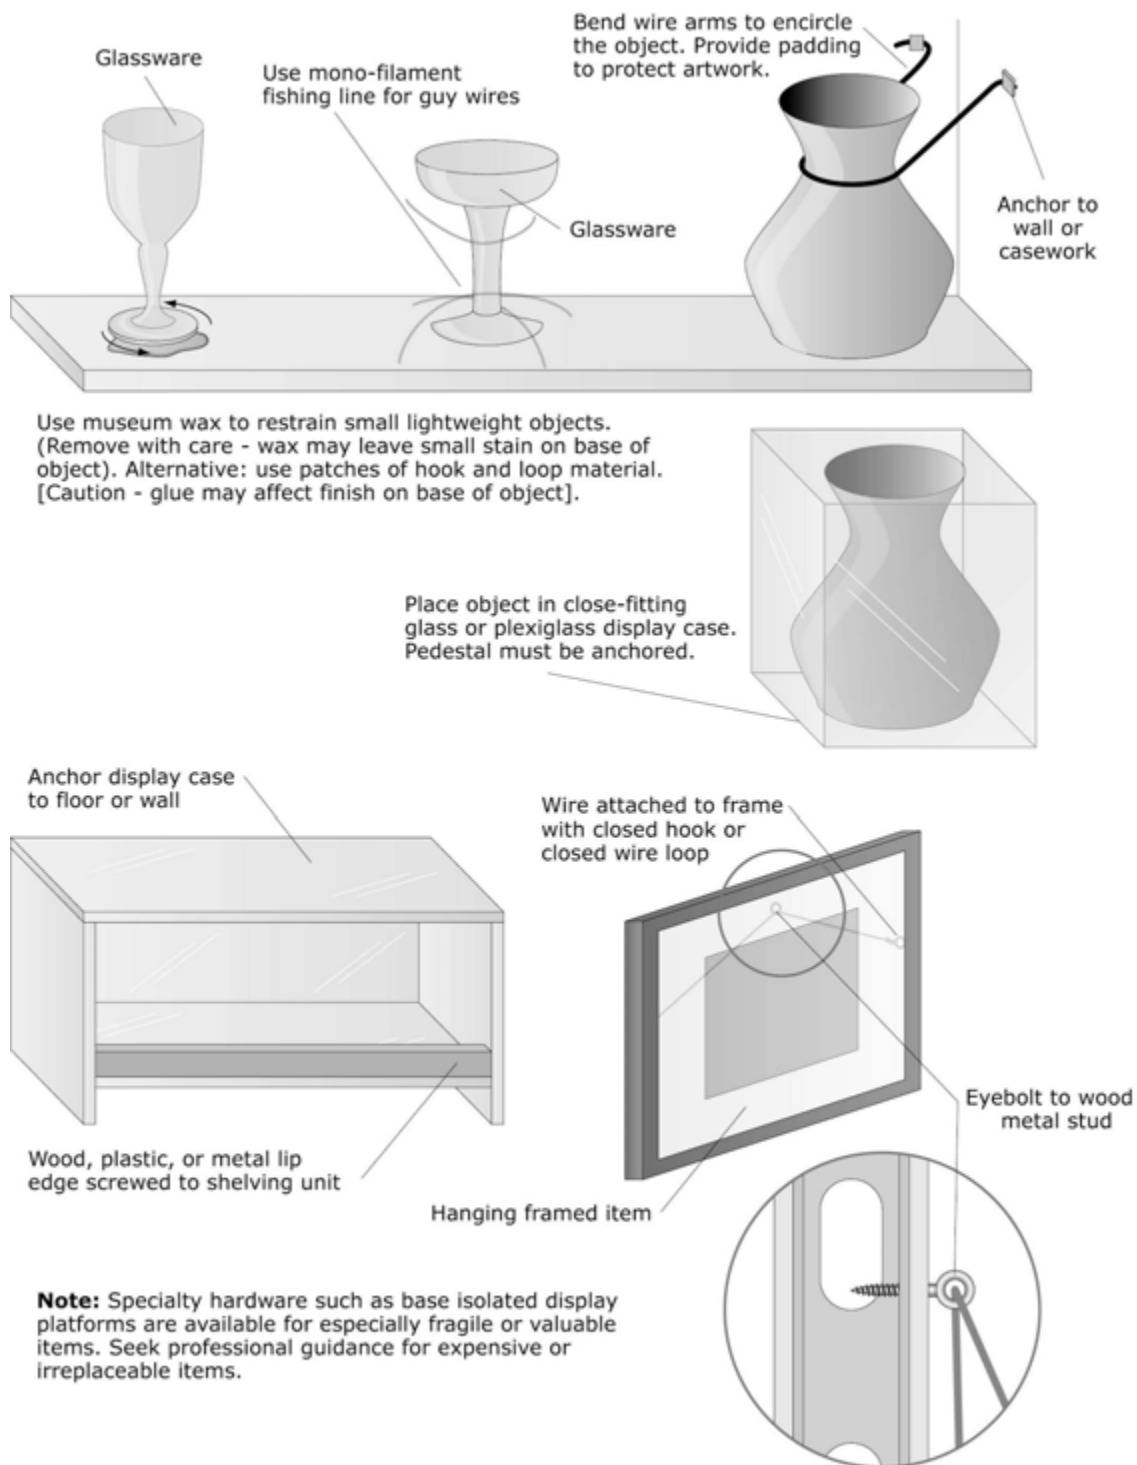
DETAIL:
114

Fragile artwork restraints: Detail 114

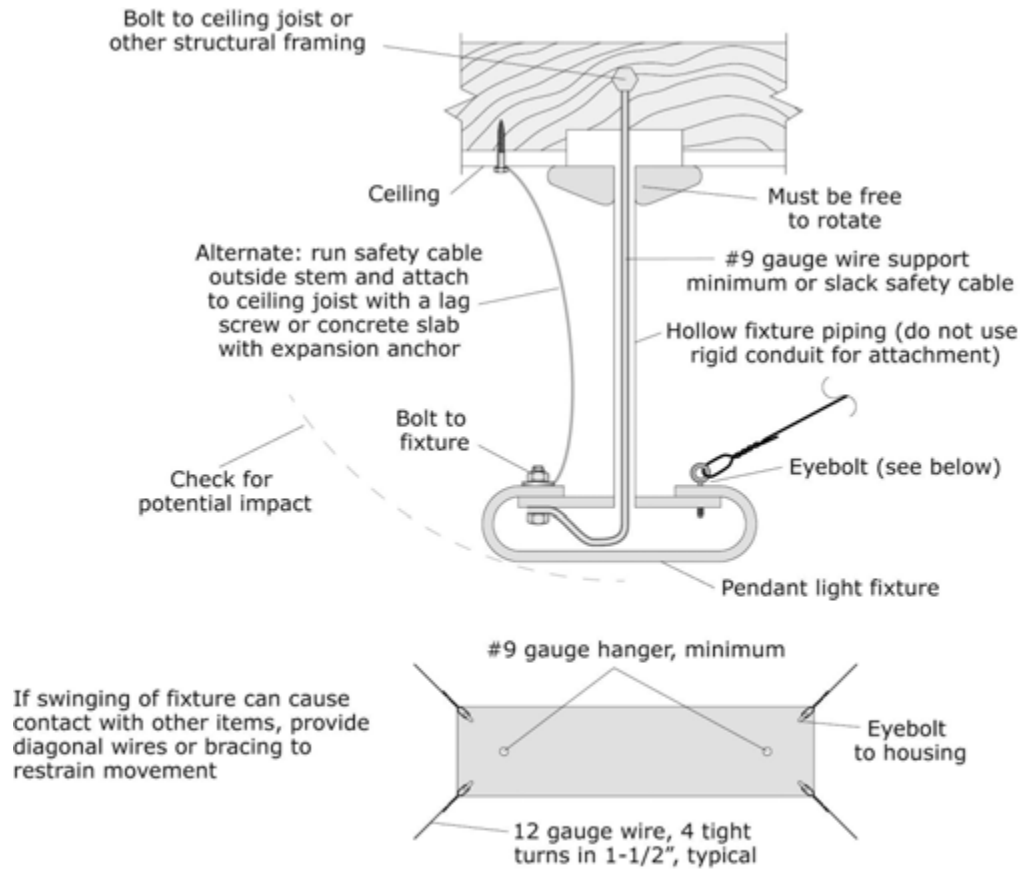
Pendant light anchoring: Detail 115

Seismic Improvement Non-Structural Detail	HOME TYPE: VARIES	Pendant Light Anchoring	DETAIL: 115
--	----------------------	----------------------------	----------------
