ALLEN PARK CULTURAL LANDSCAPE REPORT

Salt Lake City, Utah
November 2022

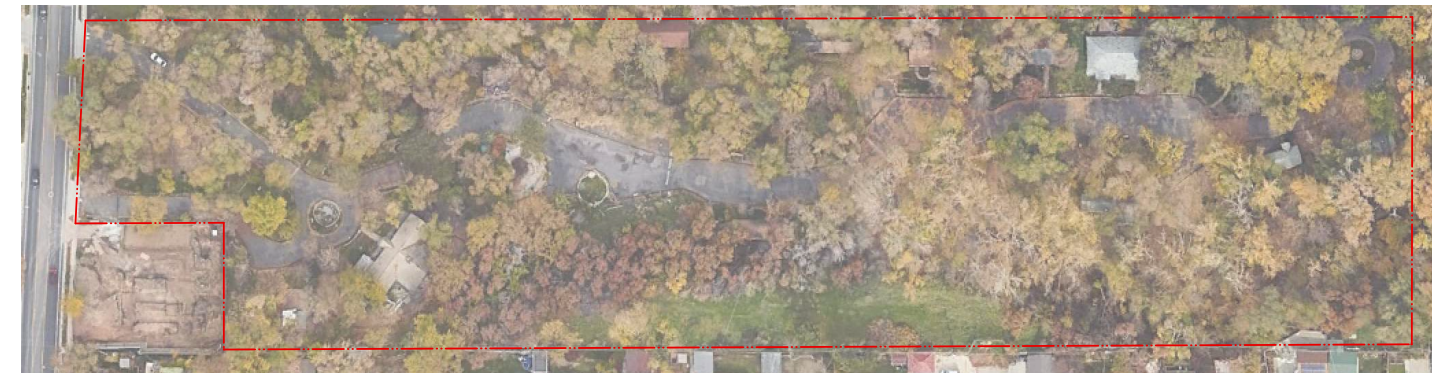
Figure 1-1. Allen Park Study Area

— Site Boundary

Allen Park is located on the east side of Salt Lake City, Utah, on 1300 East and Allen Park Drive. The study area for The Allen Park Cultural Landscape Report is limited to the legal property boundary description of the park as owned by Salt Lake City for the purposes of the inventory and existing conditions report.

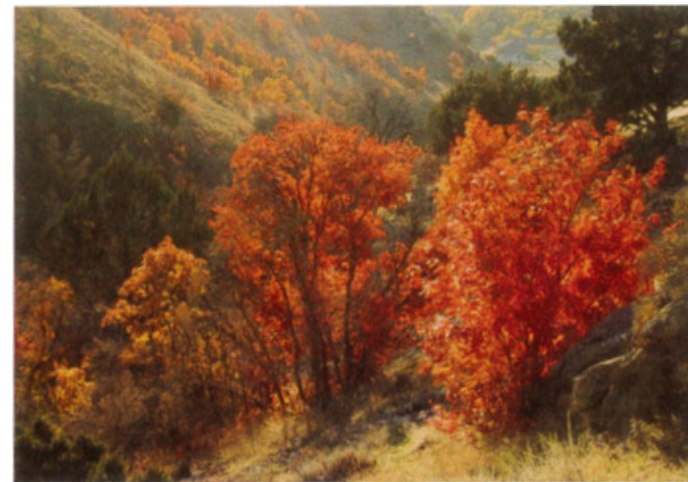
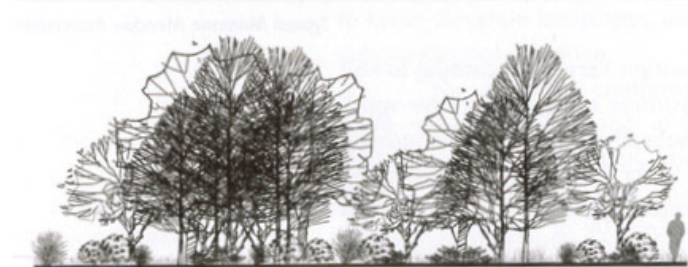
Figure 2-2. Typical Intermountain Mountain Brush Plant Association. Credit: Water Wise, 2003. (H-1-J)

Typical Mountain Brush Association

Plan View - Typical Mountain Brush Plant Association

Section - Typical Mountain Brush Plant Association

Park study area would likely have been the Foothill plant association, typically found on sites between 4,000 to 7,000 feet in elevation. This would have included two common plant communities including Mountain Brush and Shrub Steppe, with the former located in microclimate areas that receive and retain higher amounts of precipitation, similar to the large north-facing slope of the Allen Park study area. The latter would have been found on the flatter and dryer areas of the indigenous landscape.

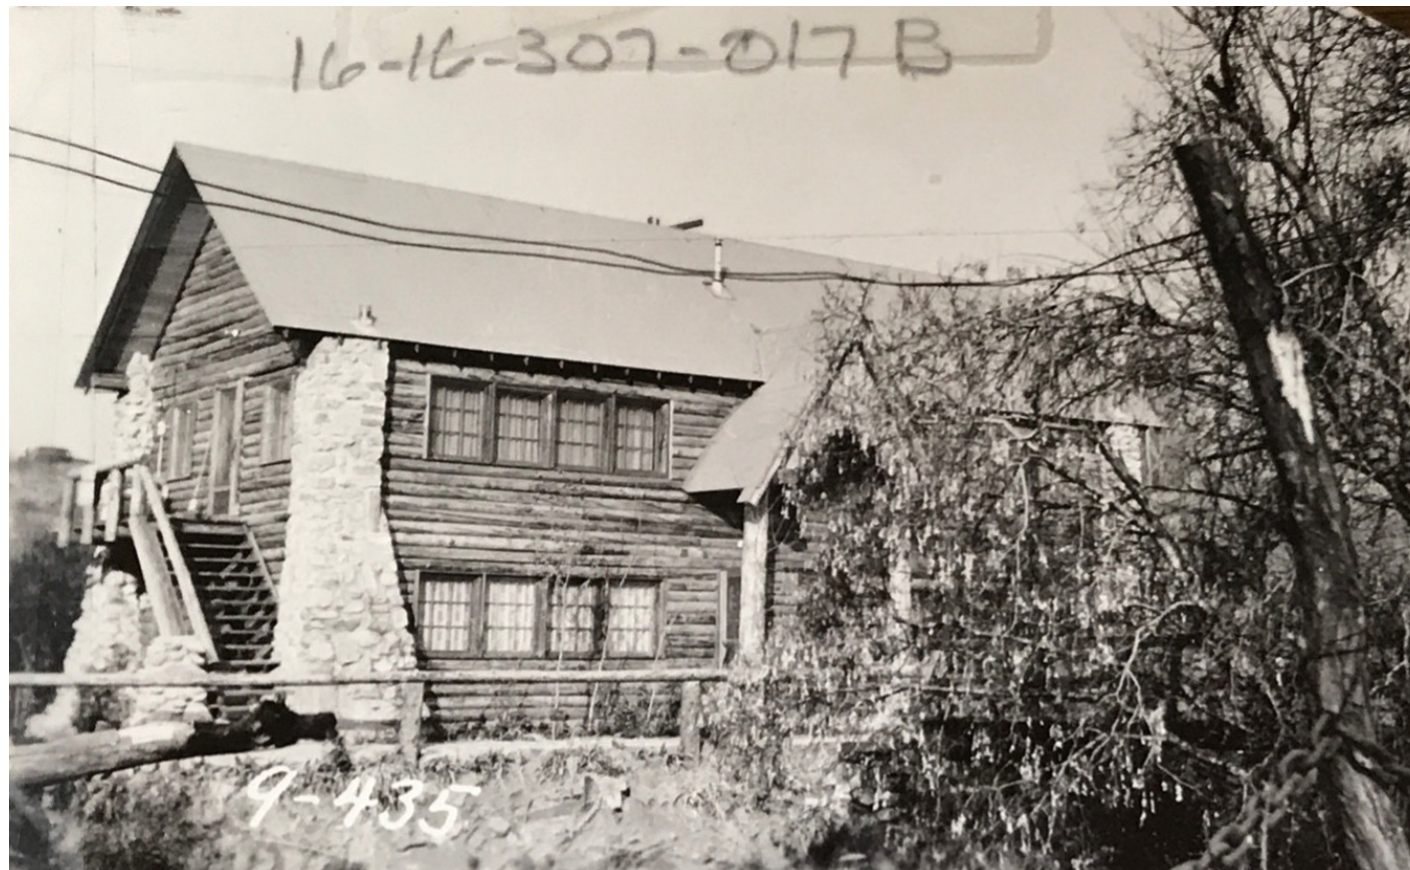
Figure 2-19. Ye Olde George Albert apartments, c. 1939. (H-3-H)

Ye Olde George Albert was named for Dr. and Ruth Allen's son George, Jr. It is a two-story log building with log siding and a symmetrical façade. The roof is side gabled while a steeply-pitched protruding porch shelters two separate doors for the ground floor living units. Decorative fieldstone pillars wrap around each building's corner from the ground to the height of the roof. Assessment of the current materials of the side porches indicates that they were replaced in the past but the exact date is unknown.

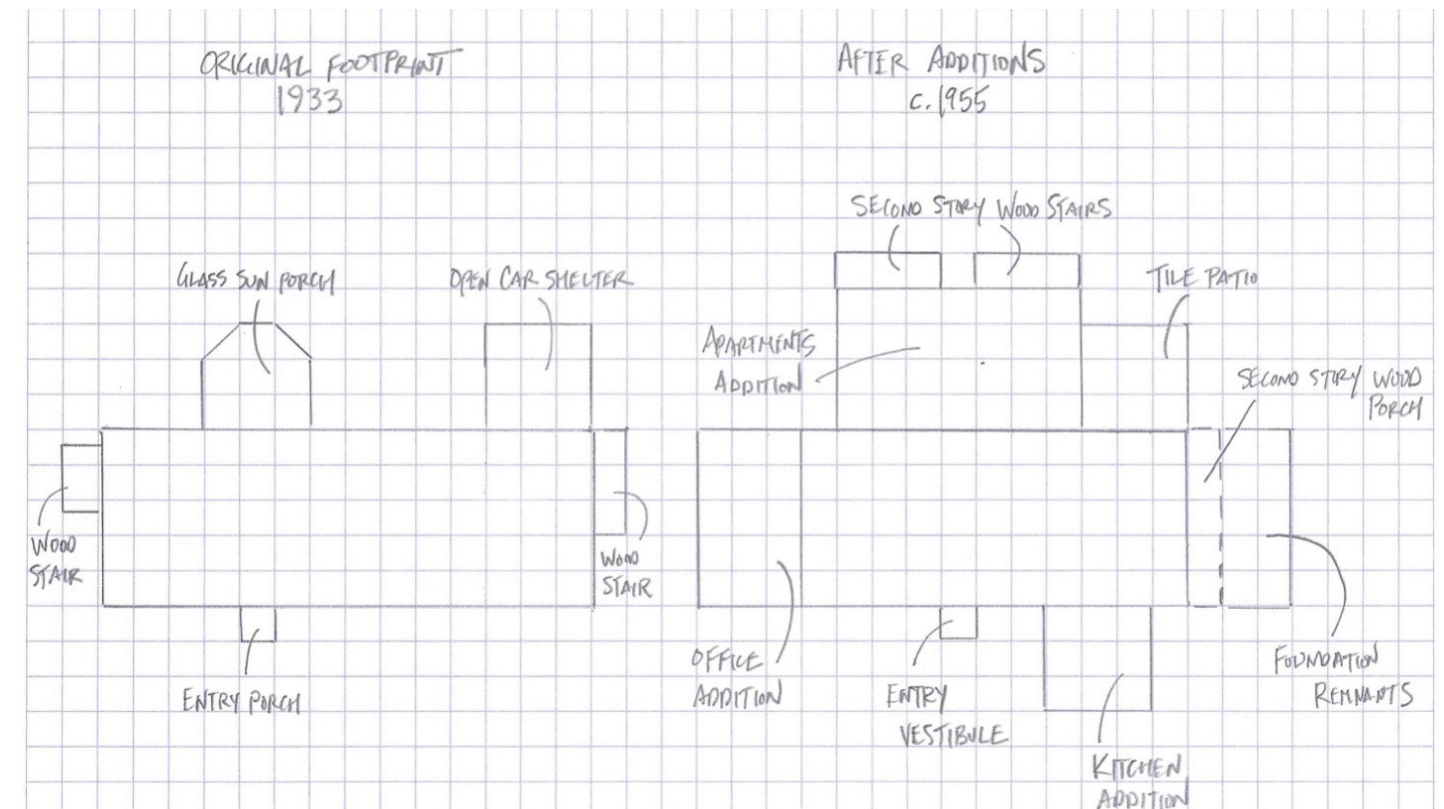
Figure 2-21. Footprints of the Allen House in 1933 and about 1955 after several additions. (H-3-GG)

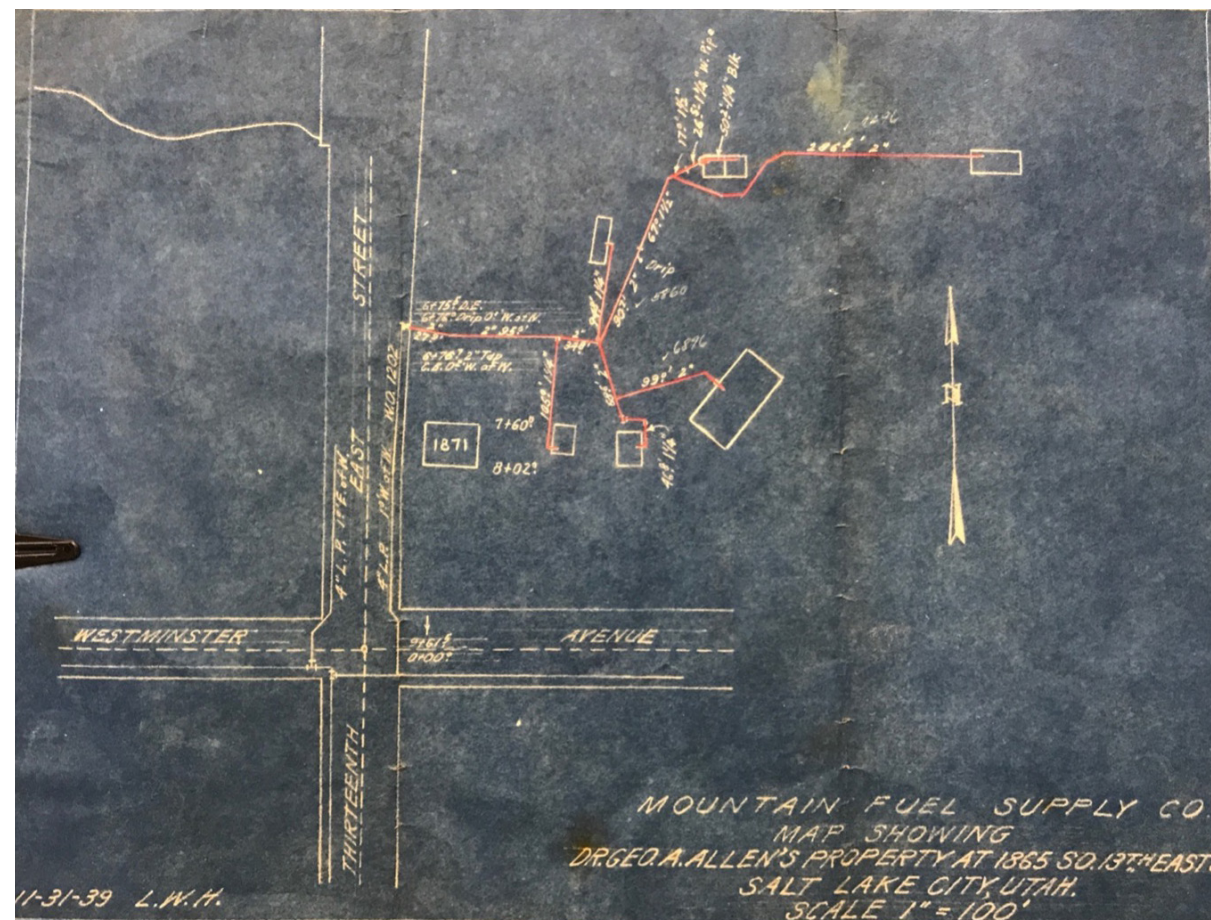
Figure 2-23. The six buildings that compose lower Allen Park Drive were connected to natural gas lines by Mountain Fuel Supply Co. in 1939. (M-2-H)

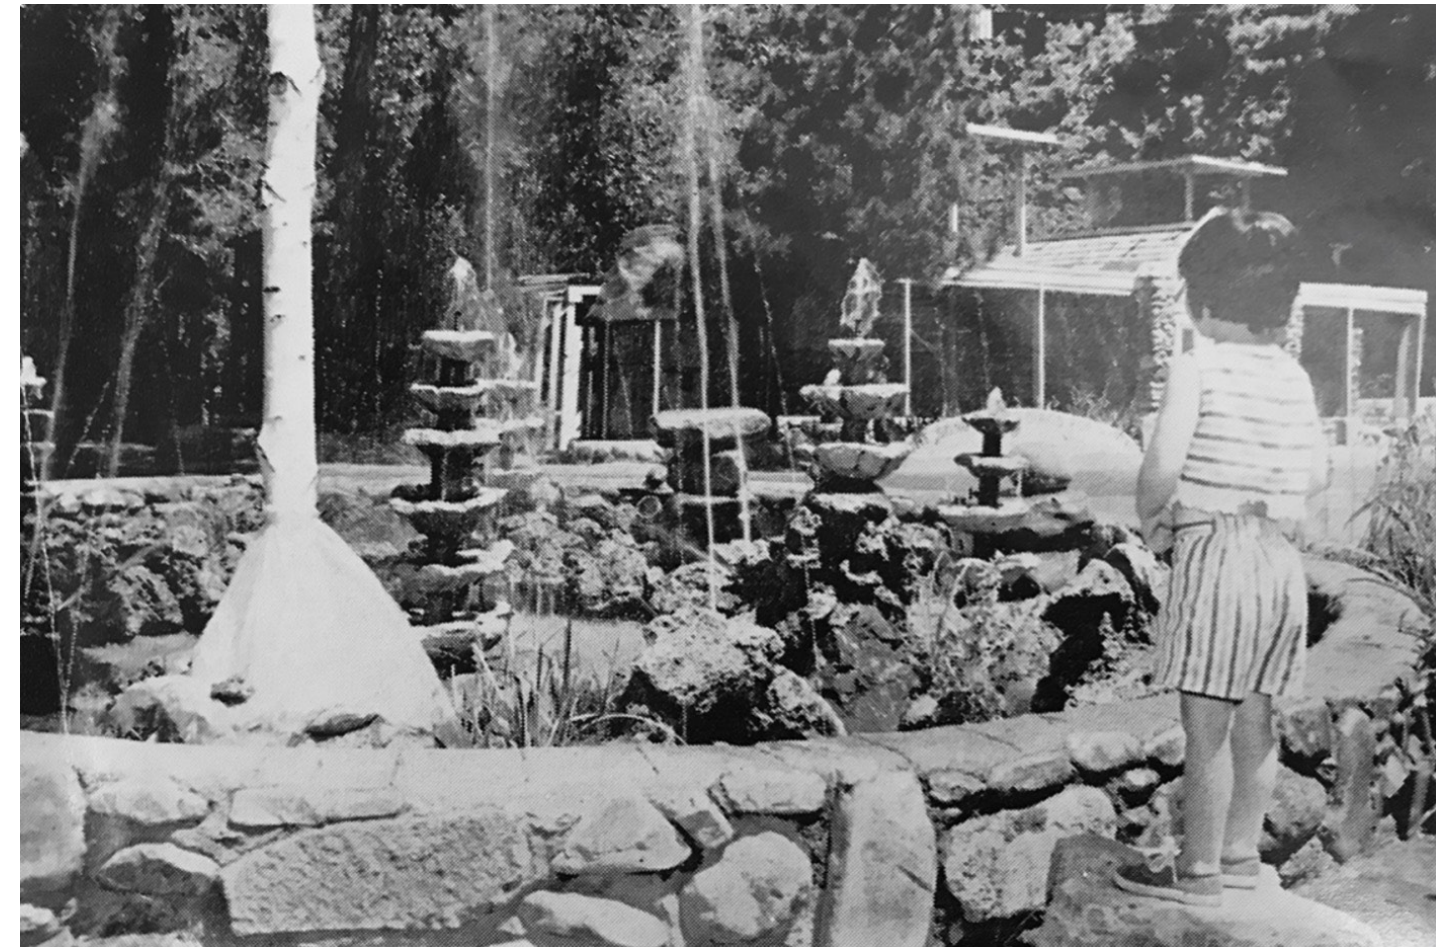
Figure 2-27. One of the constructed water features, "The elaborate fountain and many bird pens that compose... interesting Allen Park" in 1961. (H-4-V)

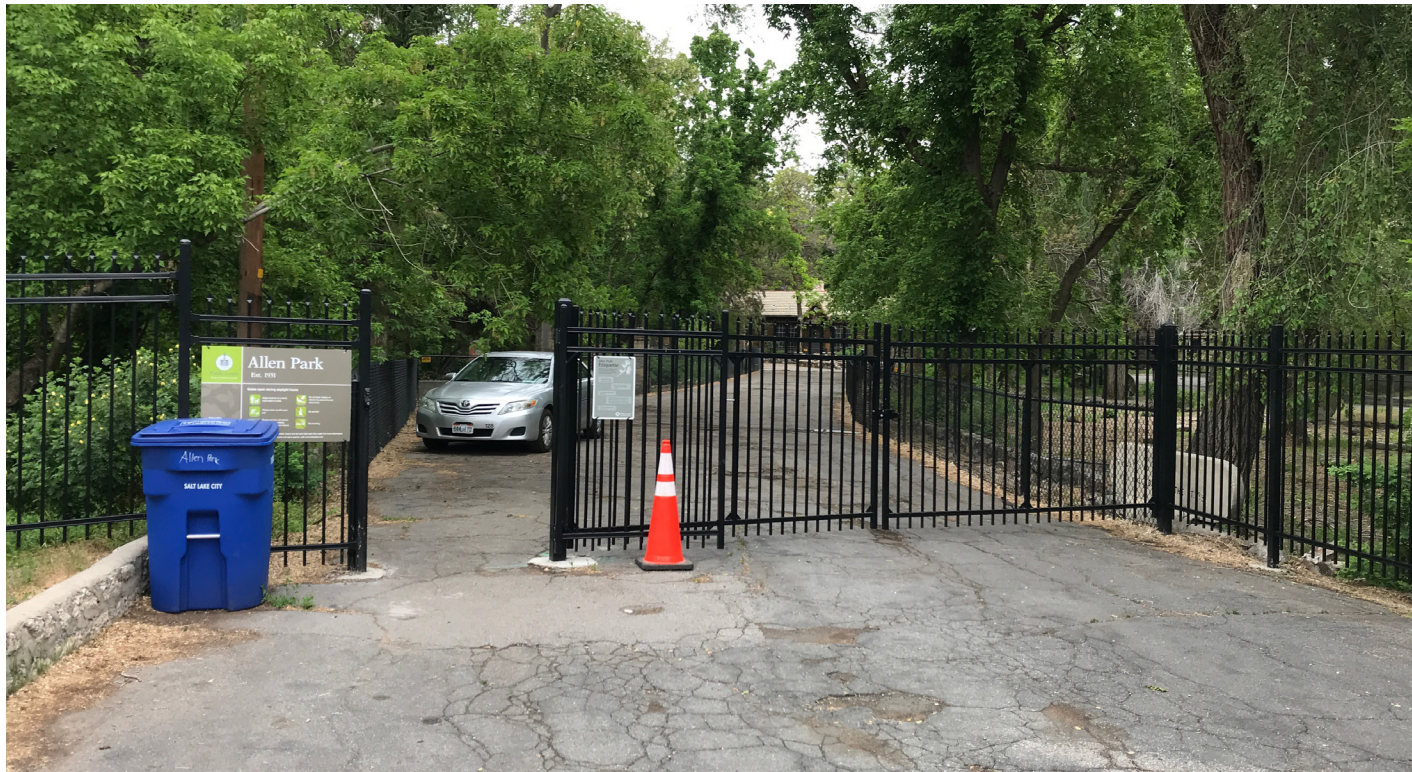
Figure 2-33. West entry of Allen Park showing black aluminum fence, May 2021. (H-5-E)

- in height, on the exterior of the park at the west property line with pedestrian and vehicular access gates. Sections are composed of single pickets of standard width between and single top and bottom rails that are evenly spaced above the bottom and below the top;
- Black chain link fencing, 42 inches in height, on interior of the park with pedestrian and vehicular access gates; and,
- Plywood on all windows, mostly placed on the interior surfaces.

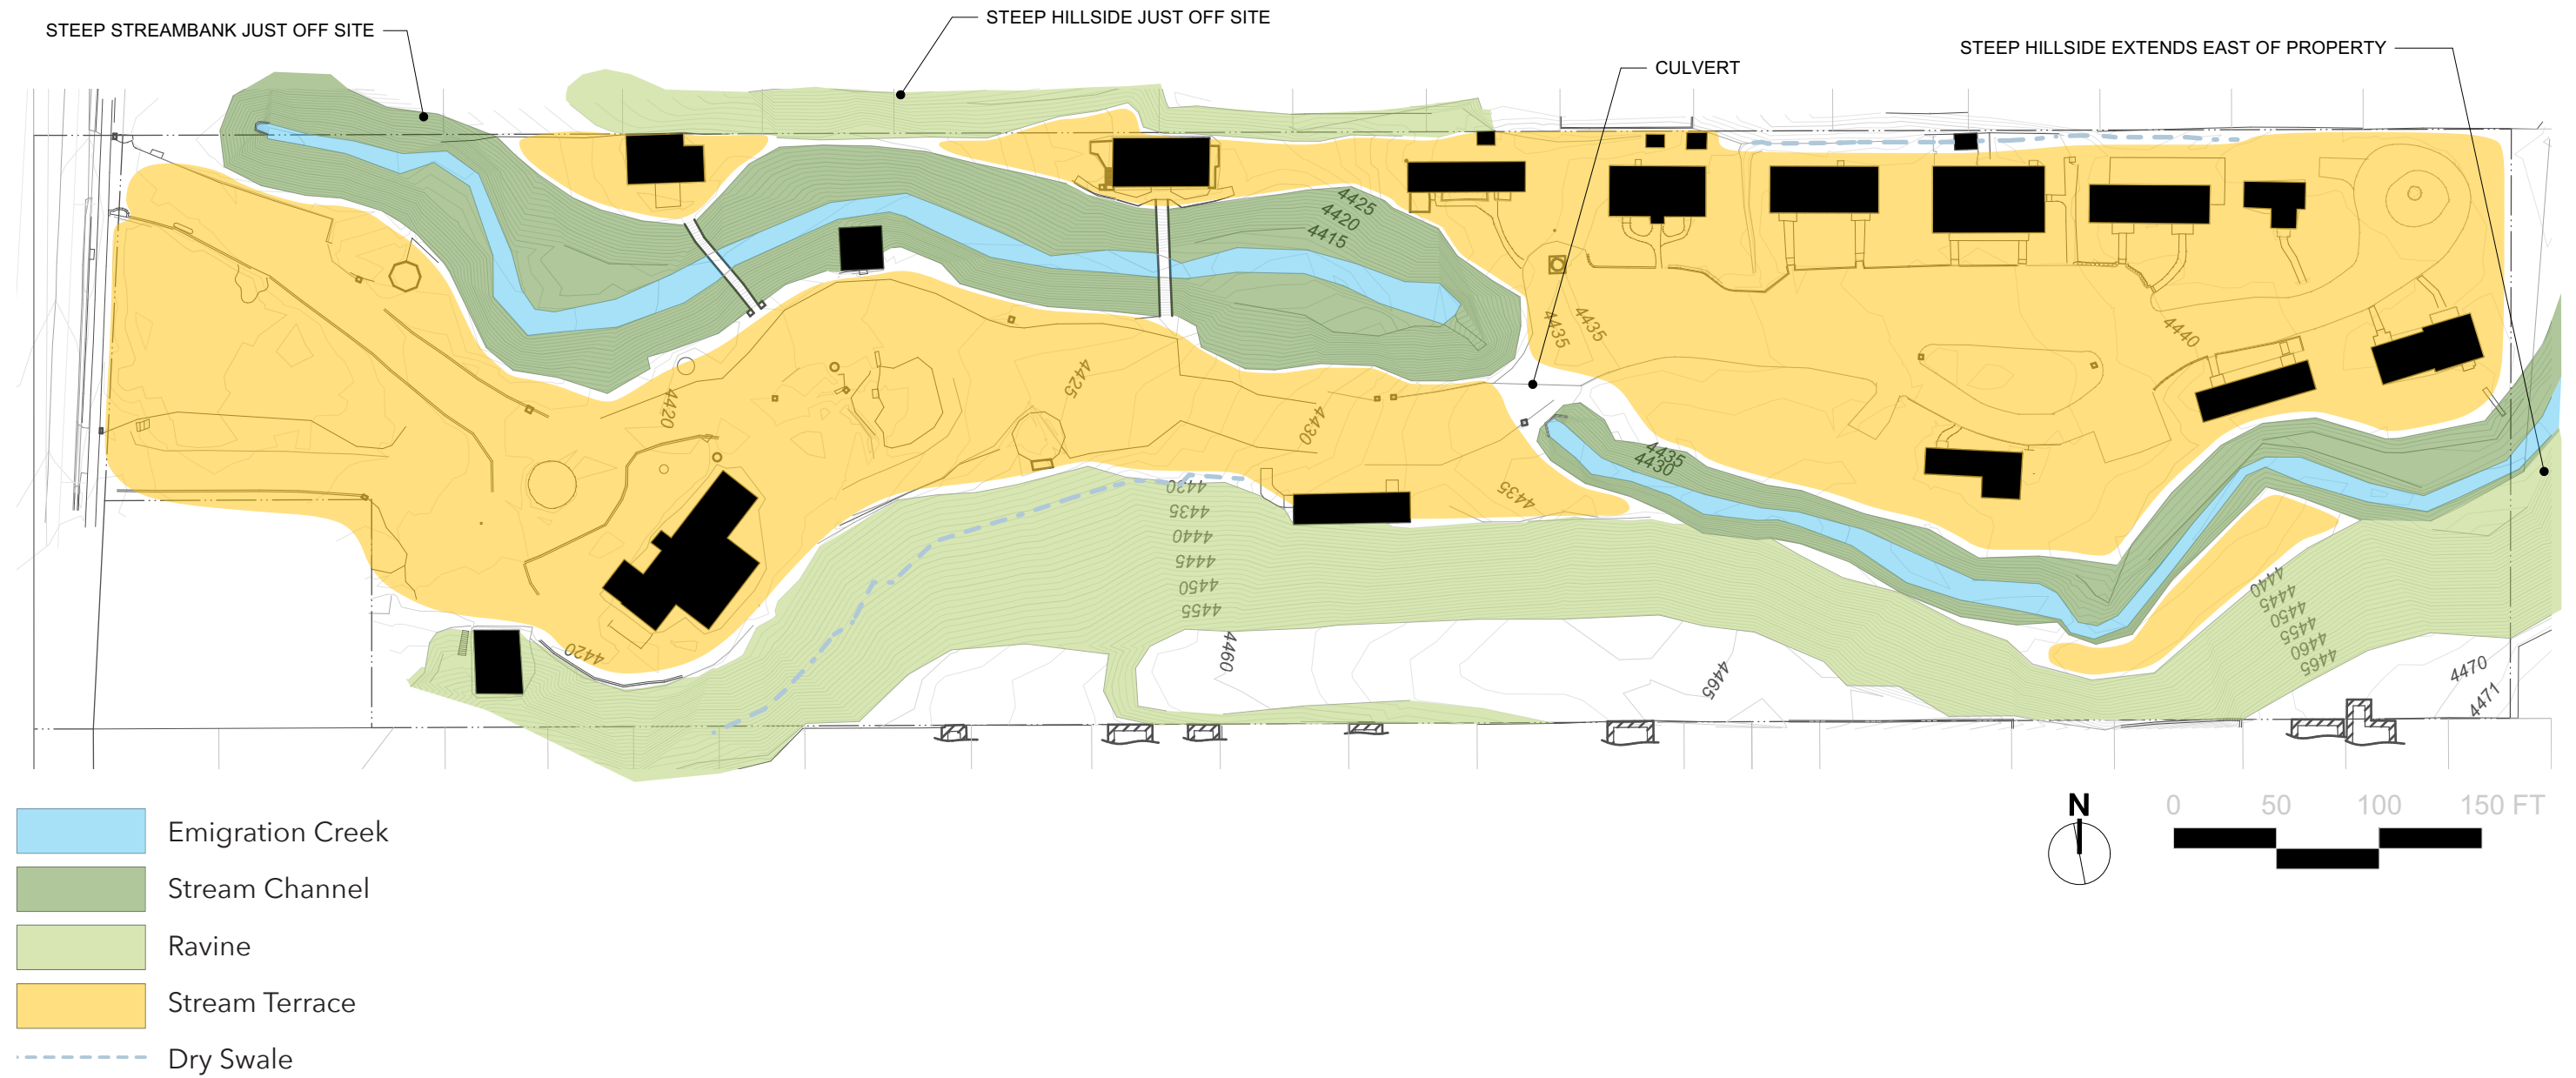
NATURAL SYSTEMS, FEATURES AND TOPOGRAPHY

Figure 3-2. Natural Systems, Features & Topography Map

The foundations of the Allen Park Study Area cultural landscape are natural systems and features. These are illustrated in Figure 3-2 on page 21.

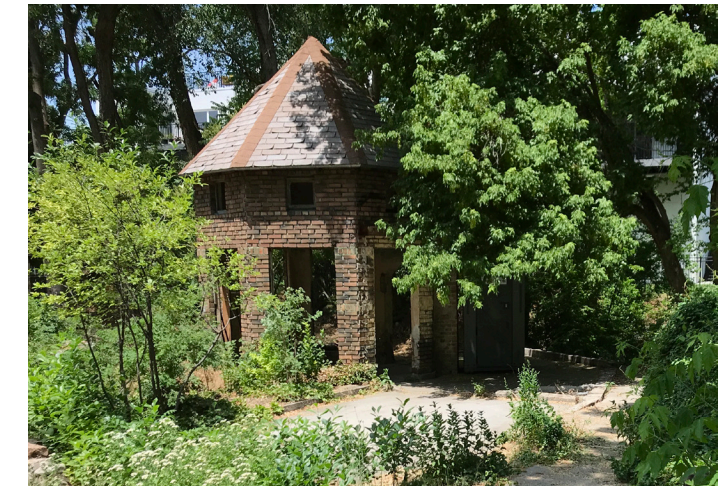
Figure 3-5. View looking west toward the grassy area from the gathering space.

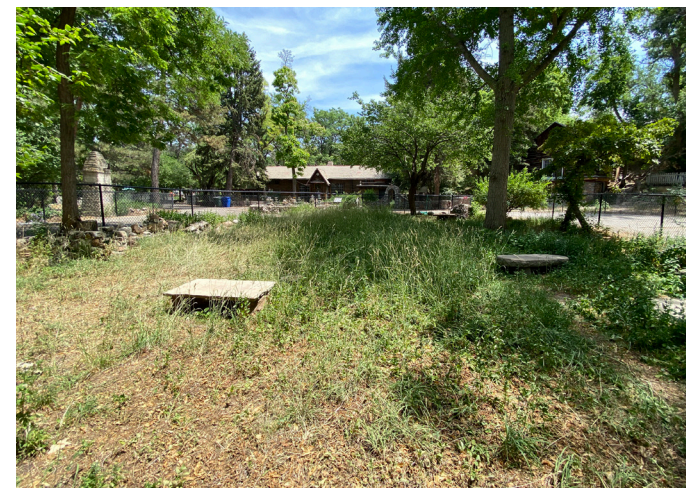
Figure 3-6. View looking north to the gazebo across a portion of The Peacock foundation.

The Peacock - Along the north side of the north driveway between the driveway and the creek, a small, recessed space centers around the remnant turret of the former Peacock building referred to in this document as the gazebo. The transition to this area is created by subtle localized grade and paving material changes as it steps down from the driveway towards the creek. Some sections of brick and stone walls define the west and south edges of the space.

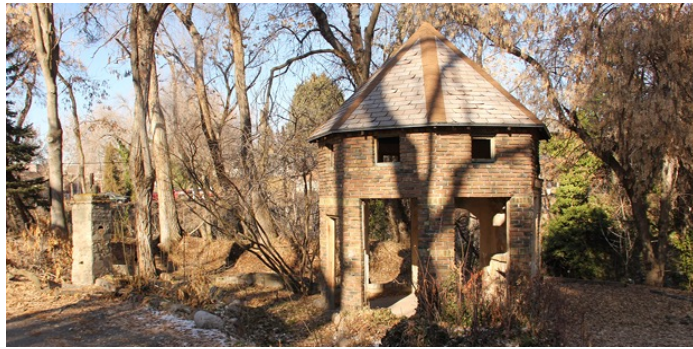
Figure 3-15. Gazebo

- 16. Gazebo - This structure is the remnant turret of the former Peacock building. It is a 1.5-story octagonal shaped brick structure with an octagonal turret roof (Figure 3-15).

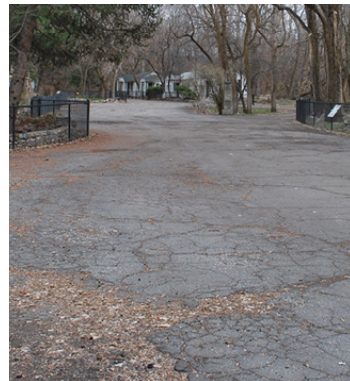
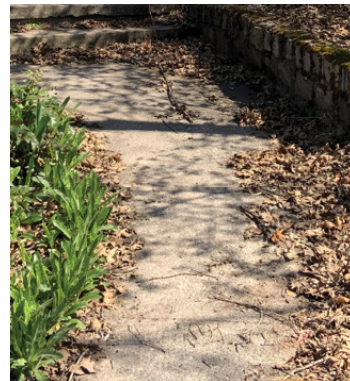
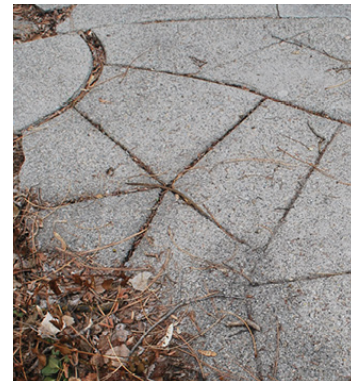
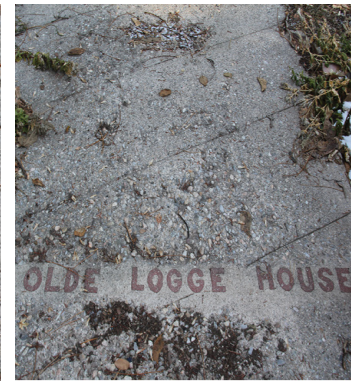
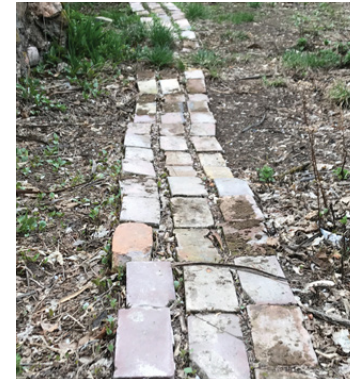
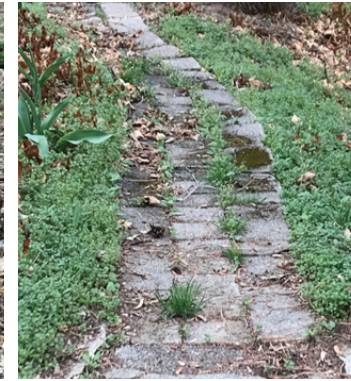
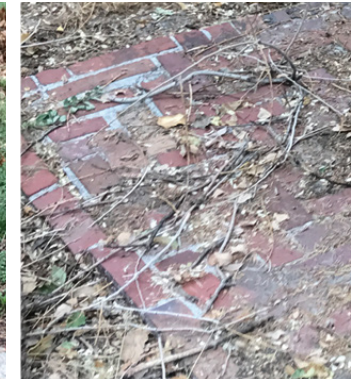
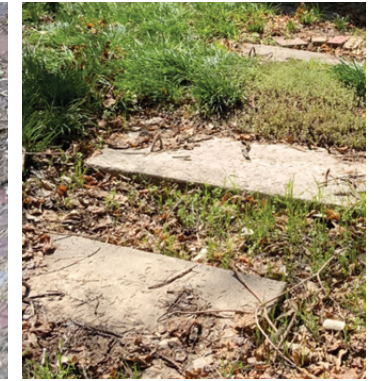
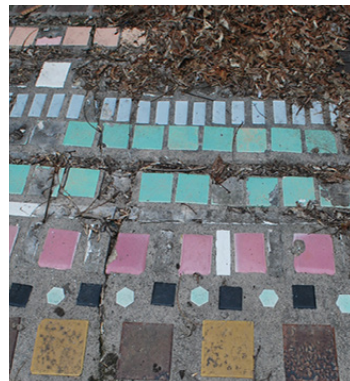
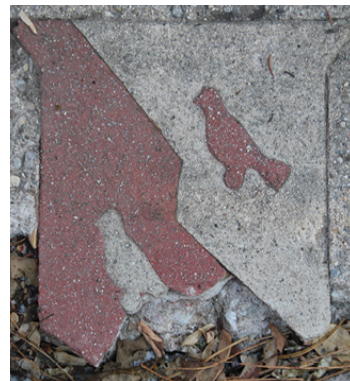
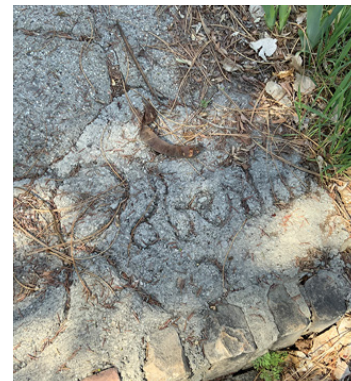
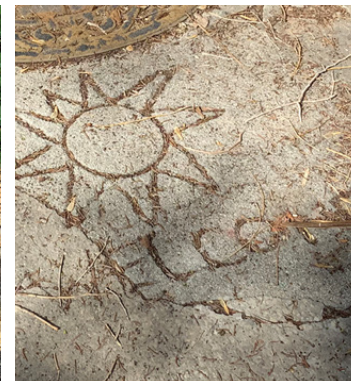
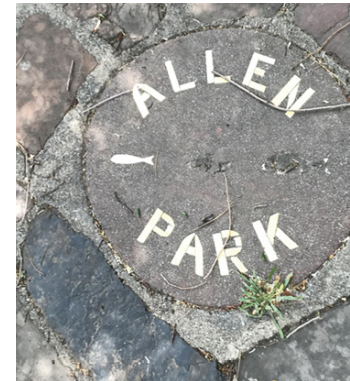
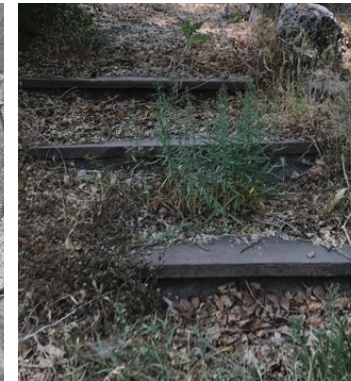
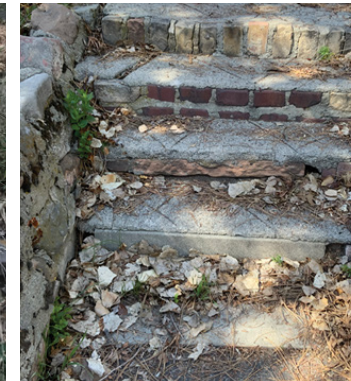
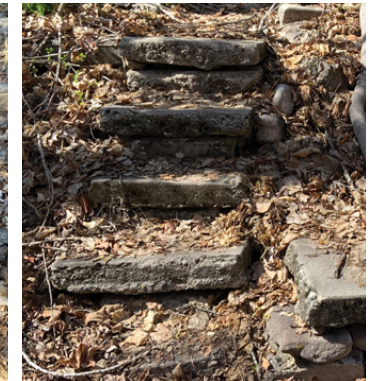
Figure 3-24. Paving Photos

- Paving, steppingstones: Steppingstones include any loosely arranged unit paving such as brick, rocks, stone in either organic or cut patters that are intentionally place with gaps in-between units.

- Paving, unit paving and artwork concrete: These elements are made of cast concrete inlaid with mosaic tiles, and are placed in the middle of unit paving.

- Paving, stairs: Staircase elements including concrete stairs integrated with concrete pathways, stone or concrete slab stairs, and/or rubble stairs consisting of mortared brick, stones, and/or recycled concrete.

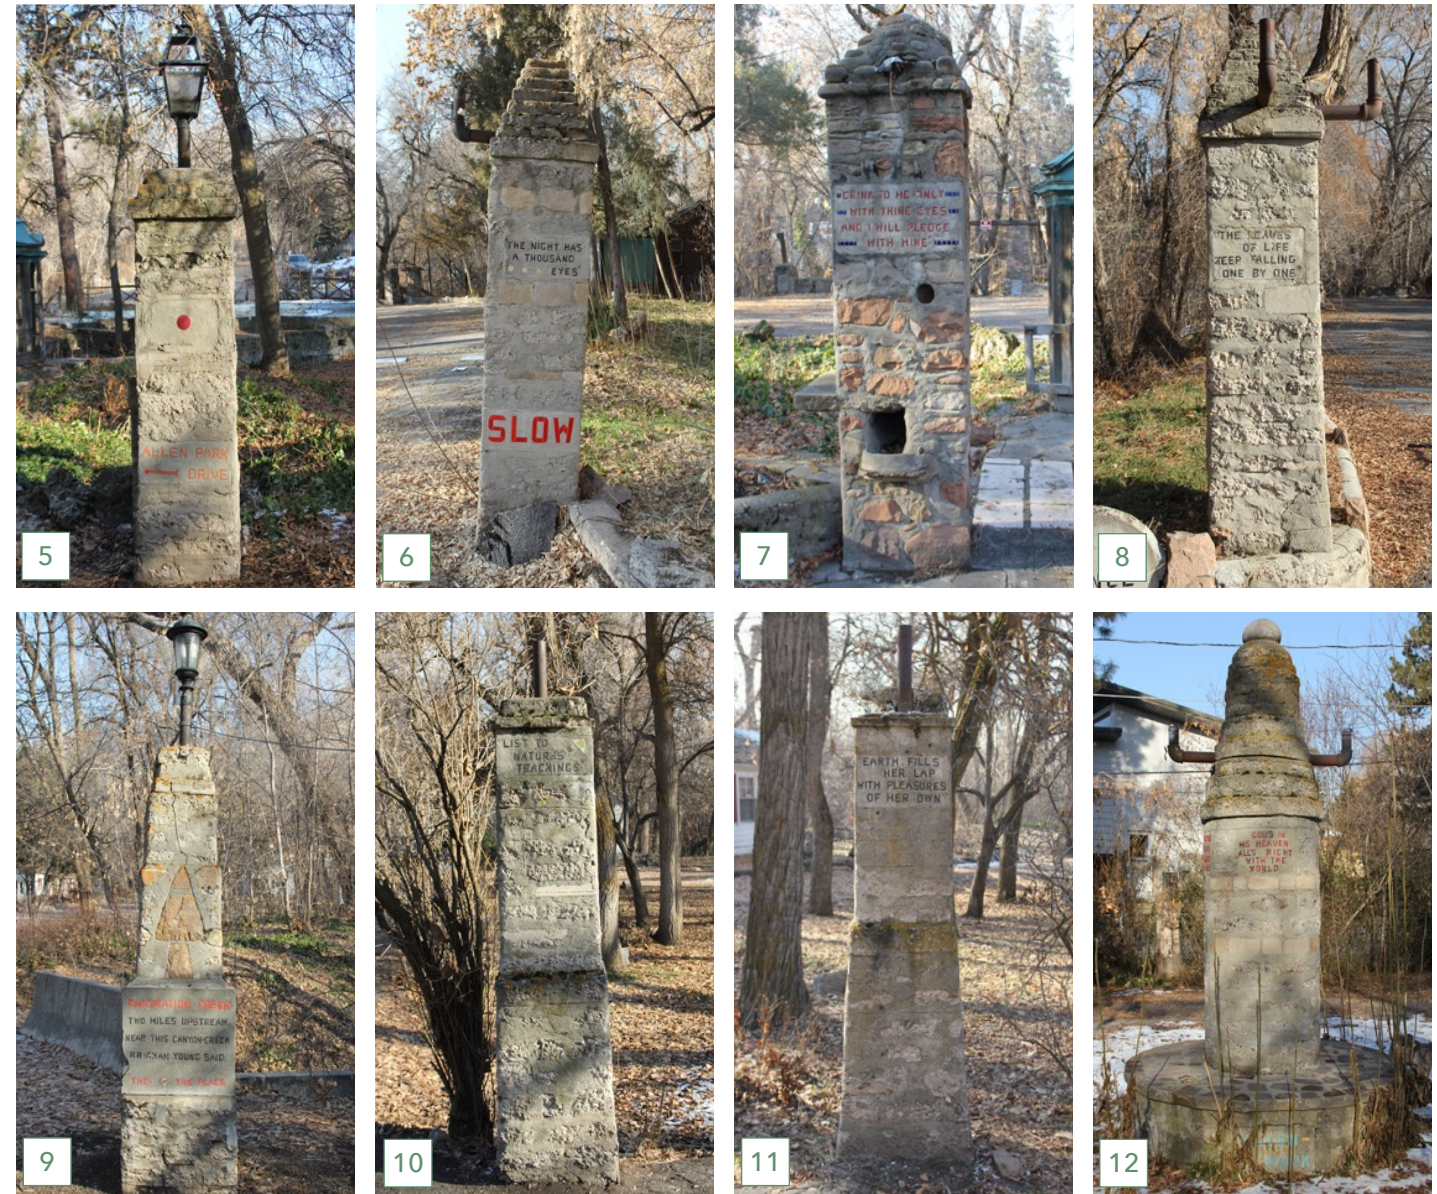
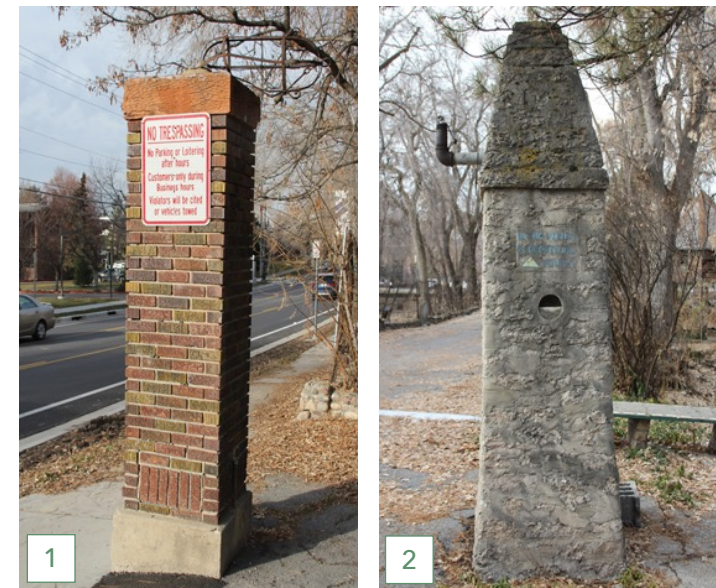
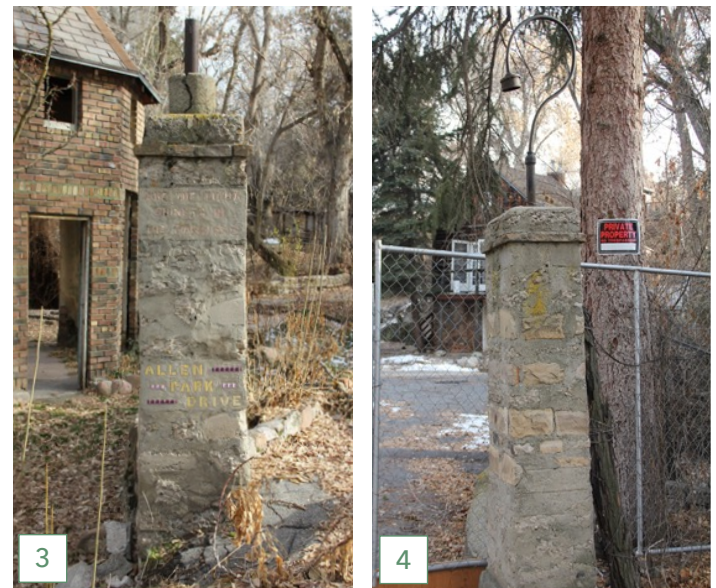
Figure 3-28. Light Pillars

These singular vertical masonry elements are repeated throughout the study area and are located mainly along the central driveway. They are generally articulated as a vertical square column, include tile mosaic ornamentation, and have an integrated light fixture or metal conduit embedded into them that formerly included light fixtures. Figure 3-28 includes photos of the light pillar artwork at Allen Park with numbering to correlate with the map on page 39.

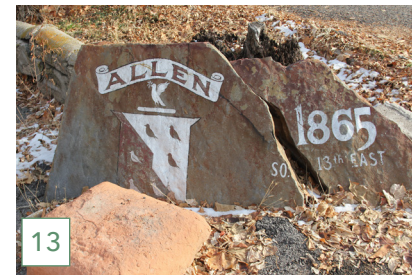
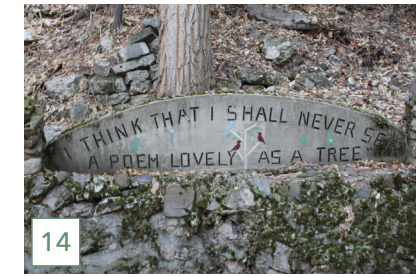
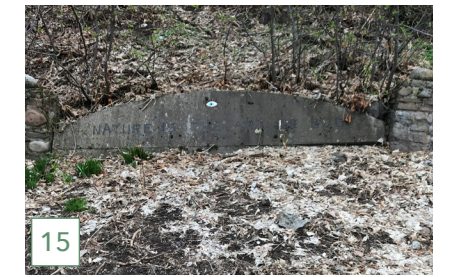
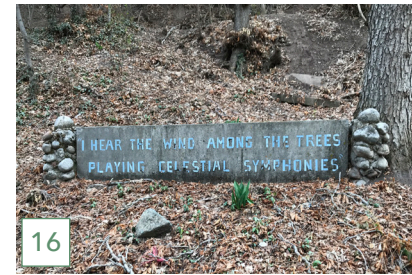
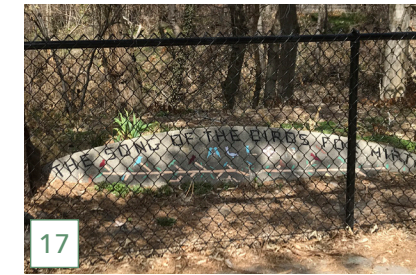
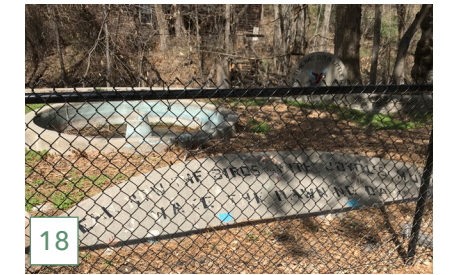
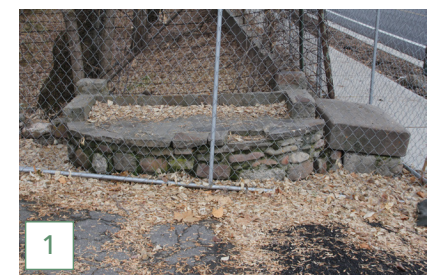
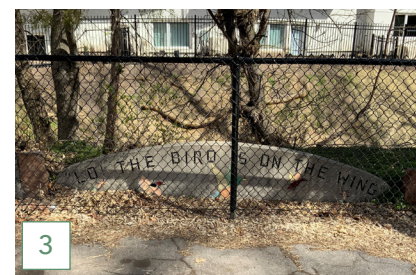
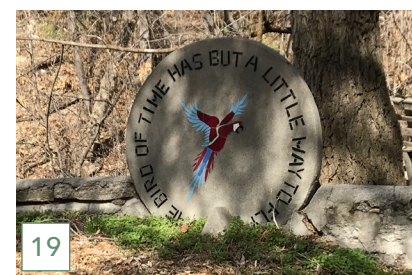
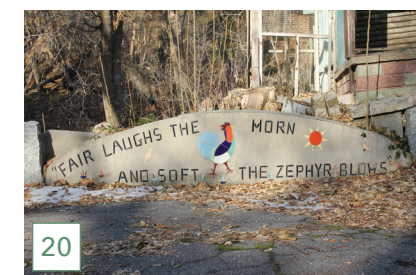
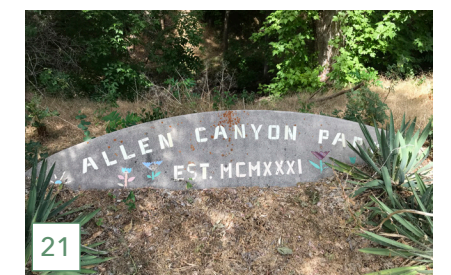
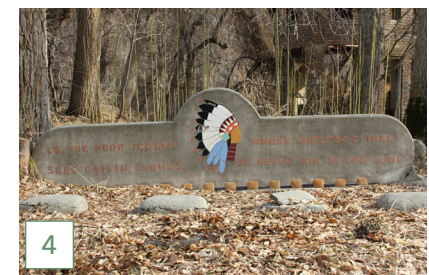
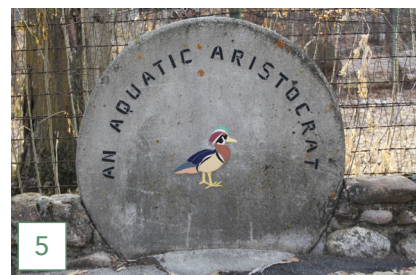
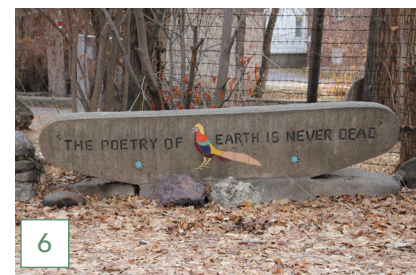
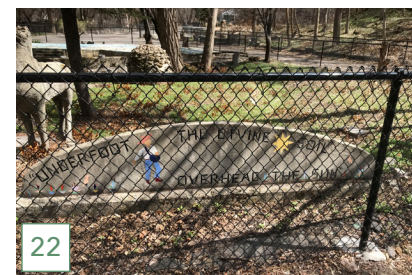
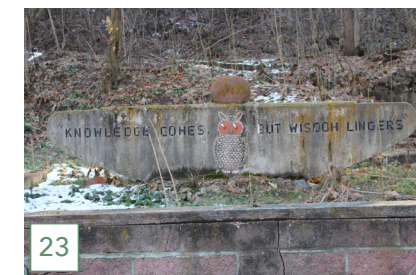
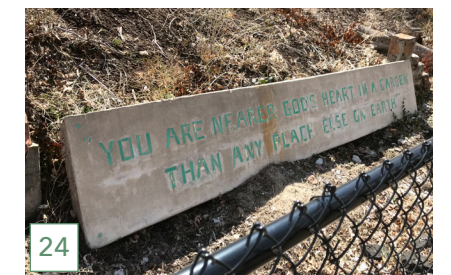
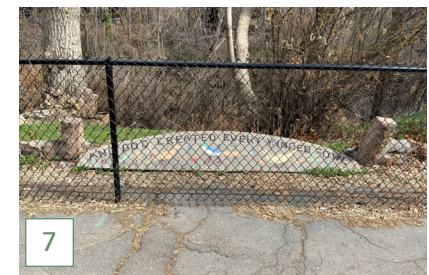
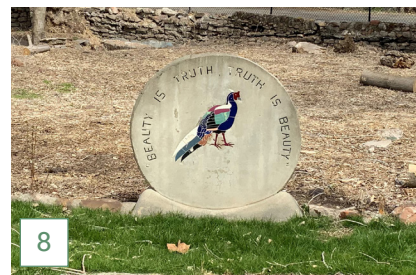
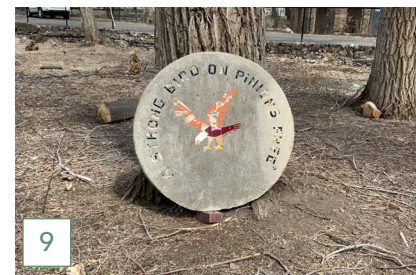
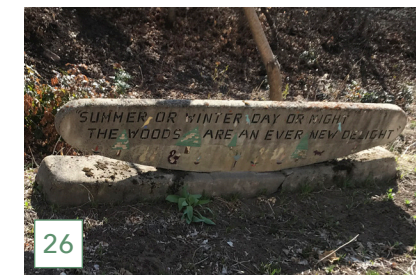
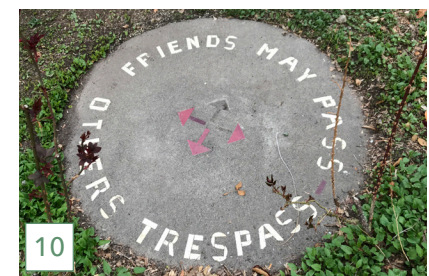
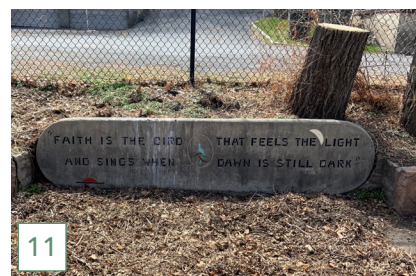
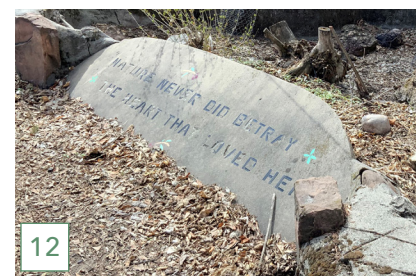
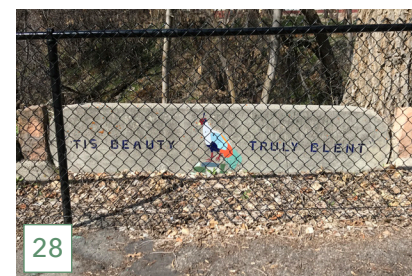
Figure 3-30. Monument Photos

These unique artworks consist of vertically positioned cast concrete panels with various tile mosaic patterns depicting images and phrases generally relating to nature, poetry, and philosophy. Figure 3-30 is a photo index of the artwork monuments at Allen Park. The following general shapes of the cast panels are repeated throughout the site, although each one is unique in terms of imagery and words:

- Monument, base (missing at entry)
- Monument, arched
- Monument, rectangular
- Monument, V-shaped
- Monument, rounded rectangle
- Monument, round
- Monument, square arch
- Monument, signage

- Preserve and restore monuments.
- A few of the monuments have become partially buried at their bases (see Figure 3-30 on page 40 for examples). Clear soil and debris from the bases of monuments, as well as adjust localized grading to provide positive drainage away from these features.

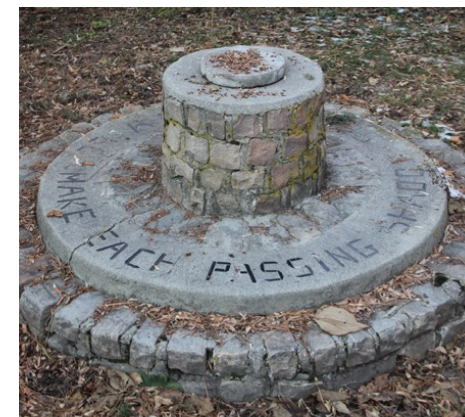
Sundial

- Other artworks, sundial: Located in the front yard of the Allen House, this composite circular element features a wide masonry base topped with a concrete ring embedded with a tile mosaic. On top of this rests a short-mortared stone column. The mosaic reads "...make each passing shadow" implying that the purpose of this piece may have been solar related such as a sundial.

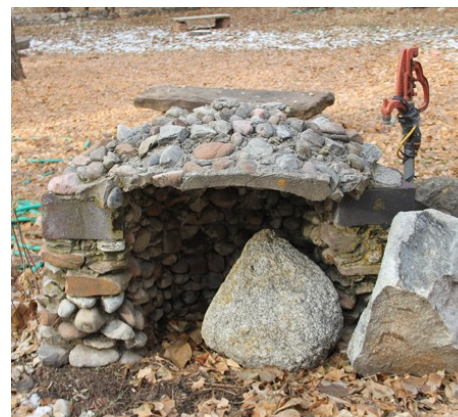
Small river rock sculptures

- Other artworks, small river rock sculptures: Two small river-rock dome-like features exist on the site, a half-dome located at the far southeast end of the 'living room' space, and another located in the swimming pool garden space. These are composed of smaller sized mortared river rocks.
- Other artworks, animal statue: This feature appears to be a horse cast out of concrete. Its head is missing.

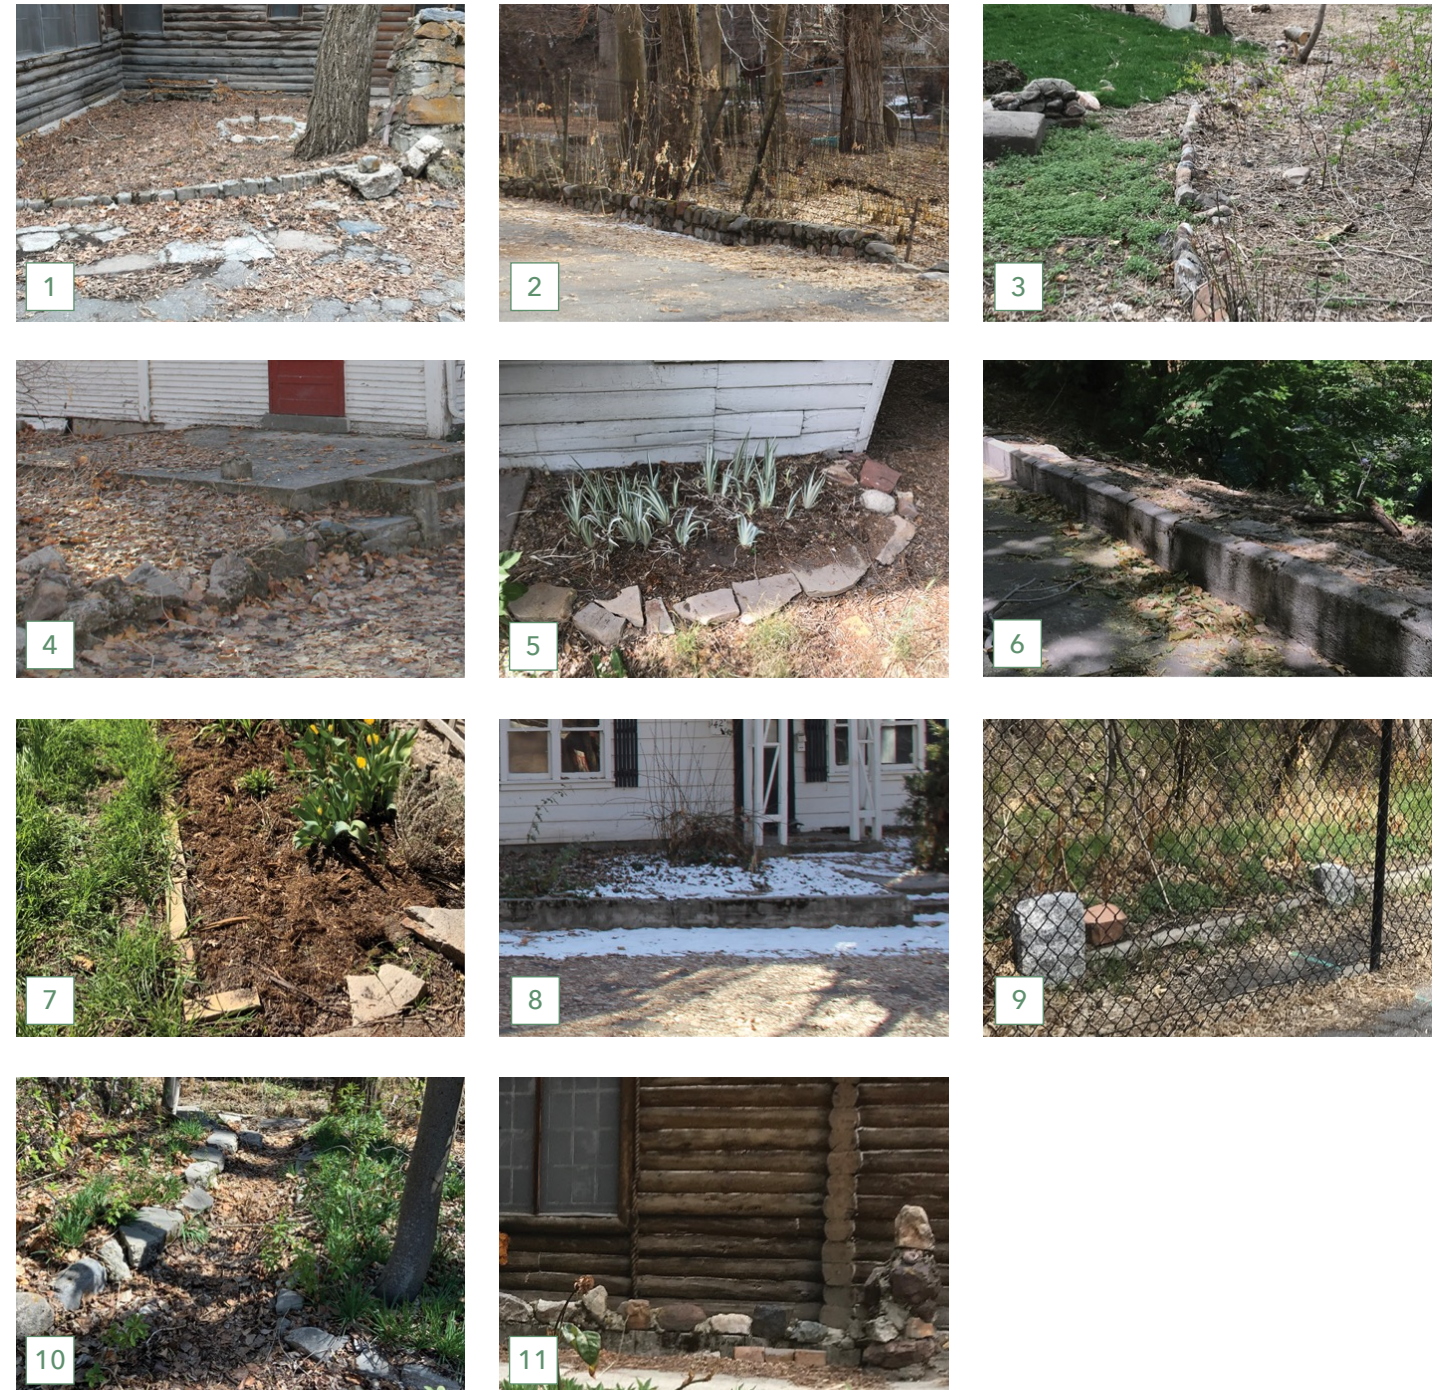
Figure 3-34. Edging Photos

The study area also contains a large number and variety of edging materials. Edging usually appears in more manicured spaces such as along the fronts of houses to define foundation planting beds, along driveway or pathway edges as a curb, and in some instances to define a trail. The following types of edging can be found throughout the study area:

- Edging, mortared stone: Composed of various types of stone including mainly river rock, but in some areas also cut stone including granite and sandstone, mortared together.
- Edging, loose stone: Composed of various types of stone fit loosely together along the ground-surface to define an edge.
- Edging, mortared brick: Composed of brick mortared together to define a planter area or edge.
- Edging, loose brick: Edging composed of brick dry fit together along the ground plane or partially embedded in the ground-surface to define an edge.
- Edging, concrete: Cast concrete along the ground-plane used to define an edge.
- Edging, composite: Some combination of the various edging types in one area.
