ALLEN PARK CULTURAL LANDSCAPE REPORT

Salt Lake City, Utah
November 2022

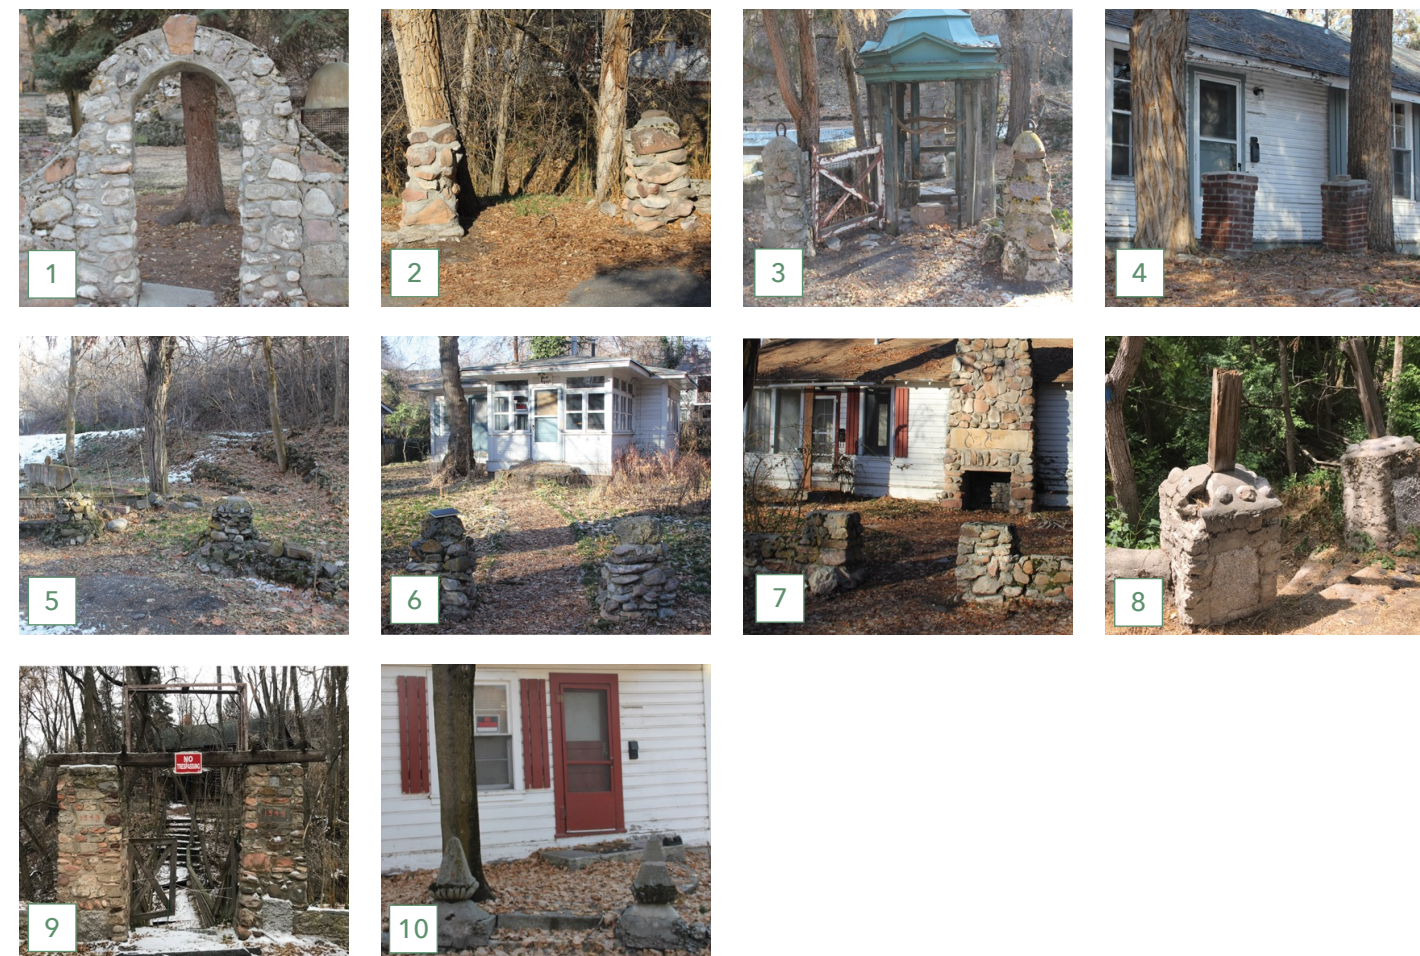
Figure 3-35. Gateway Photos

- Gateway, pillars with posts and beam (8): Stone pillars at the base of vertical posts, supporting a horizontal member over an opening.
- Gateway, tall stone pillars with wooden lintel (9): Tall, masonry, mortared stone pillars flanking an opening with a wooden lintel spanning the opening.
- Gateway, cast concrete pillars (10): Decorative cast concrete elements, usually combined with some masonry component, flanking the sides of an opening.

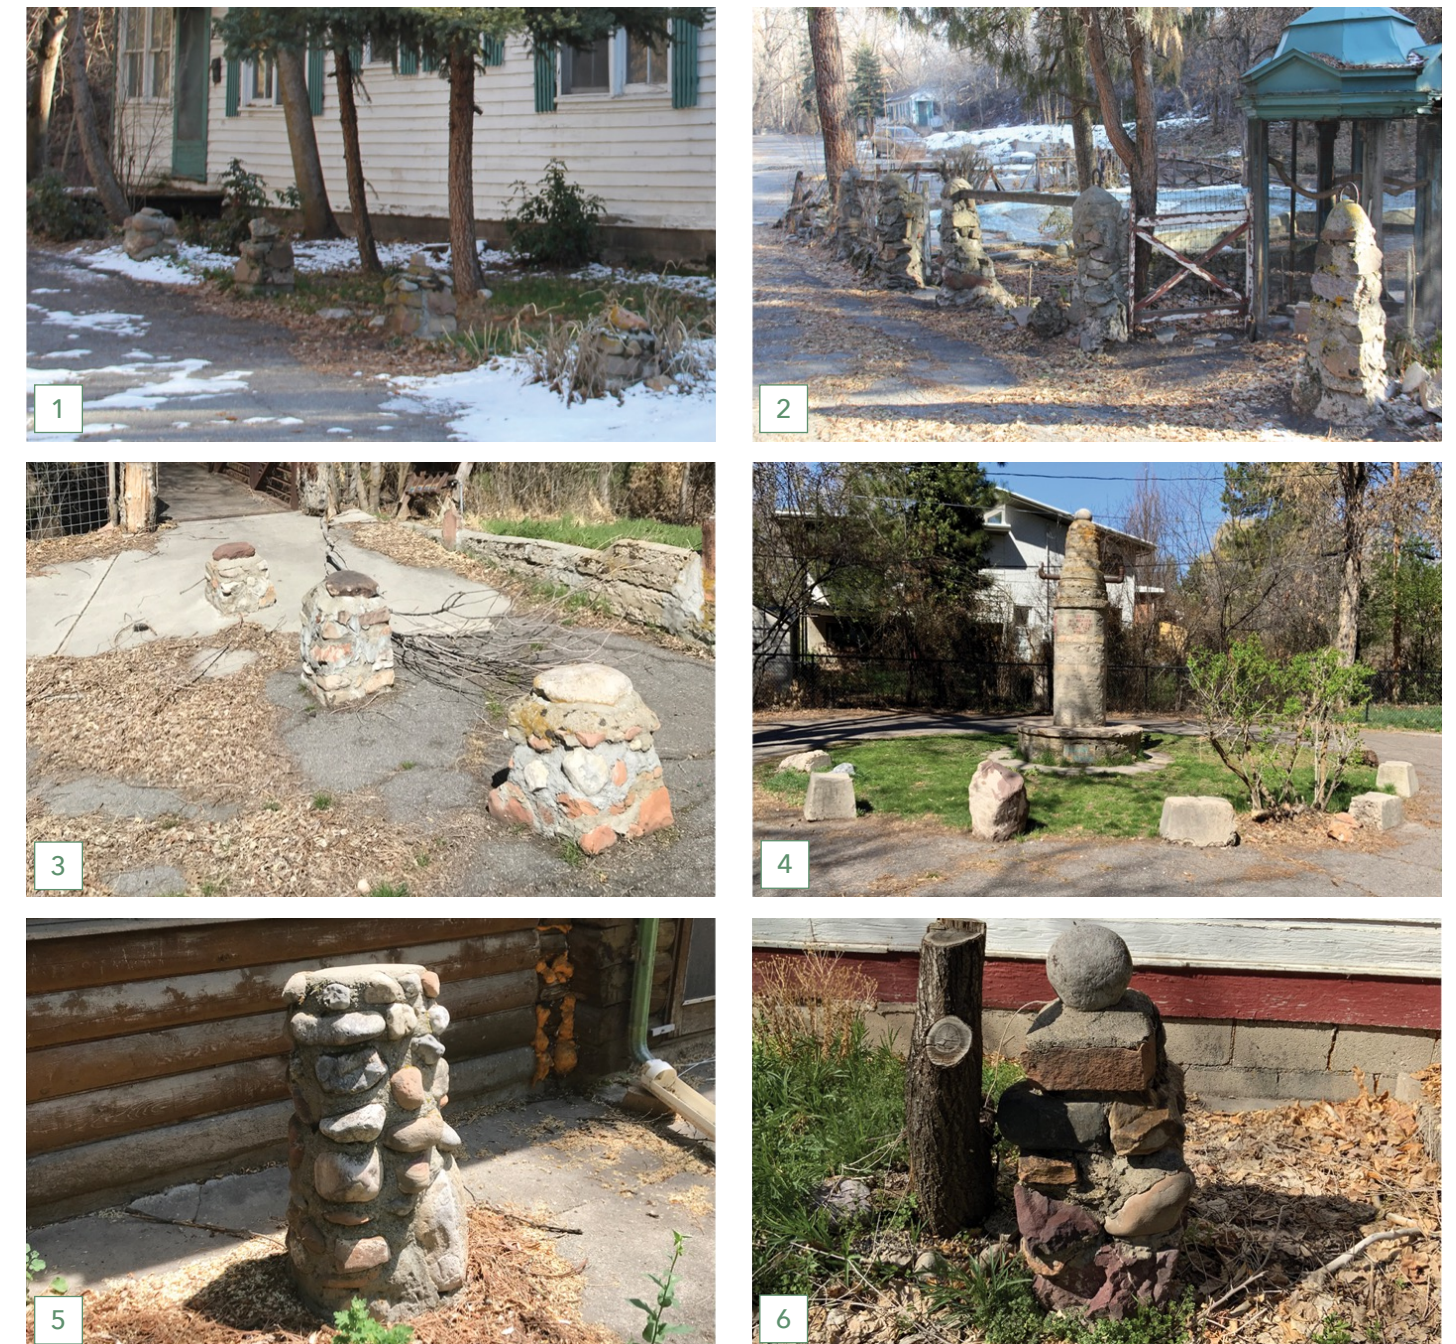
Figure 3-36. Bollard & Pillar Photos

- Bollards, boulders or blocks (4): Large natural or cut stones placed singularly or in rows to delineate and buffer an edge.
- Masonry pillars (5-6): These are similar to the mortared stone pillars appearing at gateways and used as bollards but appear singularly and are not associated with either a driveway or an opening.

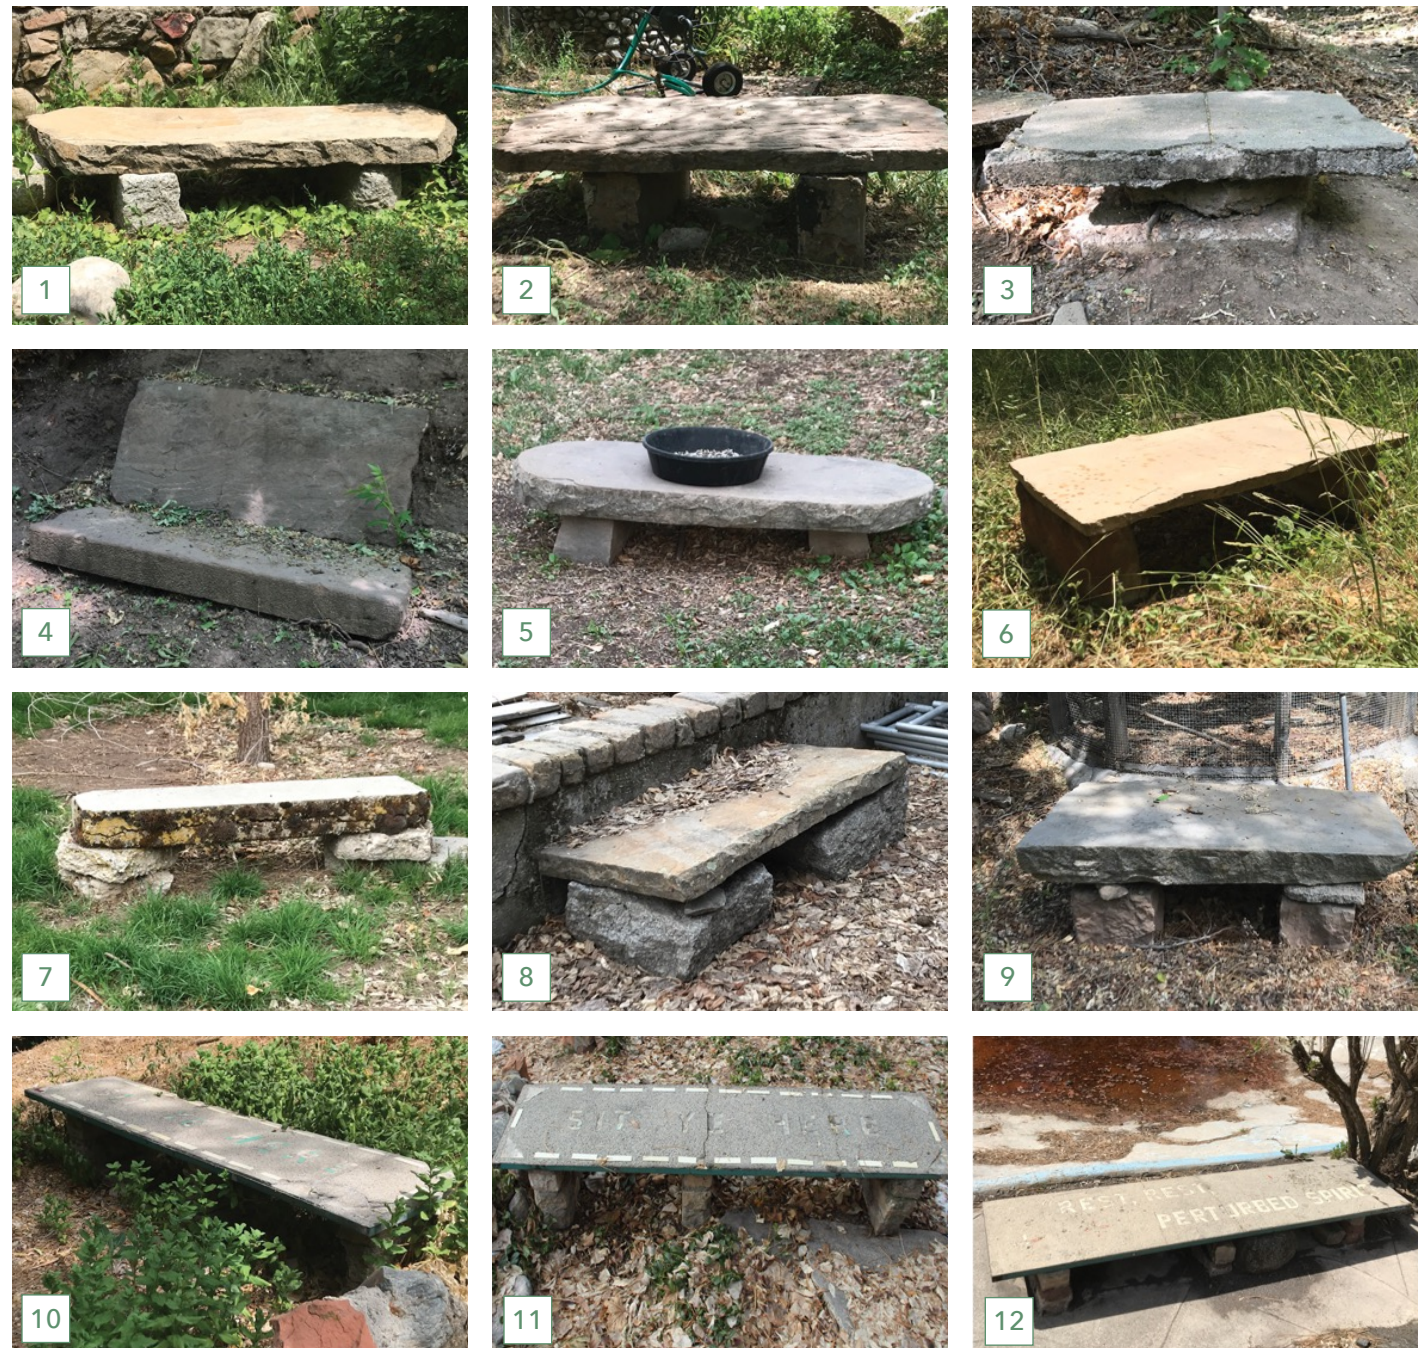
Figure 3-37. Bench Photos

- Bench, slab (1-9): large slabs of stone or recycled concrete resting across two columns of smaller stones.
- Bench, artwork mosaic (10-12): The seat portion of these benches is cast in concrete, and ornamented with mosaic tiles, similar in construction and appearance to the monument artworks, but articulated as a horizontal bench surface.

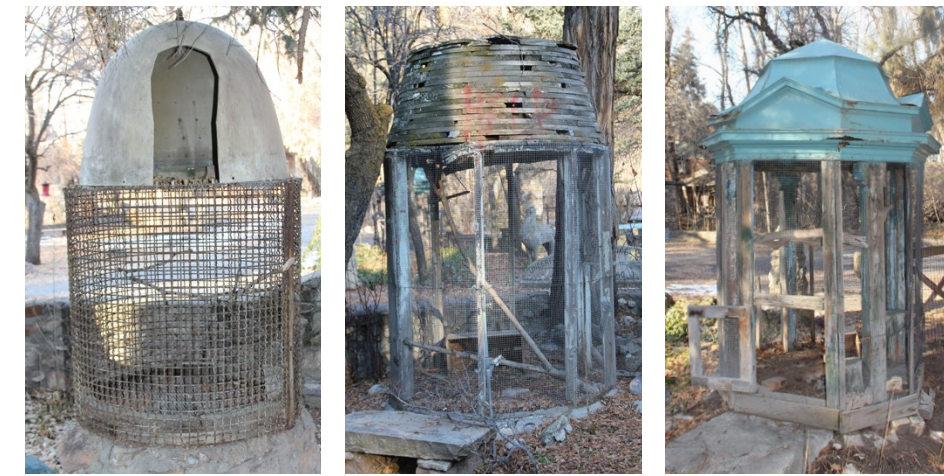
Figure 3-38. Bird Cage Photos

The study area contains several bird cages. Although the form, structure, materials, and articulation of these vary somewhat they are all constructed as permanent landscape features that have a sculptural quality.

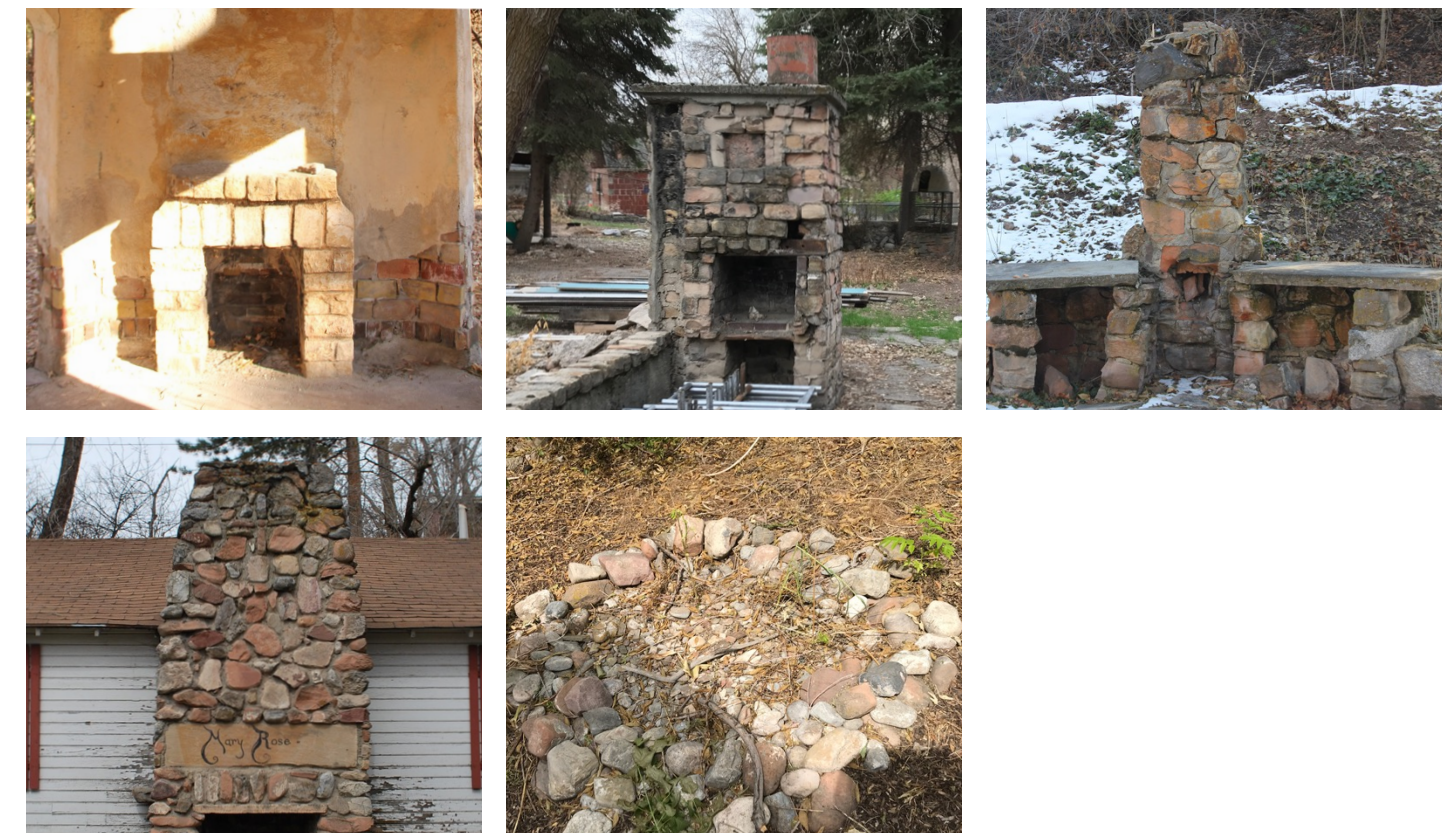
Figure 3-39. Fireplace Photos

- Fireplaces, fire rings - Circular elements on the ground surface delineating a space for a fire, consisting of stone or cast in concrete.
- Fireplaces, masonry - Freestanding outdoor fireplaces mortared brick or stone.

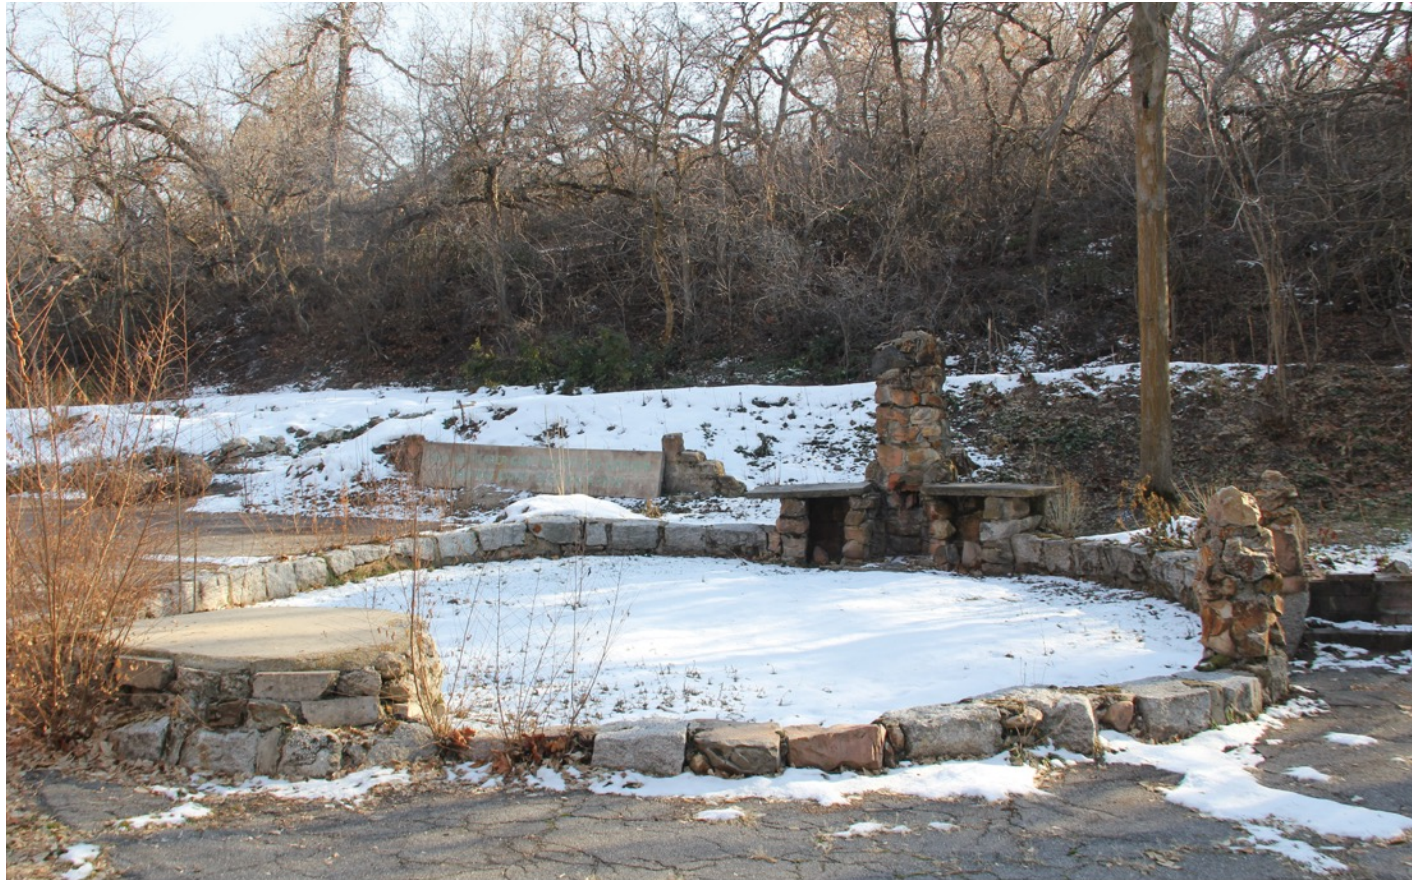
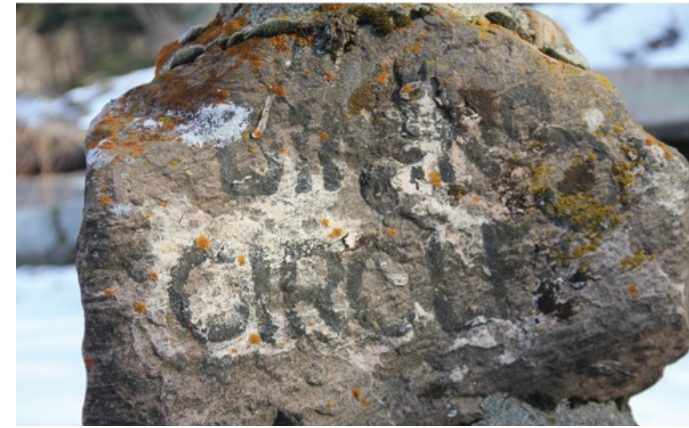
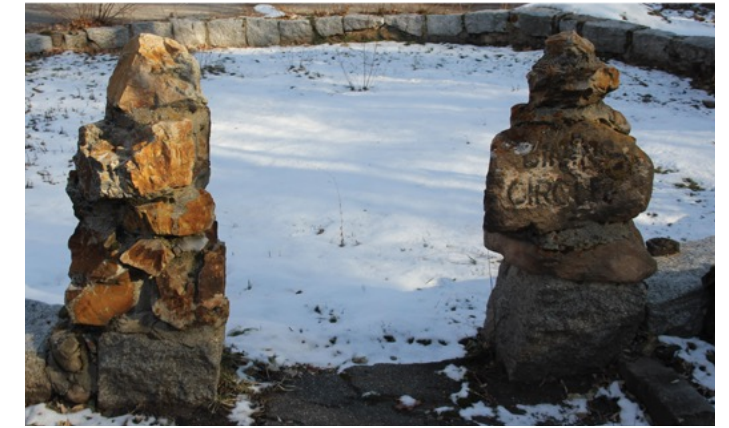
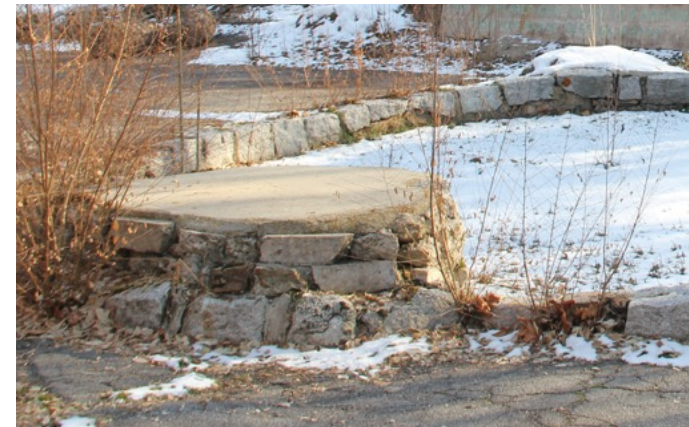
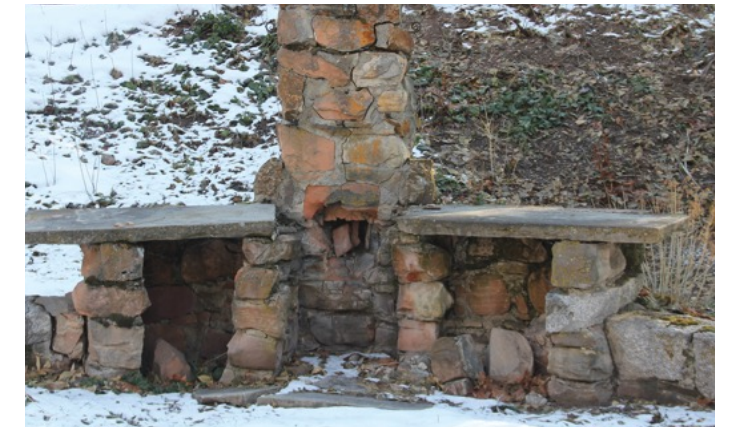
Figure 3-40. Dining Circle Photos

Dining Circle - Stone wall perimeter with integrated masonry fireplace on the south side, and built-in stone dining table at north side.

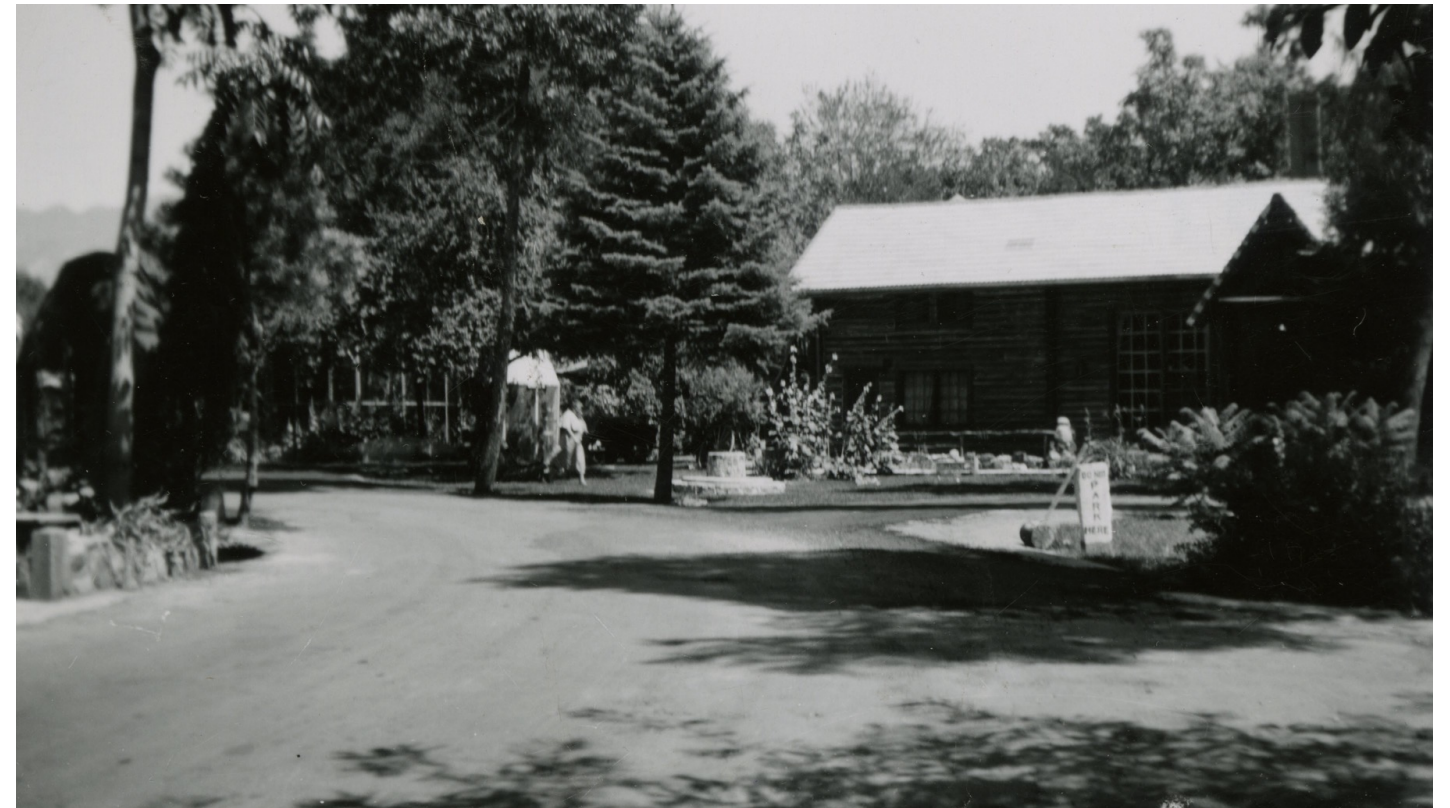
Figure 4-1. Ca. 1950 photo of Allen Park showing strong vertical planes of the Allen House and surrounding vegetation that work to separate the space of the Entry Sequence from the spaces east of the home, and serve as the visual terminus of this space.

The manicured landscape in front of the Allen House is shown in Figure 4-1 on page 55, taken ca. 1950. The image shows a tidy lawn area in front of the Allen House that is neatly mown with a crisp edge. Larger trees line the driveway, including a younger version of the same spruce tree that exists in that location today. A large shrub flanks the northwest corner of the house and the distinctive form of hollyhocks (*Alcea rosea*) dominate the border in front of the house. Inside the round-about the palm like foliage of some large shrubs mimics the same leaf pattern on the large tree of heaven (*Ailanthus altissima*) clearly visible

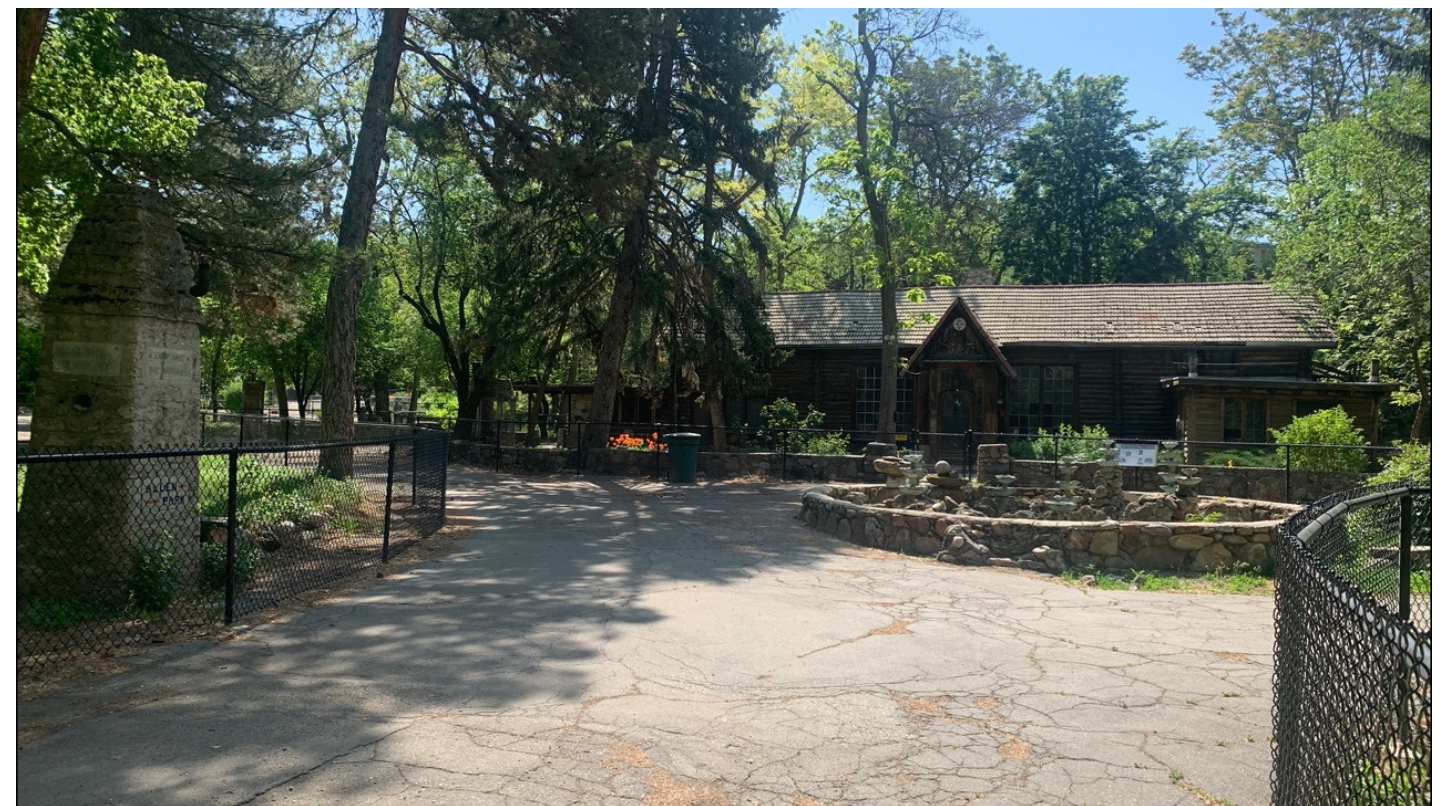
Figure 4-2. May 2021 comparative photo showing continuation of the strong vertical planes defined by the Allen House and adjacent vegetation.

The manicured spaces throughout the study area have fallen into a state of neglect since the end of the period of significance as is visible in another series of comparative photos. In a 2021 comparative photo (Figure 4-2 on page 55) the groundcover in front of the Allen House is blocked by the wall. Larger shrubs not apparent in the ca. 1950 photo are visible just behind the wall that borders the Allen House front yard. The large shrub off the northwest corner, the hollyhocks, and the ailanthus are noticeably absent. The young conifer trees have matured, and now dominate this view. A new catalpa tree (*Catalpa sp.*) flanks the north side of the entrance to the home.

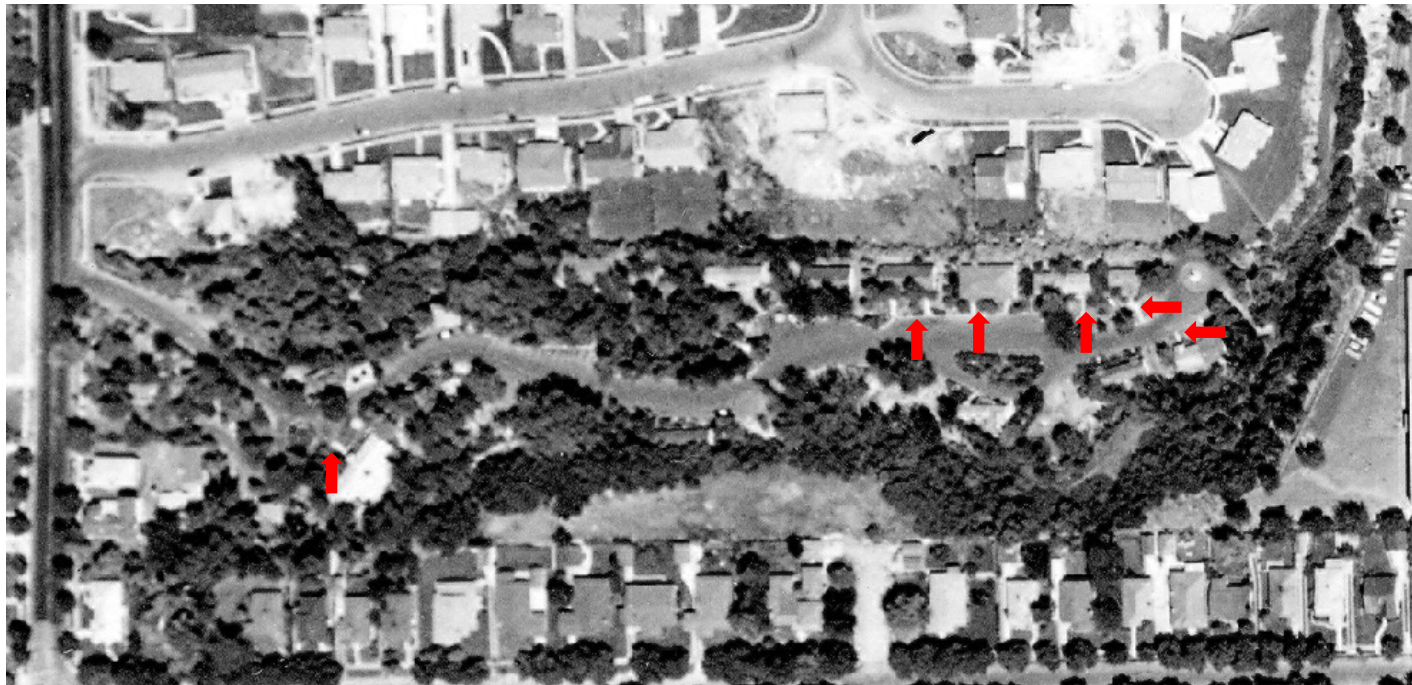
Figure 4-3. 1958 aerial photo depicting pathways at the Allen House and village area.

Data sources documenting pathways at Allen Park during the period of significance are limited, but at least some such pathways are visible in a 1958 aerial image of the property (see Figure 4-3 on page 56). Photographs of the property from the 1940s and 1950s depict many of these pathways, at least in part (see Figure 4-5 on page 57). The pathways are highlighted by such features as stone, concrete, or brick entry posts or columns or breaks in stone or concrete walls flanked by

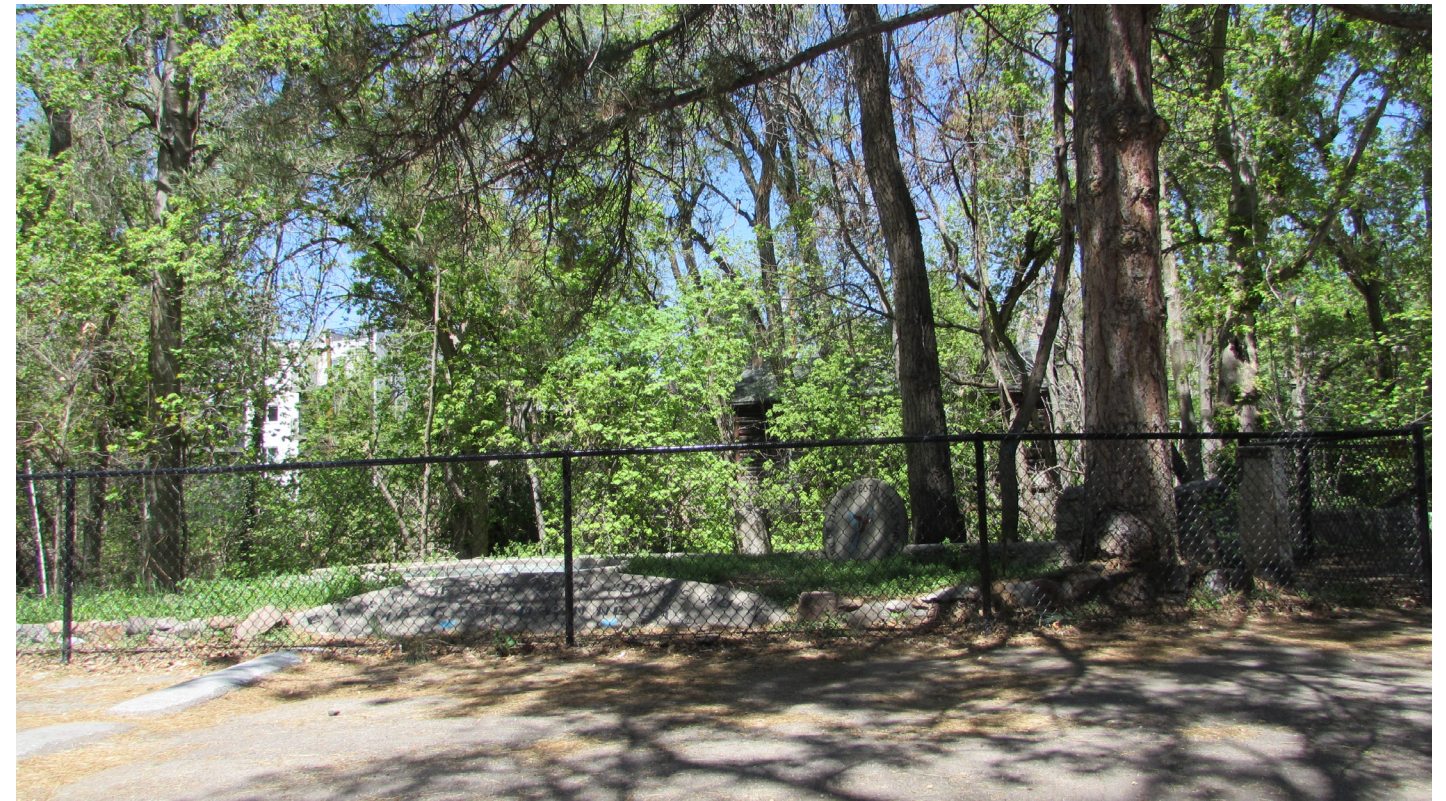
Figure 4-6. 2021 view looking north from central roundabout toward surrounding structures.

the north, east, and south; however, during the winter months, the exterior walls of adjacent structures, especially those of multi-story dwellings along the northern property line, appear to loom over the park. These structures create an altered north-facing view from the western part of the property (e.g., from West Allen Park), and erode the sense of privacy that is so apparent during the rest of the year. It is important to note, however, that the Allen Park parcel has been surrounded by development since at least the 1920s. As such, the views and vistas from the property today, though somewhat more screened due to the maturation of vegetation over time, are not substantially different than they were during the period of significance (see Figure 4-5 and Figure 4-6 for comparative views).

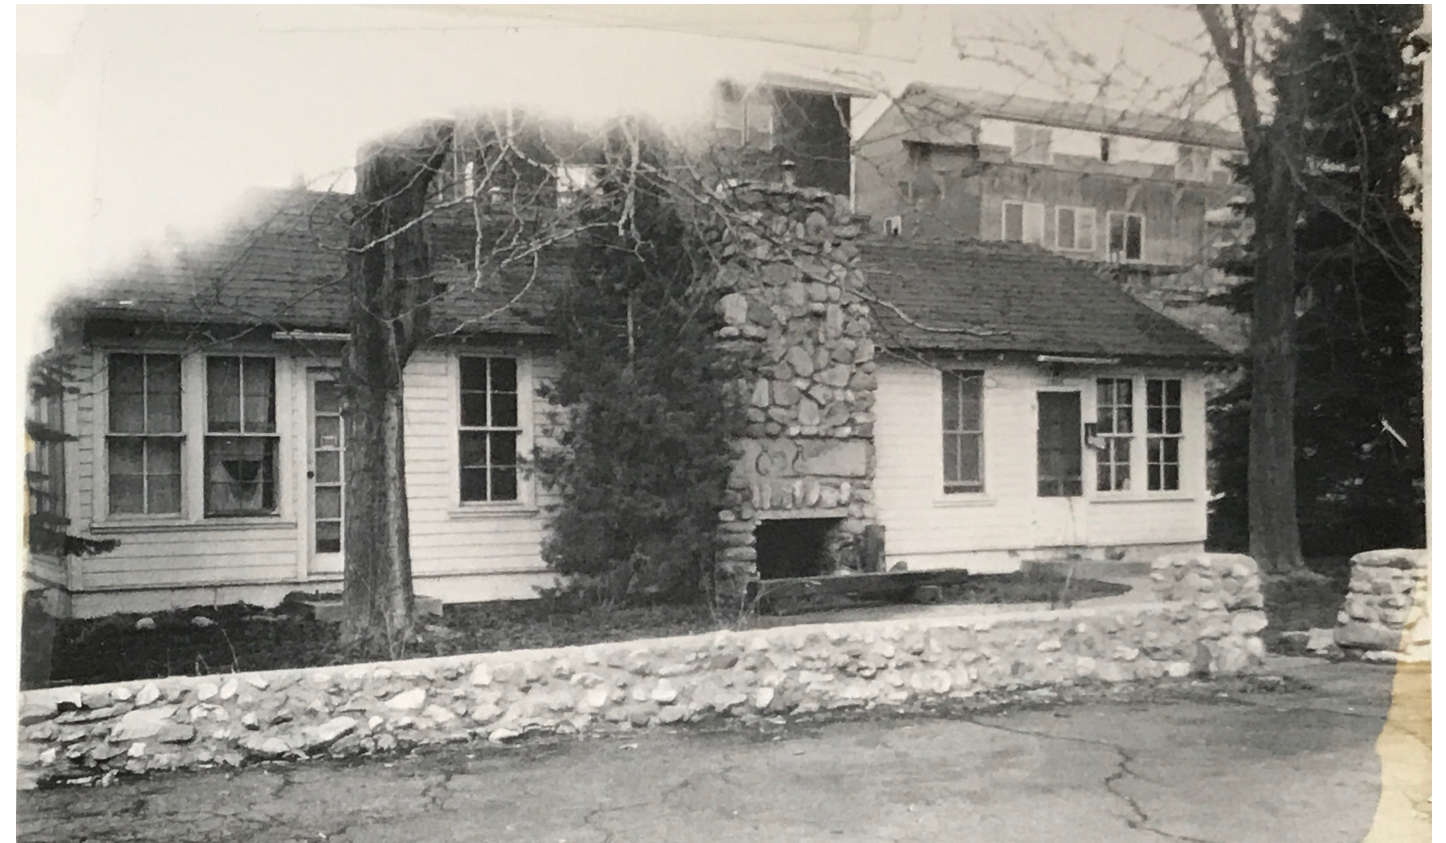
Figure 4-7. Ca. 1948 photo of the Mary Rose cottage and its stone wall.

A small number of the walls present on the property during the 2021 site inventory appear in historical photographs of the property. Generally, the walls that remain today and are visible in historical photographs are consistent with their design and materials from the period of significance. See Figure 4-7 and Figure 4-8 for an example of the historical and current nature of the wall features.

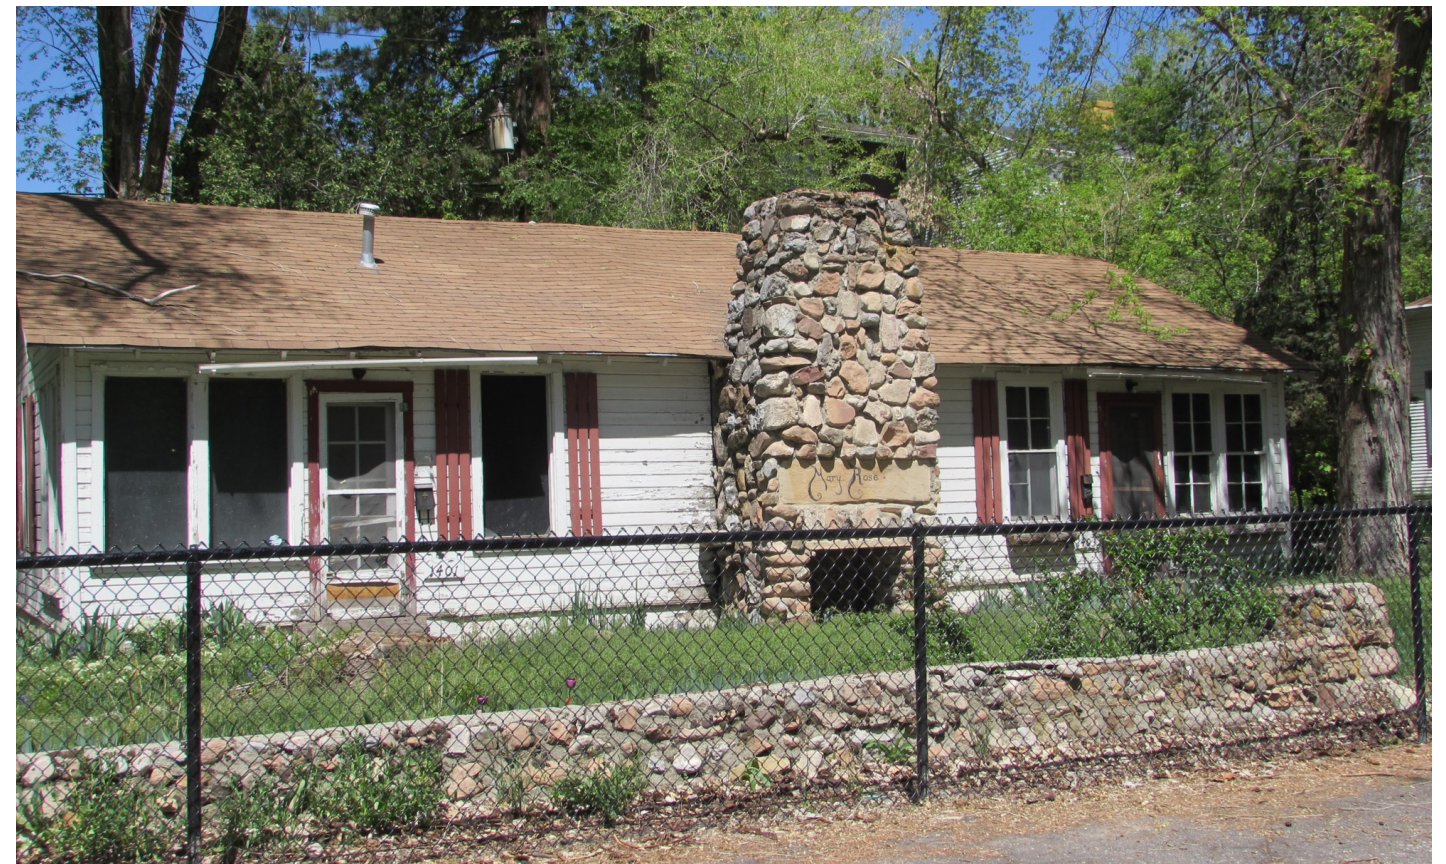
Figure 4-8. 2021 comparative photo of the Mary Rose cottage and its stone wall.

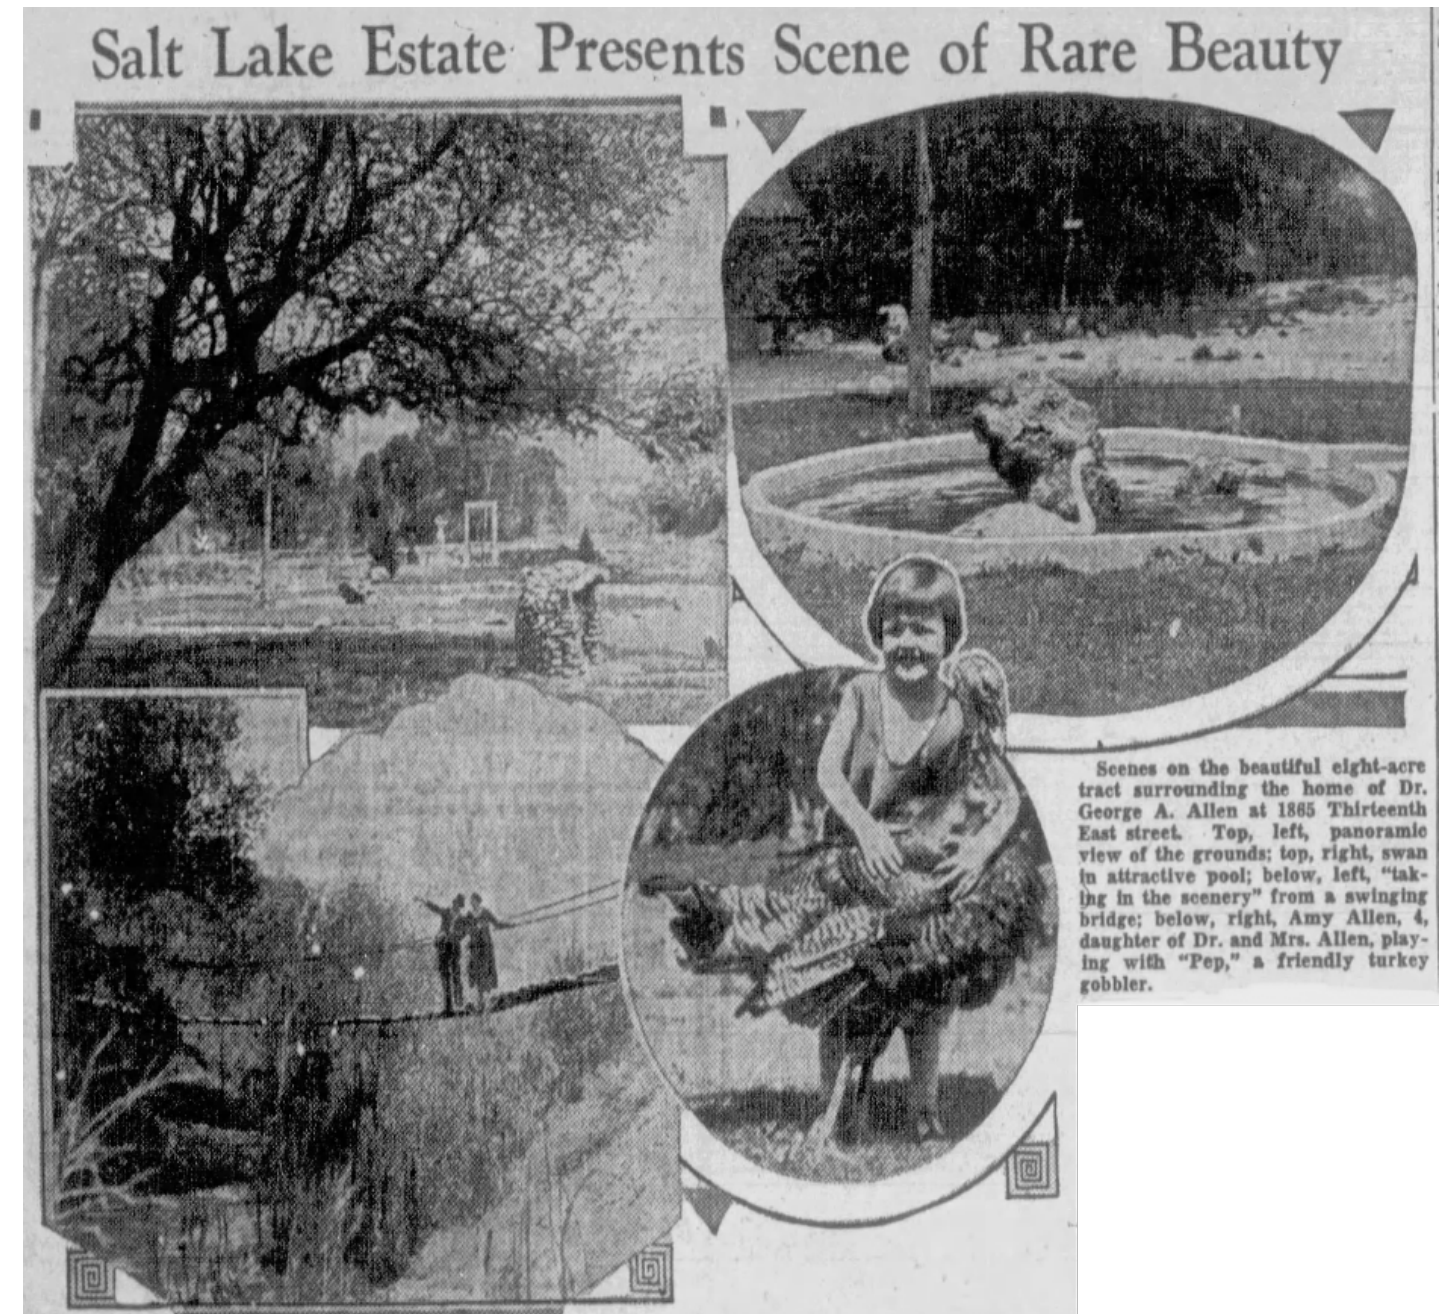
Figure 4-10. Excerpt from ca. 1932 newspaper article showing understory near suspension bridge at lower left.

The understory vegetation is visible in a small number of ground-level photographs of the property. For example, Figure 4-10 gives a better indication of what understory riparian vegetation existed during the period of significance. Some overstory vegetation is

visible on the left side of the image, but on the right side of the creek the bank is more open, with a noticeable line of large woody shrub vegetation and a healthy stand of grasses on the upper portions of the bank.

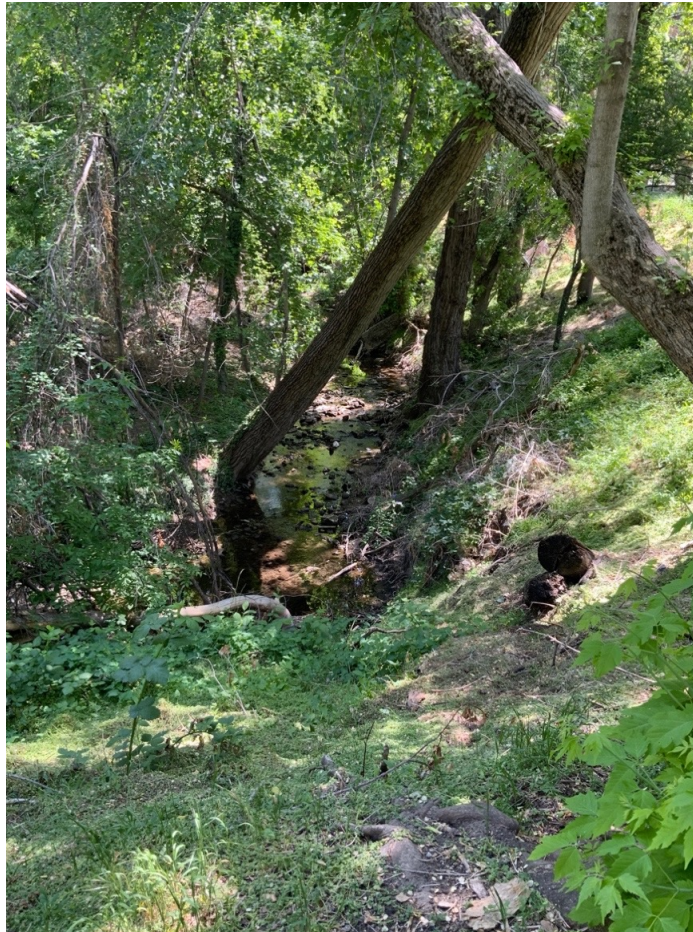
Figure 4-11. May 2021 photo of creek vegetation showing understory.

Compared to the historic conditions, the overstory vegetation (Figure 4-11) has become predominant, blocking out sunlight to support

shrubby vegetation and grasses which are not present in this image (said understory vegetation does exist intermittently along portions of the creek where the tree canopy is less dense). The remaining herbaceous vegetation has become overtaken with invasive species resulting in significant erosion on a large portion of the creek bank.

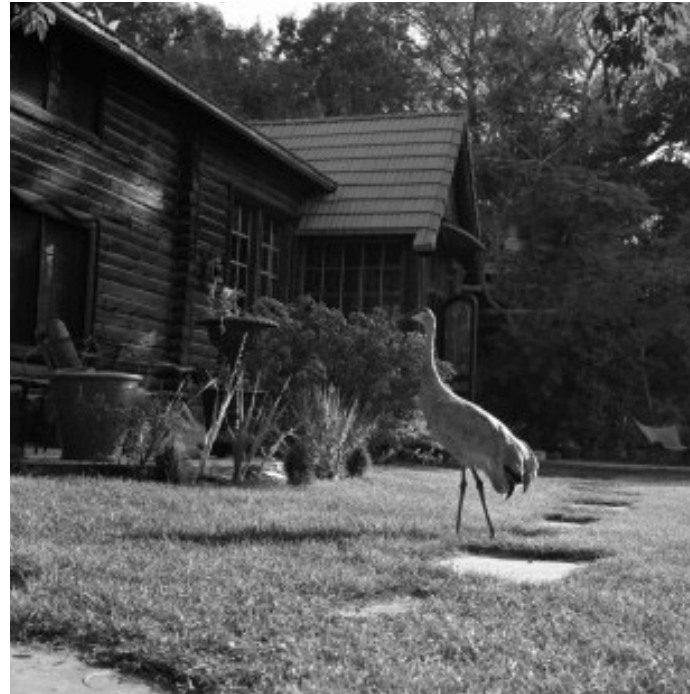
Figure 4-12. Ca. 1945 photo of Sandy the Sandhill Crane at the Allen House. Note lawn and garden spaces.

A ca. 1945 photo (Figure 4-12) shows a very small vegetative border, with an upright habit shrub or perennial flanking the north side of the entrance. The border is small and appears to include iris (*Iris germanica*) interspersed with some small tight growing vegetation that appears to have an almost boxwood (*Buxus sempervirens*) like quality. Some herbaceous vegetation appears to be visible just behind the bird. The grass is mown short and appears to be neatly edged.

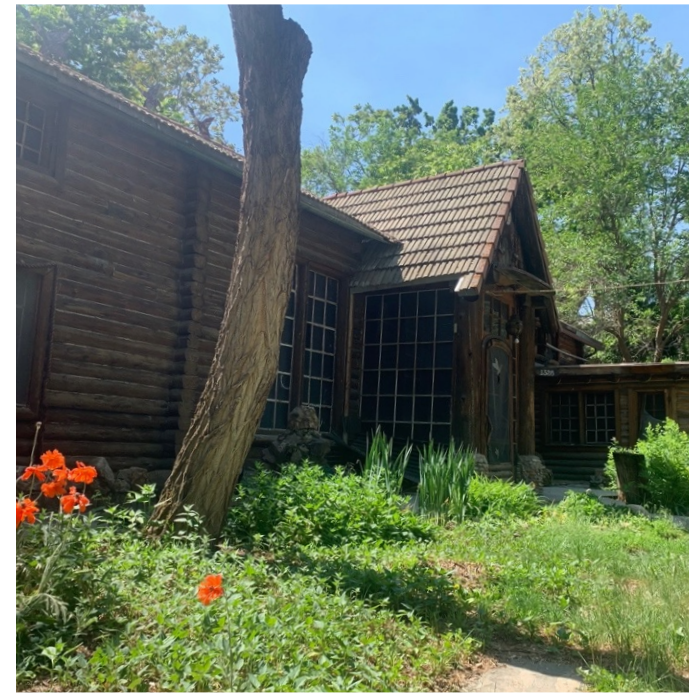
Figure 4-13. 2021 comparative photo of Allen House showing lawn and garden spaces.

In a 2021 photo (Figure 4-13) the irises are still visible. A peony and rose bush on the south side of the main entry walk mimic the form of the unidentified shrub in the ca. 1950 image. The shrub bed has encroached into the lawn and become more herbaceous. The lawn has become overgrown and naturalized but is still discernible as a lawn-like space.
