ALLEN PARK CULTURAL LANDSCAPE REPORT

Salt Lake City, Utah
November 2022

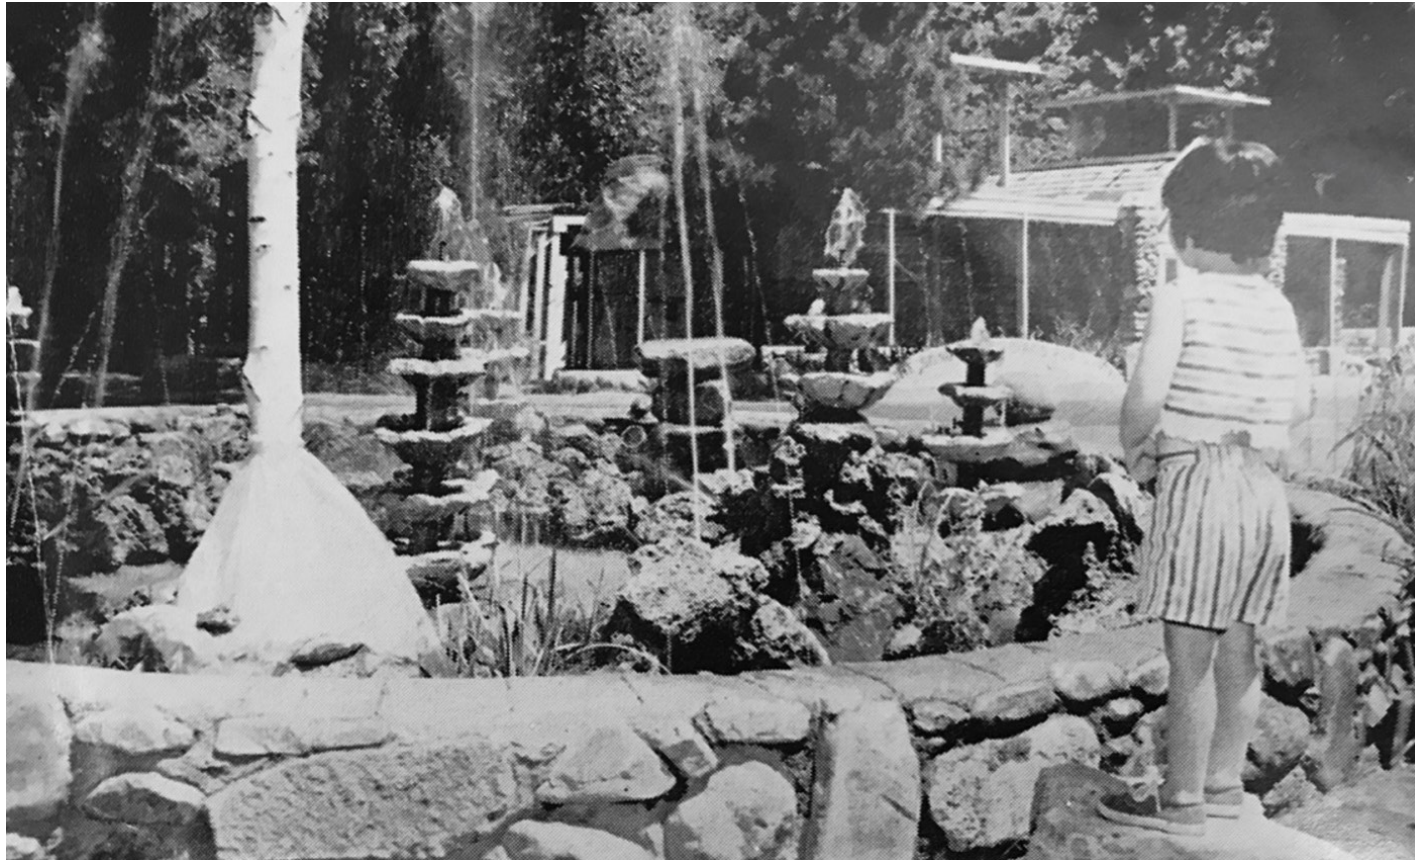
Figure 4-14. Ca. 1961 view looking at central roundabout fountain.

Analysis - Very little evidence was discovered in terms of a comparative data from the historical period. A few of the larger water features, such as the central roundabout fountain and swimming pool, are minimally discernible in aerial images of the area. Among the few images available, one from ca. 1961 depicts much of the central roundabout fountain (see Figure 4-14 on page 61) and one from ca. 1950 that partially depicts the small concrete

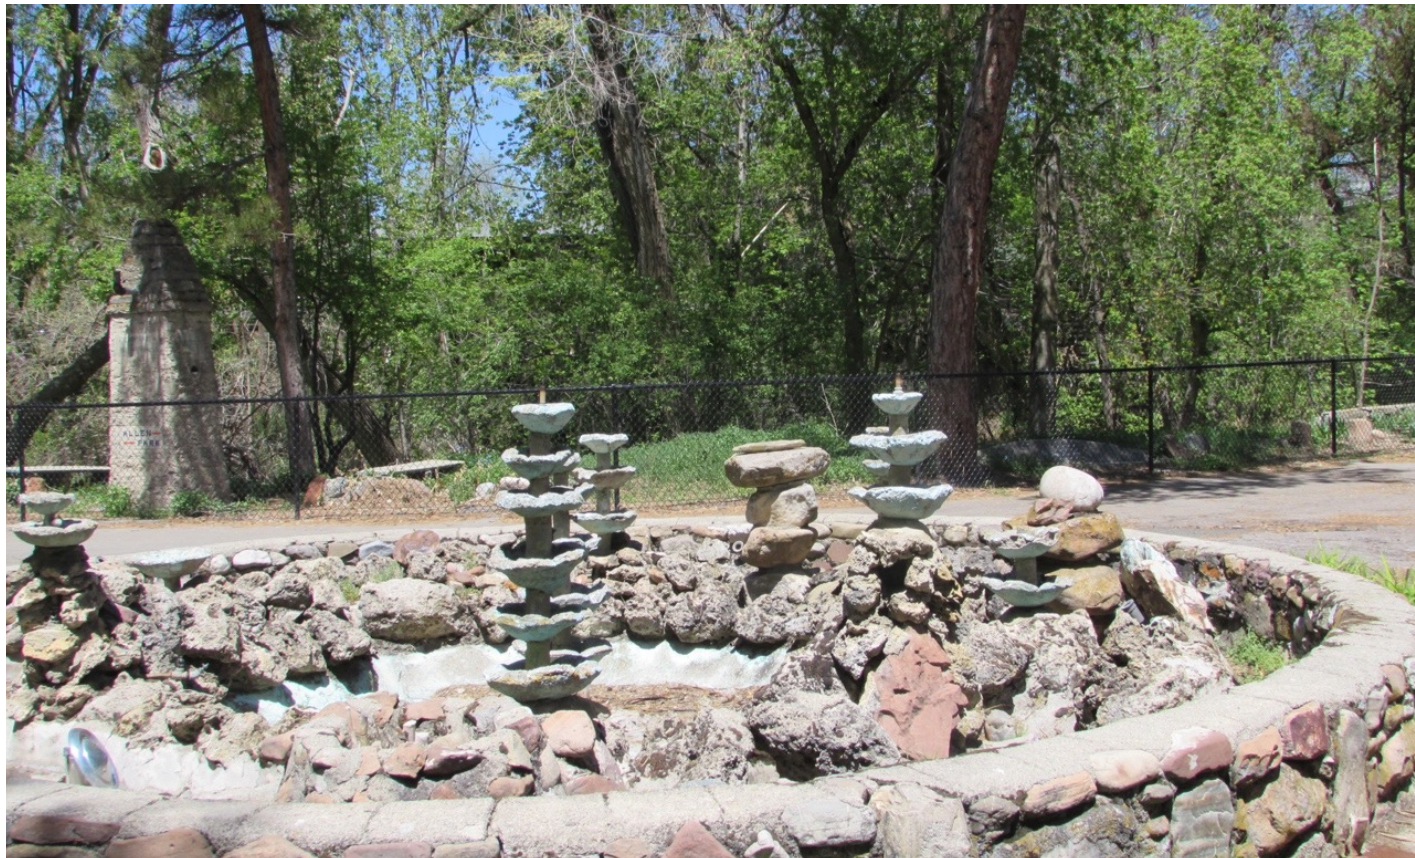
Figure 4-16. 2021 comparative view looking at central roundabout fountain.

fountain north of the Allen House (see Figure 4-15 on page 61). Comparing the central fountain as shown in the ca. 1961 photo with its current condition (see Figure 4-16 on page 61) indicates that the feature substantially retains its historical integrity. The only changes of note are that the tops of two of the fountain "towers" have broken off, and an aspen tree once located in the southwest quadrant of the fountain has been removed. The small fountain north of the Allen House also substantially retains integrity with the primary change in the feature being limited to the loss of the metal fountain spout that projected upward from the center of the concrete pedestal in the middle of the fountain (see Figure 4-17 on page 61 for the present-day comparative view).

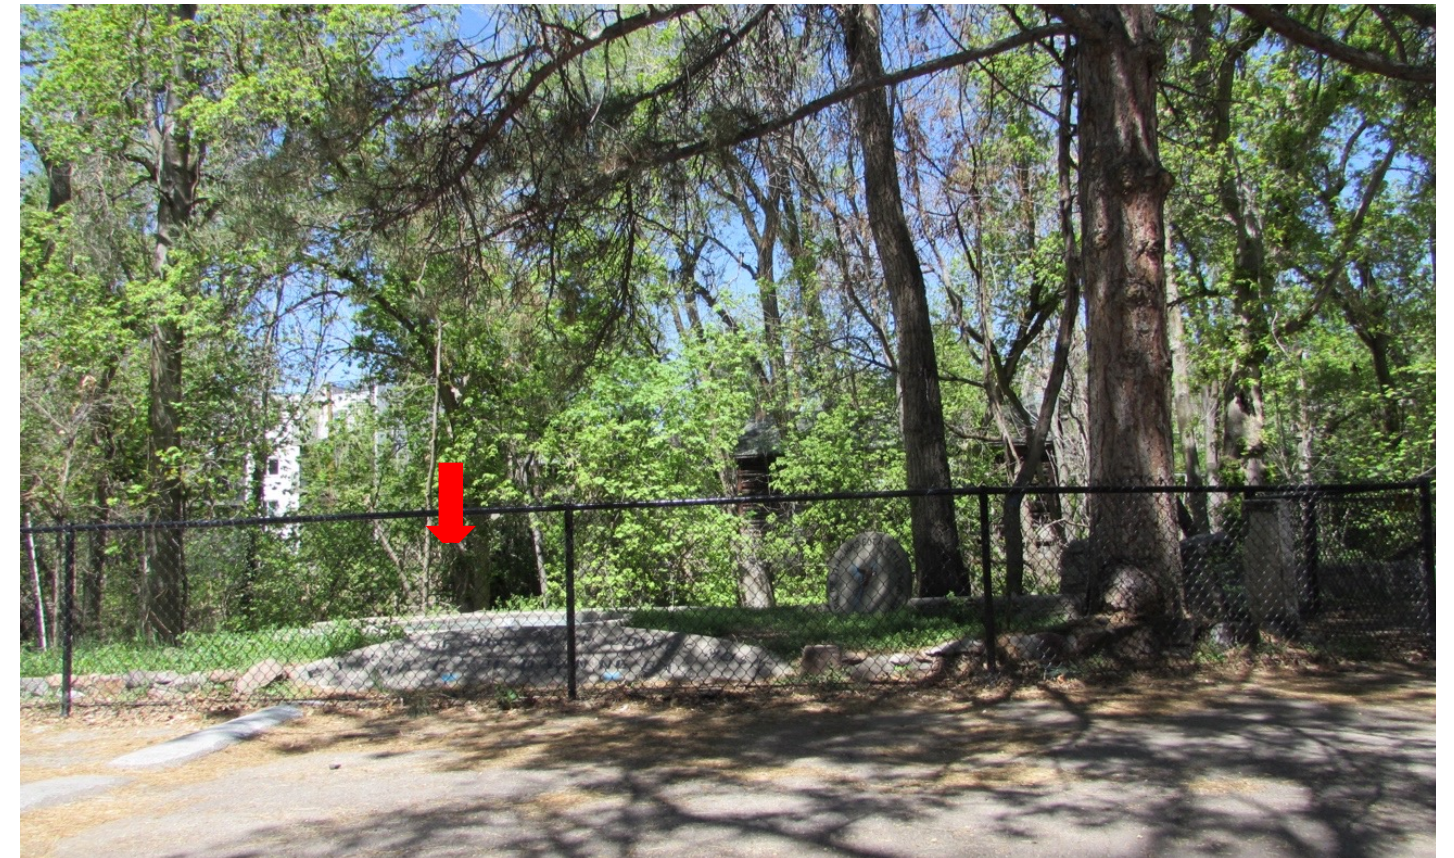
Figure 4-17. 2021 comparative view depicting concrete fountain north of Allen House.

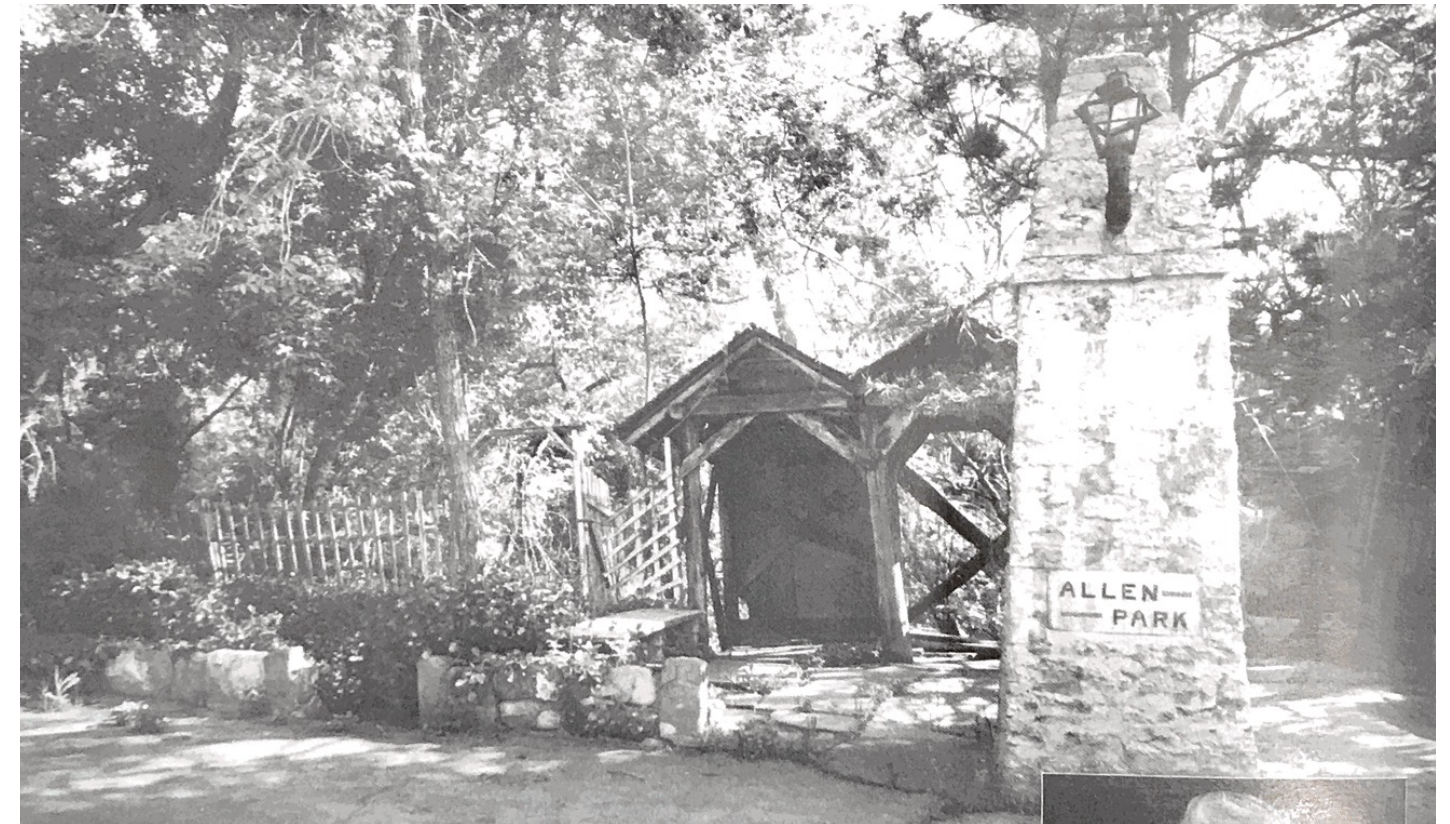
Figure 4-18. Ca. 1986 image of a light pillar located northwest of the Allen House.

The only notable change to the light pillars is that the lamp fixtures themselves, though not the connecting armature, has been removed (see Figure 4-18 and Figure 4-19 on page 62 for a comparison of one historical light pillar to its current condition). Ten of these pillars include either incised or tile mosaic art in the form of text or images of animals, plants, or people, and, as such, they are considered artworks as much as they are light installations.

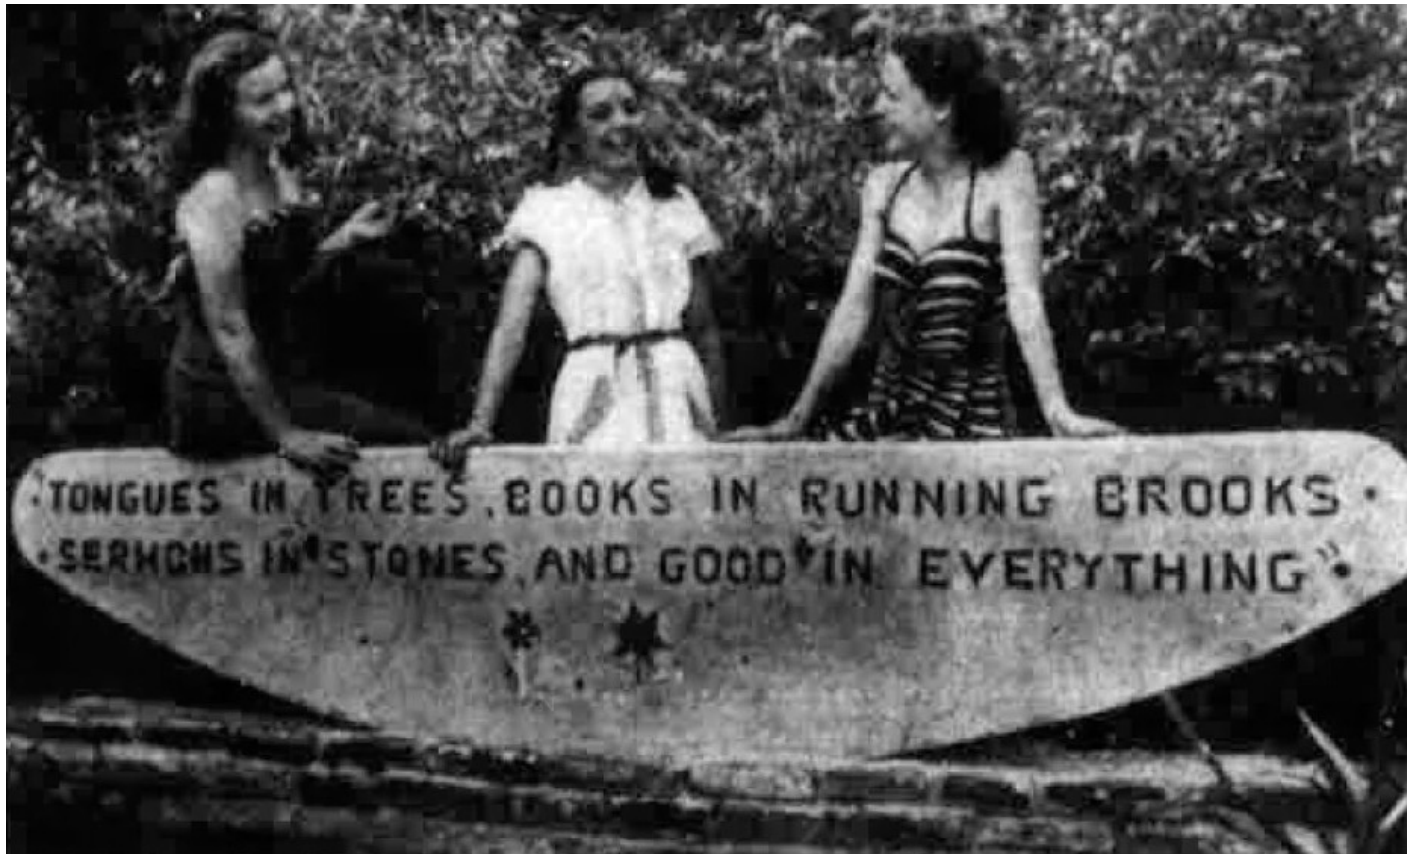
Figure 4-20. Ca. 1949 image of monument northeast of Allen House.

these features. A few of the monuments have become partially buried at their bases (see Figure 4-20 and Figure 4-21 for an example) due to such factors as the build-up of the driveway/road, sediment accumulation, or accumulation of vegetation and a thick duff layer.

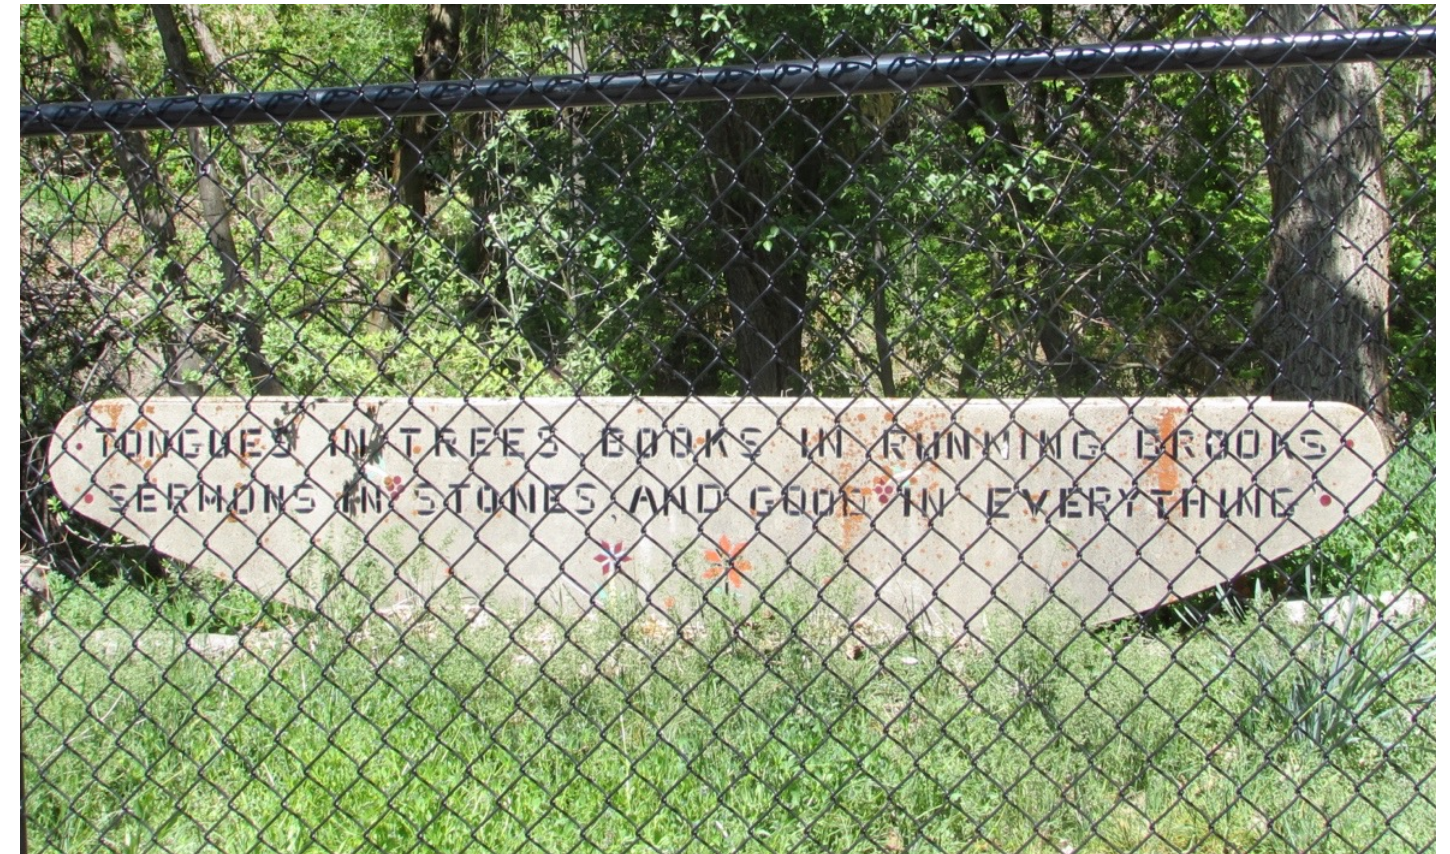
Figure 4-21. 2021 comparative view of monument northeast of Allen House.

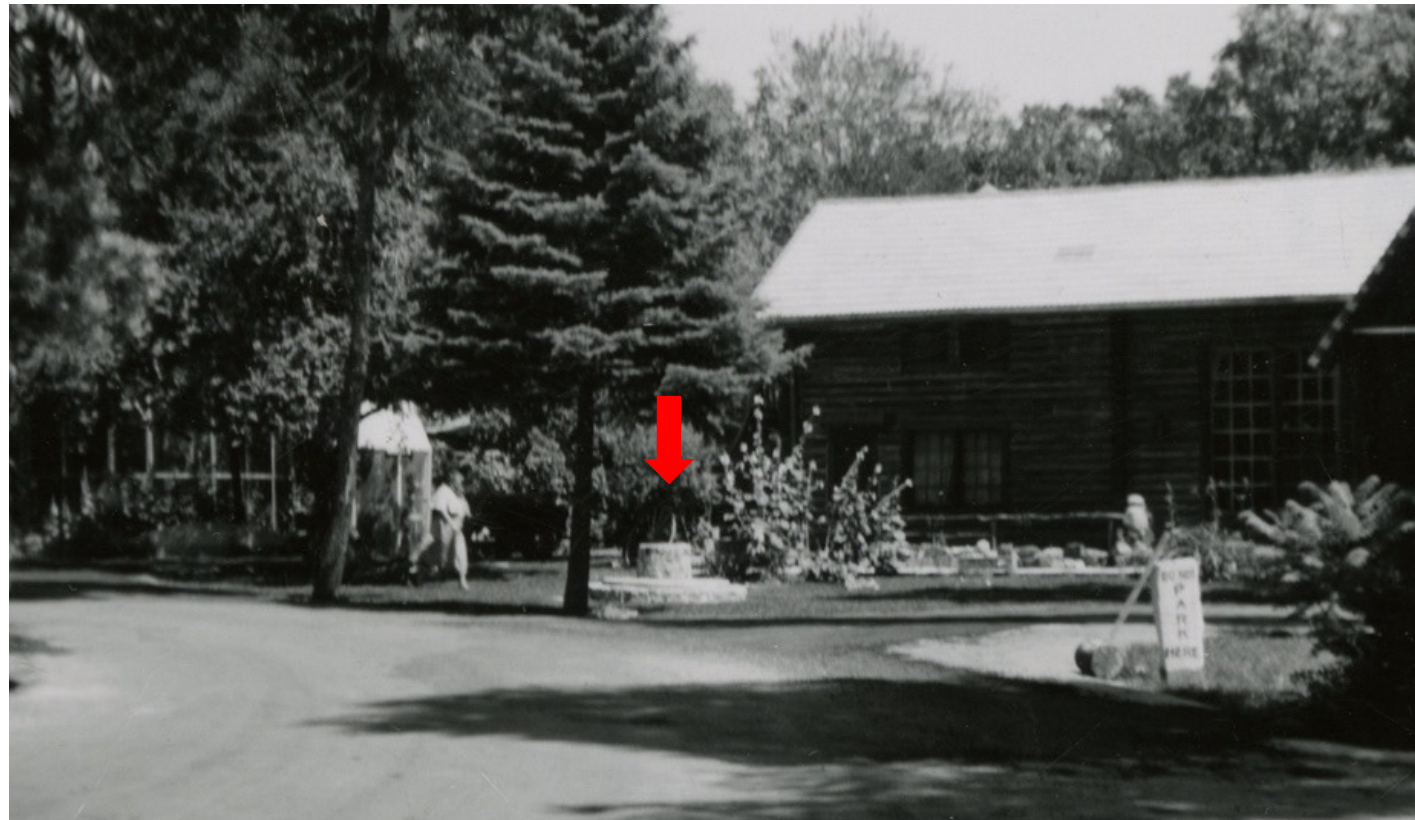
Figure 4-22. Ca. 1950 photo of Allen Park with the sundial in front of the Allen House.

Several unique art pieces are present at Allen Park. These features include the sundial in the front yard of the Allen House, two small dome-like features constructed of mortared river cobbles, a small number of singular masonry pillars, and the remains of cast concrete animal sculpture near the swimming pool. Of these features, historical photographs used in a comparative analysis only depict the sundial (see Figure 4-22 on page 64) and one of the two dome-like features (see Figure 4-24 on page 64). Present day views of these two features (see Figure 4-23 and Figure 4-25 on

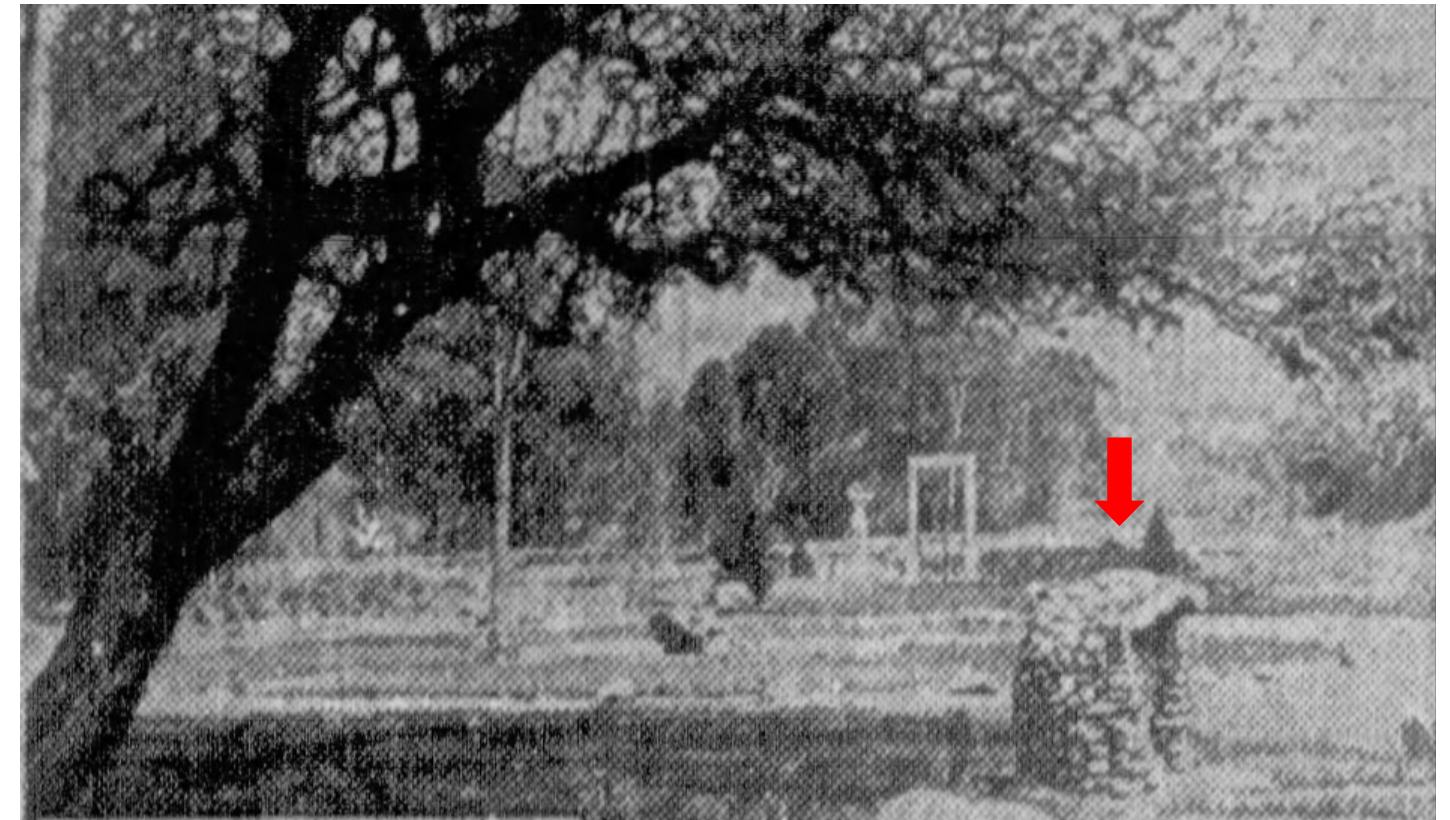
Figure 4-24. Photo from ca. 1932 newspaper article showing half-dome feature.

page 64) suggest they retain a high degree of historical integrity. The half-dome feature appears partially buried due to the built up paving that has raised the elevation of Allen Park Drive since 1950. No historical images of the second dome feature or the singular masonry pillars have been located; however, they are presumed from their current condition to have been constructed during the historical period and to retain reasonable integrity of location, design, materials, workmanship, setting, feeling, and association. All the other artworks currently present on the property are considered contributing features to the significance of the overall historical landscape.

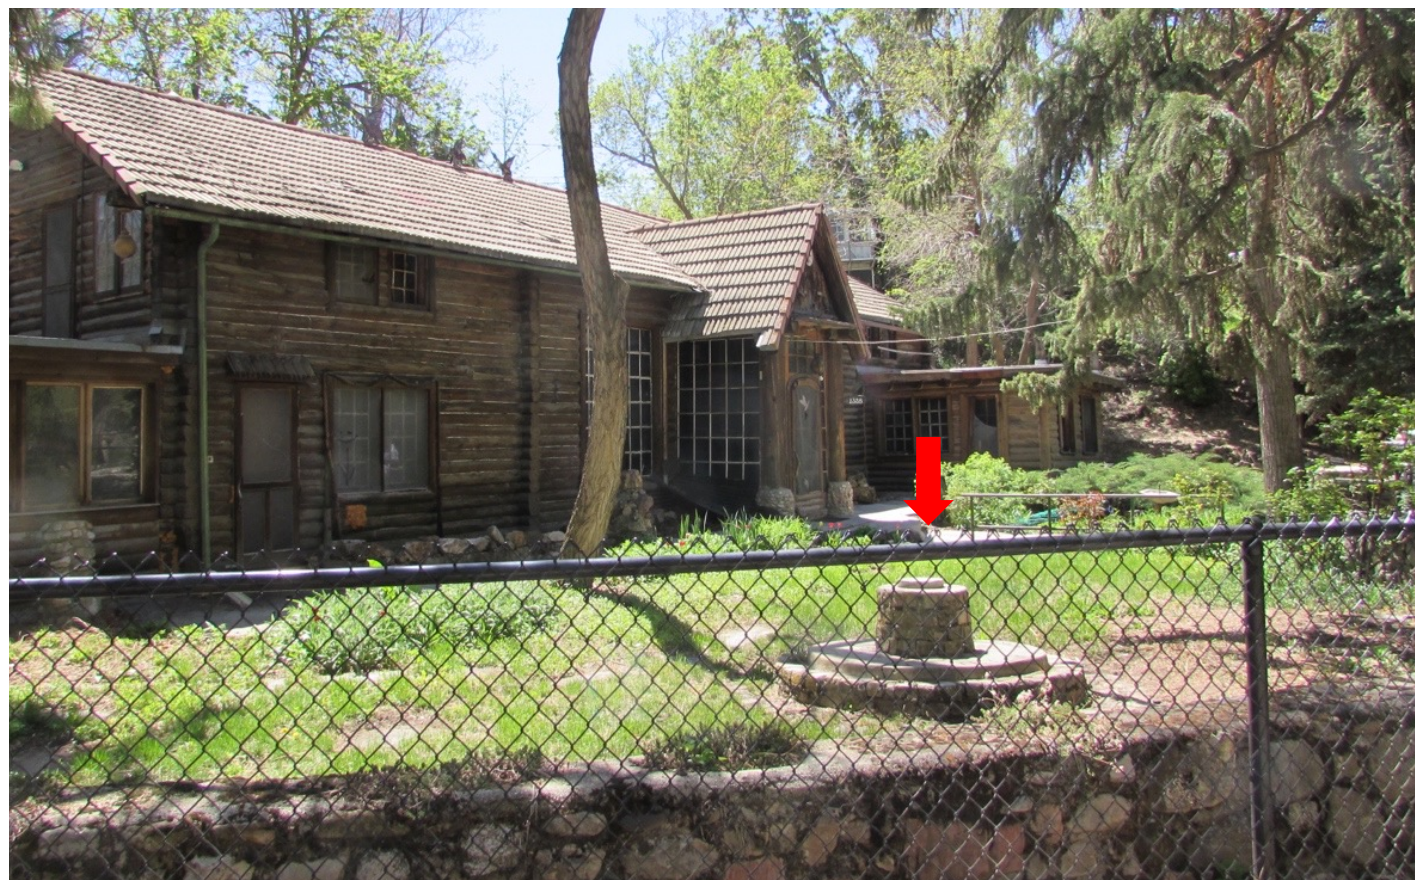
Figure 4-23. 2021 comparative photo of sundial.

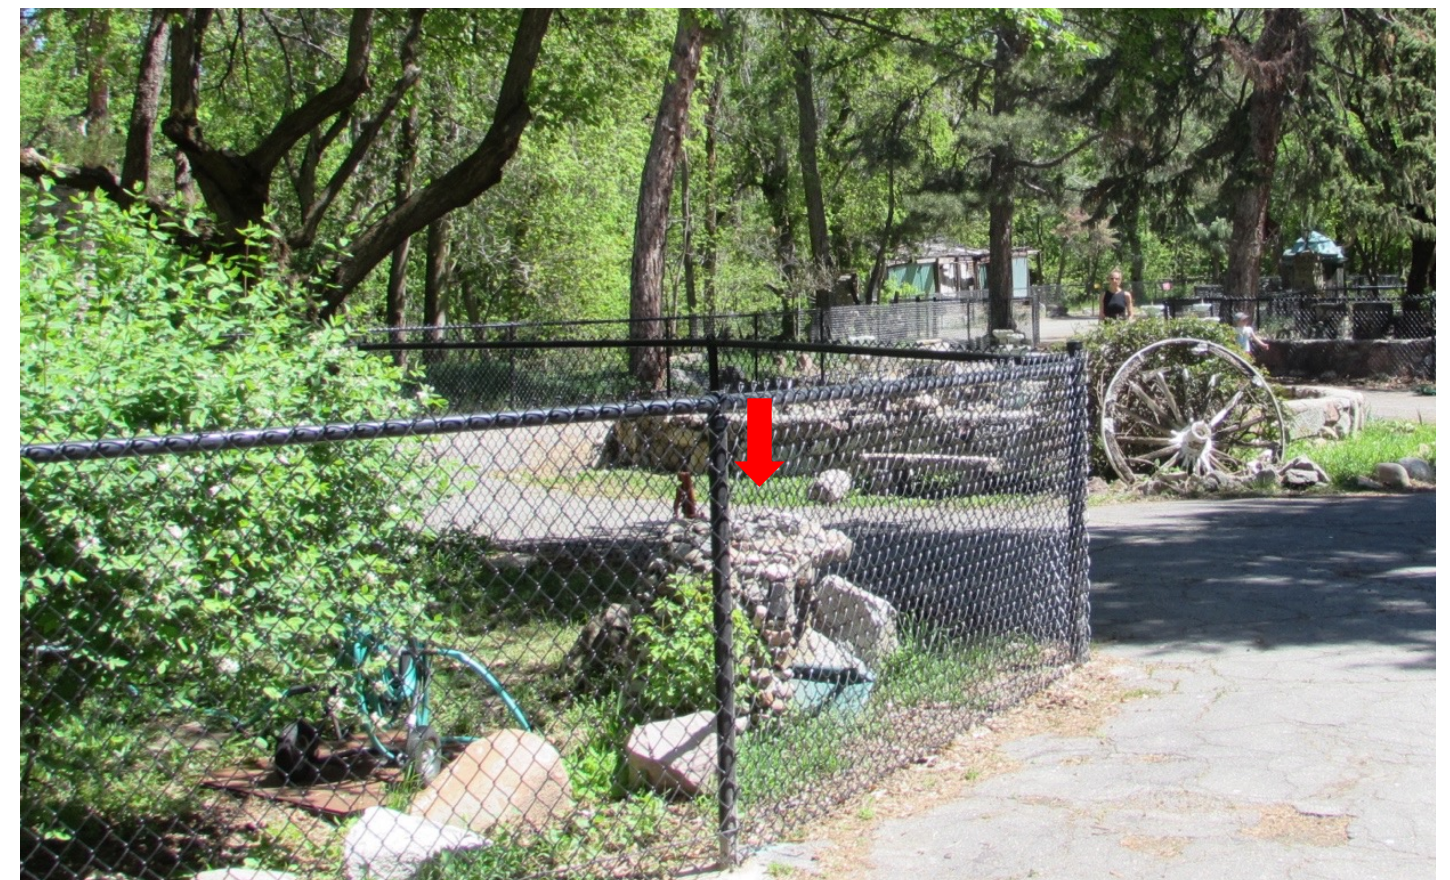
Figure 4-25. 2021 comparative photo of half-dome feature.

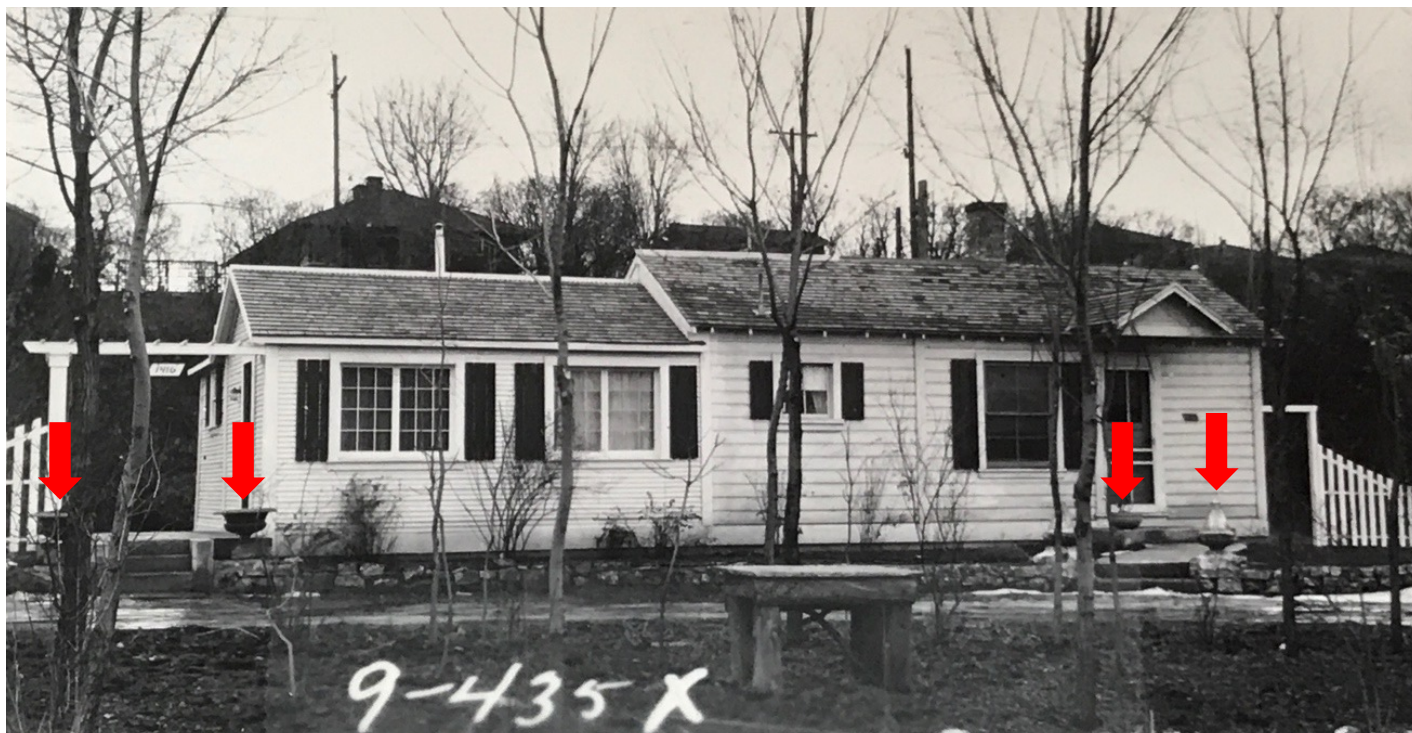
Figure 4-26. Ca. 1944 photo of the 1414-1416 East apartment with its gateway features.

This report defines gateways as vertical features delineating openings in walls or over/across pathways. All the extant gateway features on the property are presumed to date to the period of significance due to their material types, manners of construction, and level of deterioration. Gateways rarely appear in photographs. One of the rare examples of historical documentation of a gateway is shown in Figure 4-18 on page 62 (to the left of the light pillar). Another is shown in a ca. 1944 photograph of the 1414-1416 East cottage. In this image (see Figure 4-26), a pair of formed concrete pillars are visible in the porch area of the western entrance and a pair of large urns near the eastern entrance. It is unclear whether or not the urns were cemented in place however their placement and symmetry indicate their use as a finial to the columns flanking the stairs. A comparative analysis shows that the urns of the eastern gateway are no longer present, and the concrete caps of the pillars at the western gateway were replaced with finials of a different form. It is unclear exactly when the urns were removed and the western toppers were changed.

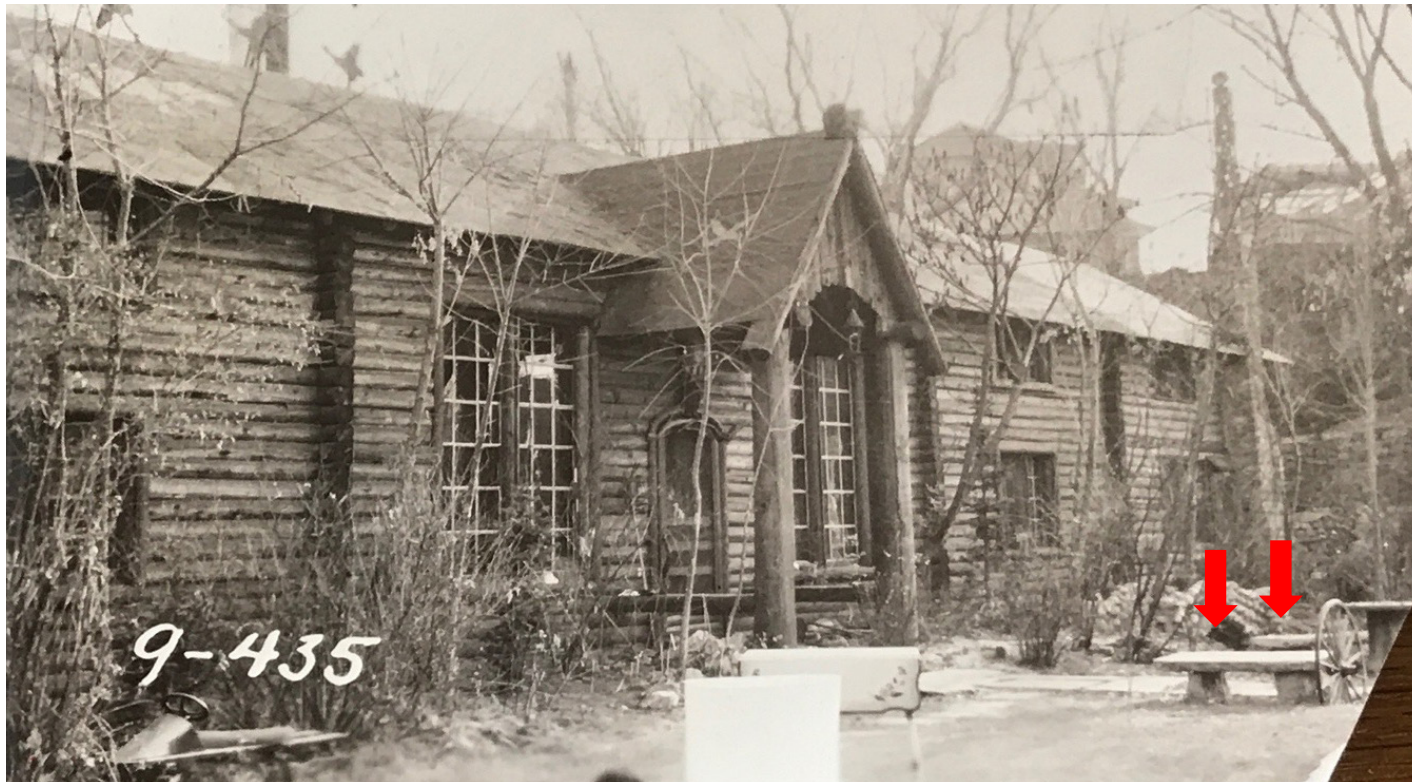
Figure 4-27. Ca. 1937 photo of the Allen House with its associated benches.

The study area contains numerous benches, which are typically located in and around points of interest. In some places they appear in multiples, like the previously discussed 'living room' space, and in other places they are singularly placed. Many of the benches are visible in historical photographs. The benches appear to have been constructed of wood and were, therefore, portable and somewhat temporary in nature. As such, it is not surprising that such features are no longer found at the locations depicted. Among the benches that do appear in historical images are two shown in Figure 4-18 and Figure 4-19 on page 62. The only other benches depicted in historical images were a pair of stone and/or concrete slab benches flanking the entry pathway to the Allen House (see Figure 4-27). These benches are no longer present at this location, and it remains unclear whether they were removed from the property or moved to other locations at the site.

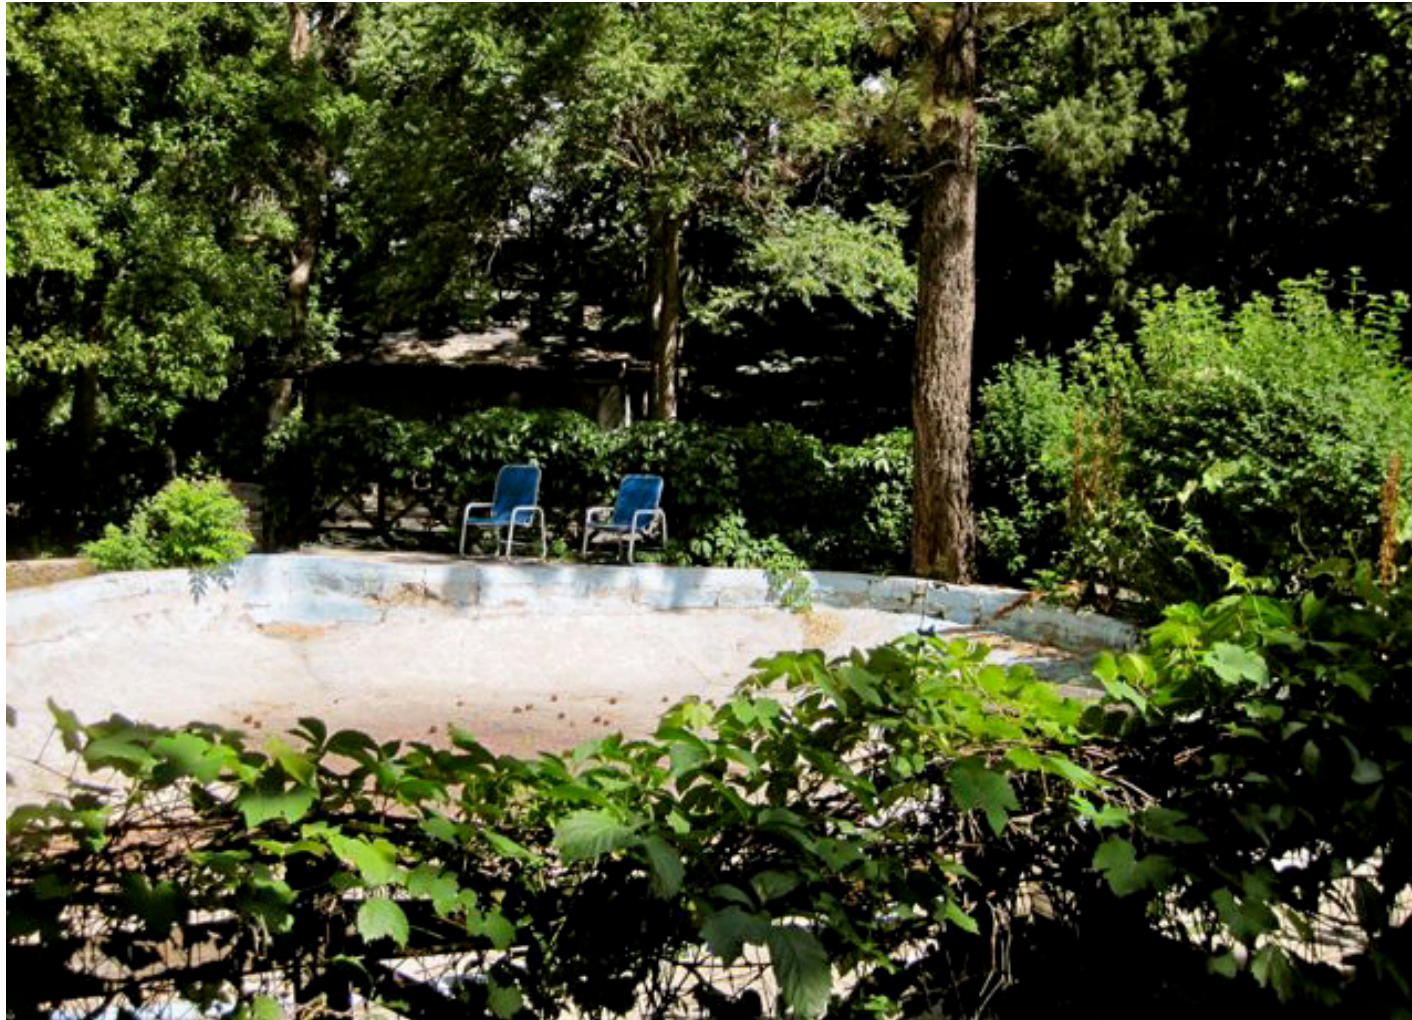
Figure 5-3. July 2012 photo of pool area showing extant fence and vegetation creating a strong sense of vertical enclosure in the pool area.
