# ALLEN PARK CULTURAL LANDSCAPE REPORT

Salt Lake City, Utah  
September 2022

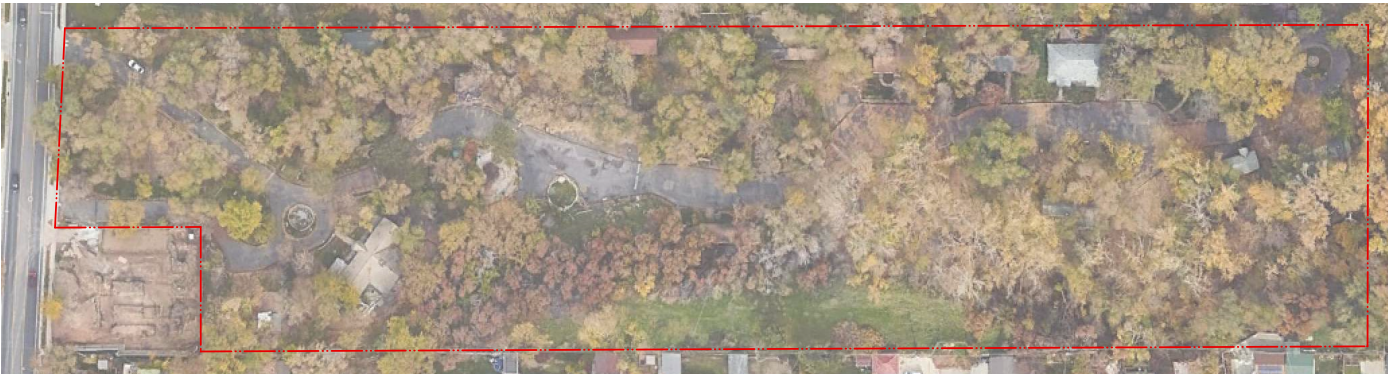
Figure 1-1. Allen Park Study Area

Site Boundary

Allen Park is located on the east side of Salt Lake City, Utah, on 1300 East and Allen Park Drive. The study area for The Allen Park Cultural Landscape Report is limited to the legal property boundary description of the park as owned by Salt Lake City for the purposes of the inventory and existing conditions report.

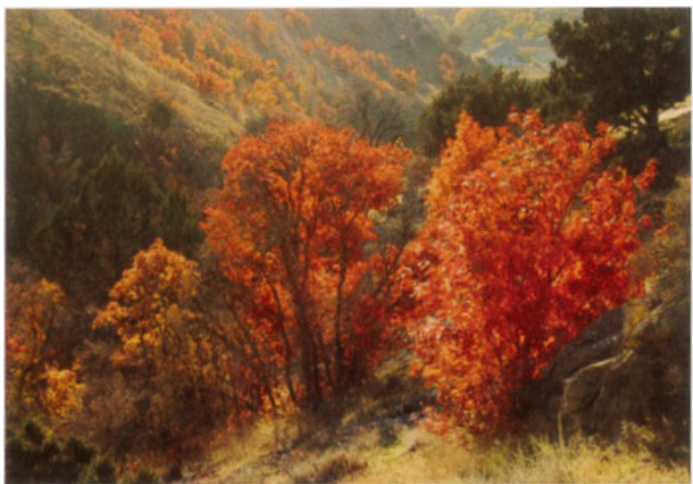
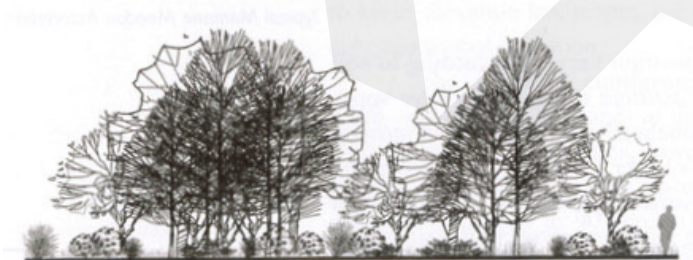
Figure 2-2. Typical Intermountain Mountain Brush Plant Association. Credit: Water Wise, 2003. (H-1-J)

Typical Mountain Brush Association

Plan View - Typical Mountain Brush Plant Association

Section - Typical Mountain Brush Plant Association

Park study area would likely have been the Foothill Plant Association, typically found on sites between 4,000 to 7,000 feet in elevation. This would have included two common plant communities including Mountain Brush and Shrub Steppe, with the former located in micro-climate areas that receive and retain higher amounts of precipitation, similar to the large north-facing slope of the Allen Park study area. The latter would have been found on the flatter and dryer areas of the indigenous landscape.

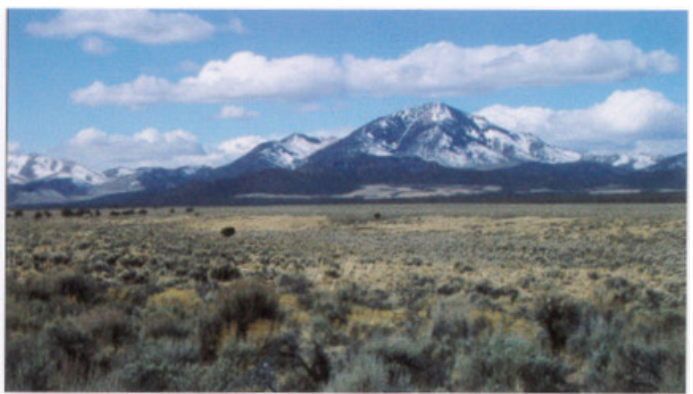
Typical Shrub Steppe Association

Plan View - Typical Shrub Steppe Plant Association

The Shrub Steppe association would have been found along flatter and dryer portions of the study area. Plant species typically found in this association include big sagebrush (*Artemisia tridentata*), rubber rabbitbrush (*Chrysothamnus nauseosus*), as well as grasses and forbs including prairie junegrass (*Koeleria macrantha*), blue-bunch wheatgrass (*Pseudoregneria spicata*), Western wheatgrass (*Pascopyrum smithii*), Idaho fescue (*Festuca idahoensis*), Great Basin wildrye (*Leymus cinereus*), Indian ricegrass (*Achnatherum hymenoides*), mountain brome (*Bromus marginatus*), arrowleaf balsamroot (*Balsamorhiza sagittate*), sulfur buckwheat (*Eriogonum umbellatum*), scarlet globemallow (*Sphaeralcea coccinea*), as well as a variety of Penstemon (*Penstemon* sp.) species.

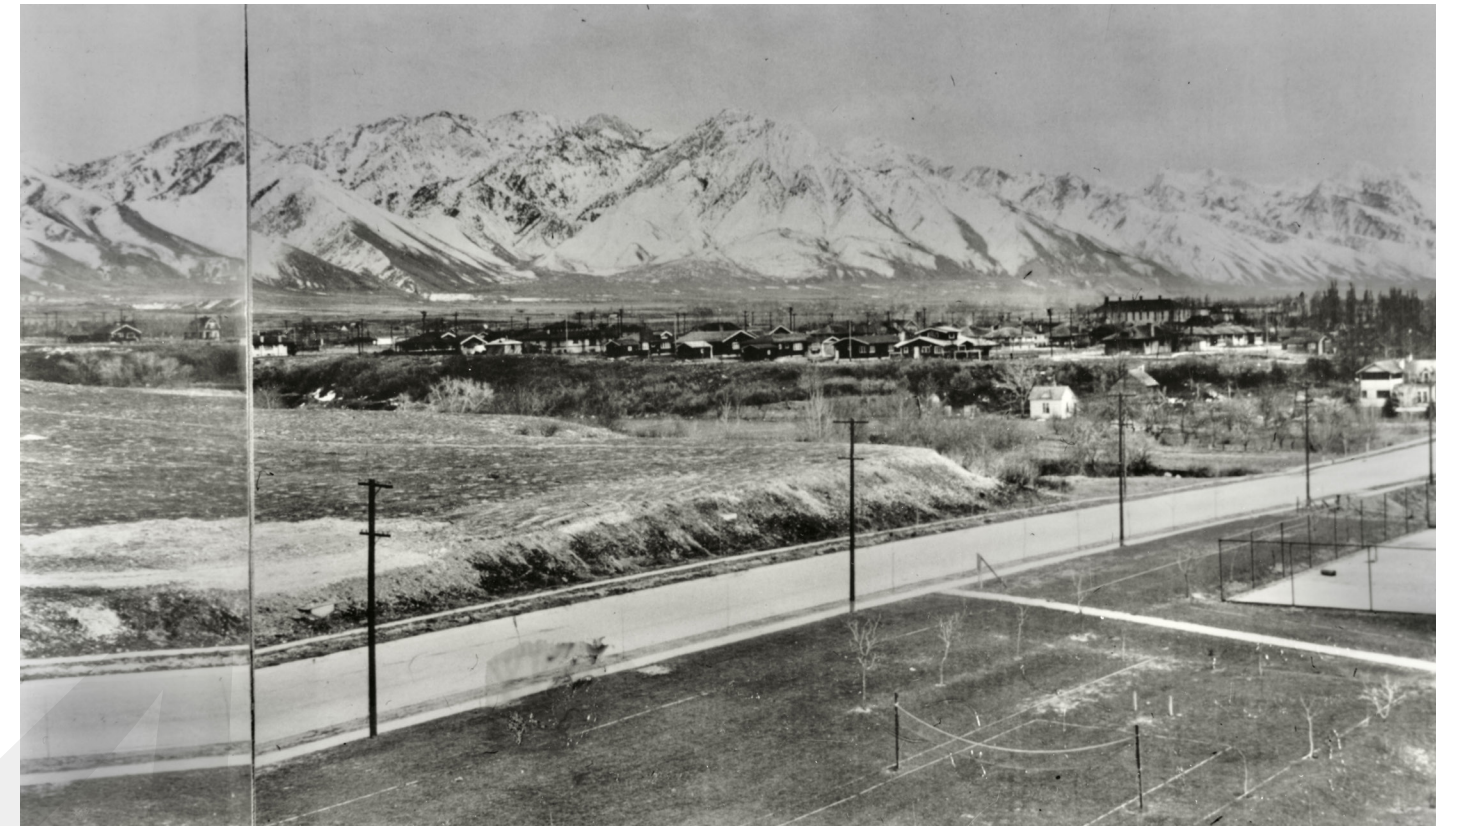
As seen in 1922, the vegetation on the steeper section of the ravine appears to be more consistent with the Shrub-Steppe Association based on height and texture. This may be due to the site being cleared for grazing. The topography visible in this photo is consistent with what is on the site today.

Figure 2-14. View southeast from atop Converse Hall at Westminster College into Allen Park, ca. 1922. The white house right of center is The Nest, to the right of that is the barn, named by the Allens as The Roost, and the path of the Kennedy Ditch parallels 1300 East. (H-2-A)

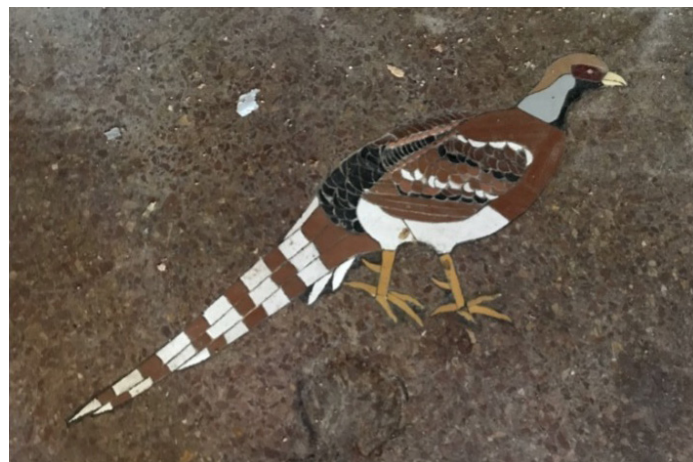
Figure 2-17. (Top) From *The Gazette*, July 1952, displaying artwork by Ruth Allen (R-1-L) and (Bottom), a photograph of inlaid tile artwork in the Allen House fireplace hearth. The similarity indicates a connection between Ruth Larson Allen's artwork in the magazine and physically throughout Allen Park.

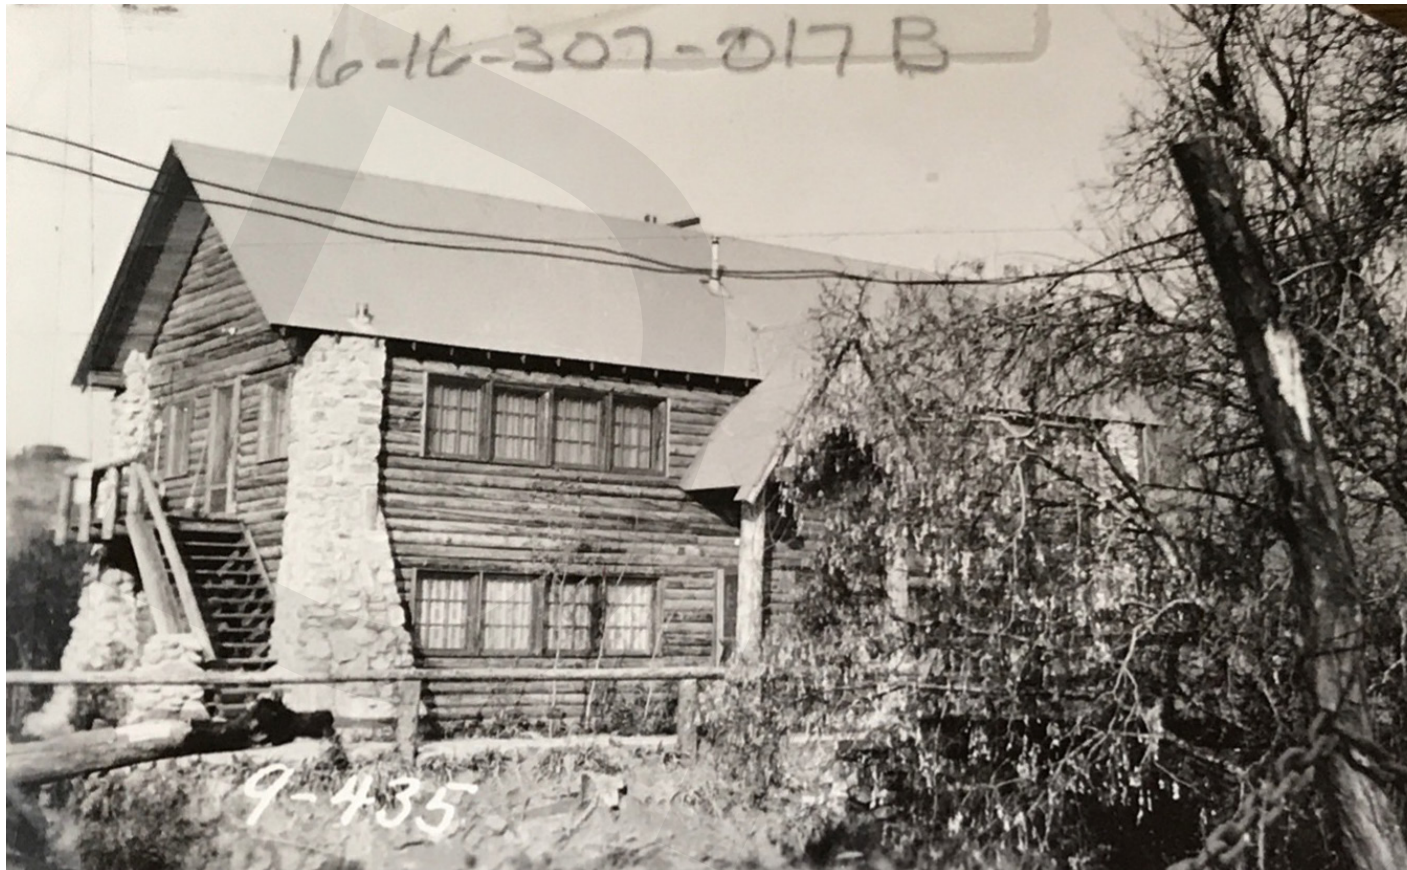
Figure 2-19. Ye Olde George Albert apartments, c. 1939. (H-3-H)

Ye Olde George Albert was named for Dr. and Ruth Allen's son George, Jr. It is a two-story log building with log siding and a symmetrical façade. The roof is side gabled while a steeply-pitched protruding porch shelters two separate doors for the ground floor living units. Decorative fieldstone pillars wrap around each building's corner from the ground to the height of the roof. Assessment of the current materials of the side porches indicates that they were replaced in the past but the exact date is unknown.

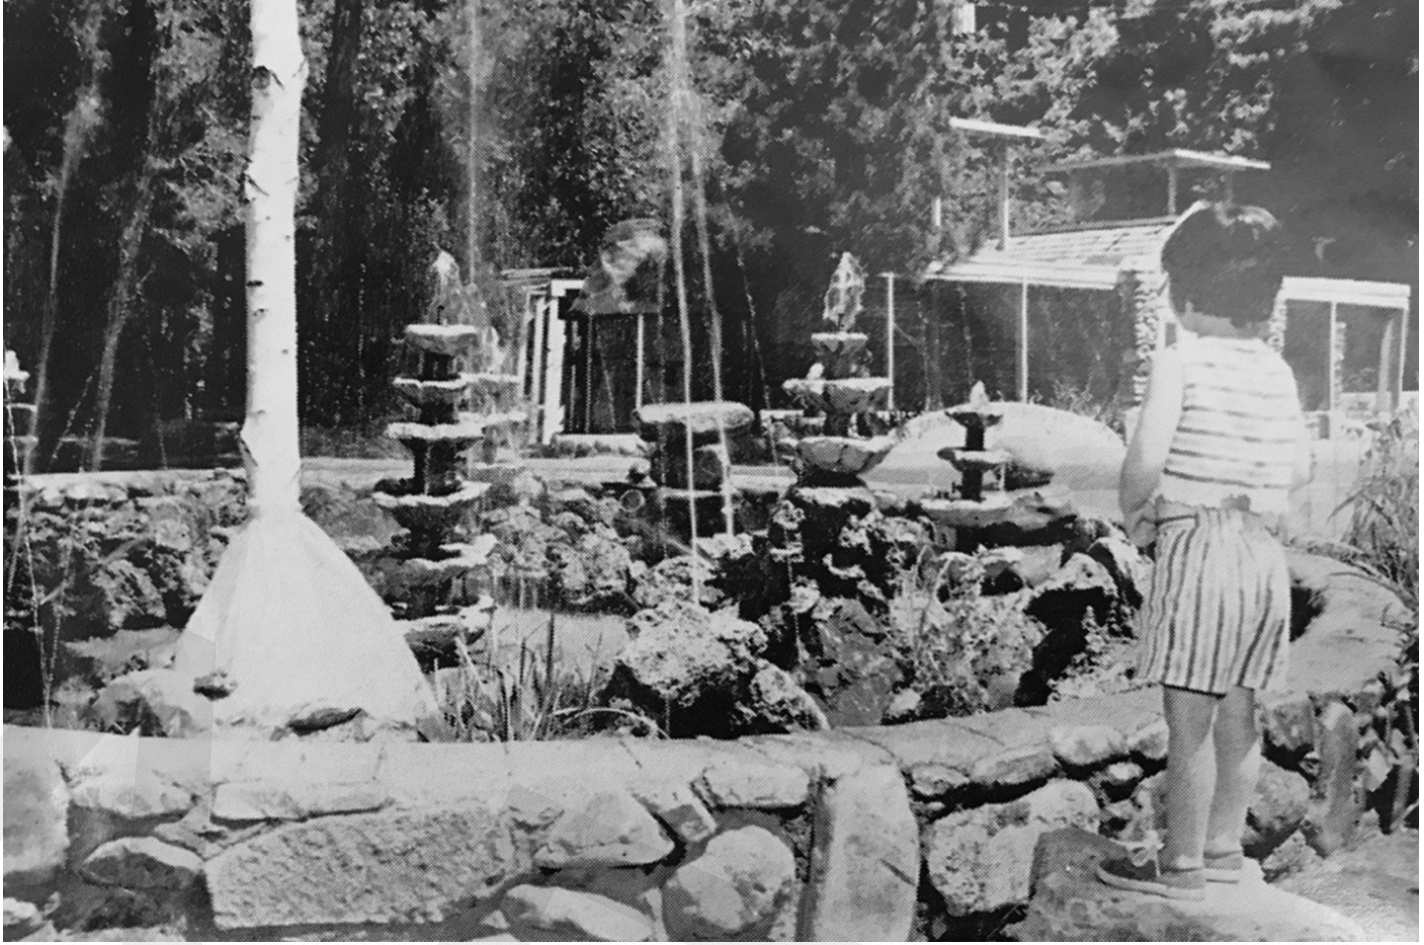
Figure 2-27. One of the constructed water features, "The elaborate fountain and many bird pens that compose... interesting Allen Park" in 1961. (H-4-V)

Dr. Allen retired from his medical practice in 1958. The large fountain had not been constructed by 1949 and was likely not constructed until after 1958.<sup>81</sup> This date coincides with Dr. Allen's year of retirement as well, the occasion of which may have given him more time to work on special projects like the fountain and the wall in front of the Allen House, which also did not appear until after 1958. Dr. George A. Allen died of natural causes on January 25, 1961, at the age of 66.<sup>82</sup>

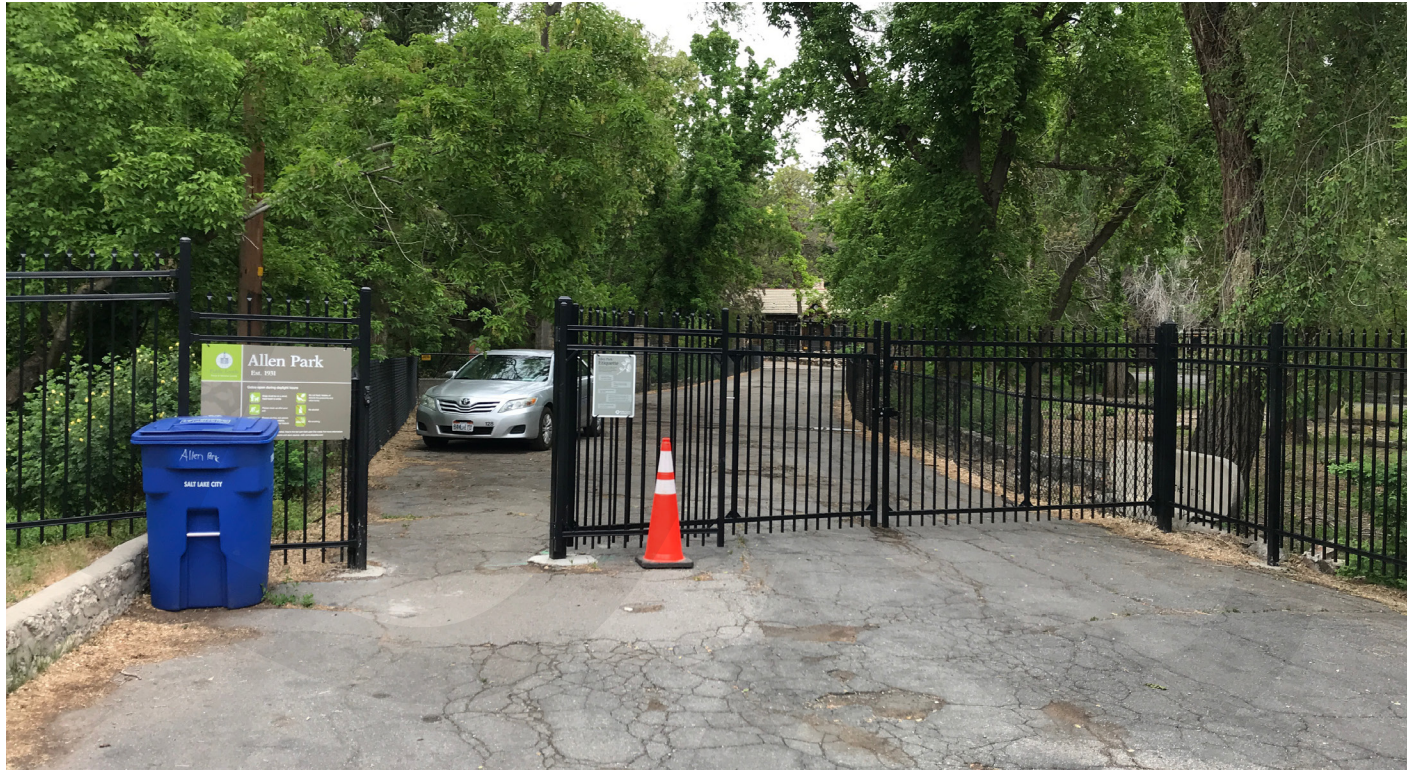
Figure 2-33. West entry of Allen Park showing black aluminum fence, May 2021. (H-5-E)

- Deconstruction of The Nest, a c. 1926 house at 1316 E. Allen Park Dr. (due to its encroachment on an adjacent property line);
- Black aluminum security fencing, 6-8 feet in height, on the exterior of the park at

the west property line with pedestrian and vehicular access gates. Sections are composed of single pickets of standard width between and single top and bottom rails that are evenly spaced above the bottom and below the top;

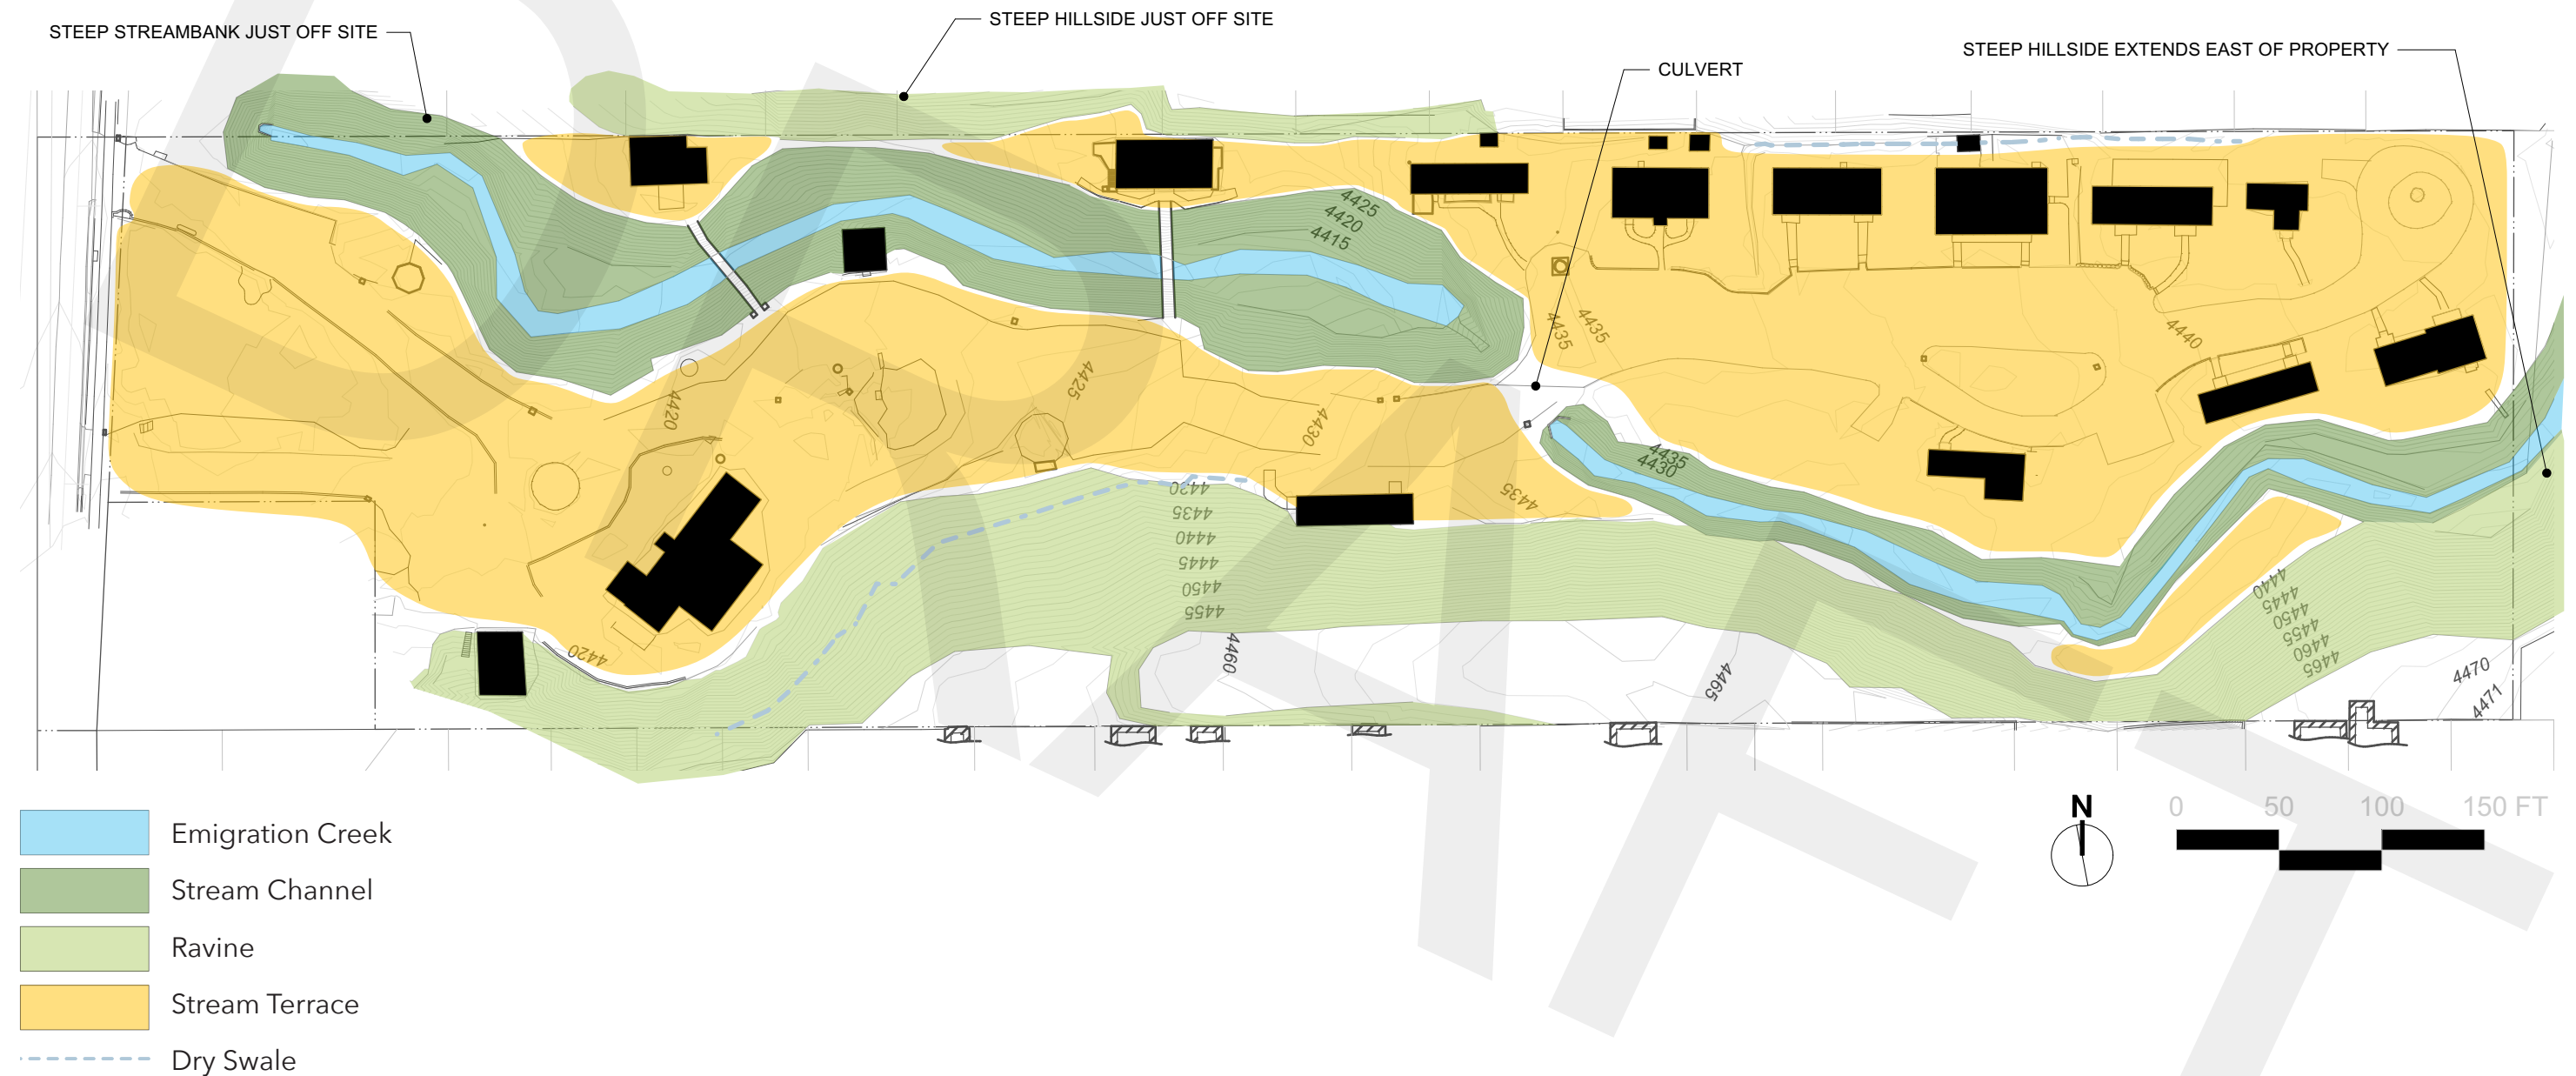
Figure 3-2. Natural Systems, Features & Topography Map

The foundation of the Allen Park Study Area cultural landscape are natural systems and features. These are illustrated in Figure 3-2, Natural Systems, Features, and Topography.

Water at Allen Park is an important character defining landscape element beginning with the presence of Emigration Creek which flows out of the mouth of the nearby Emigration Canyon and passes through this site. Over time this creek has created the landform of Allen Park, as well as the stream terrace which defines the majority of the 'flat' developed portion of the site today and the current stream channel.

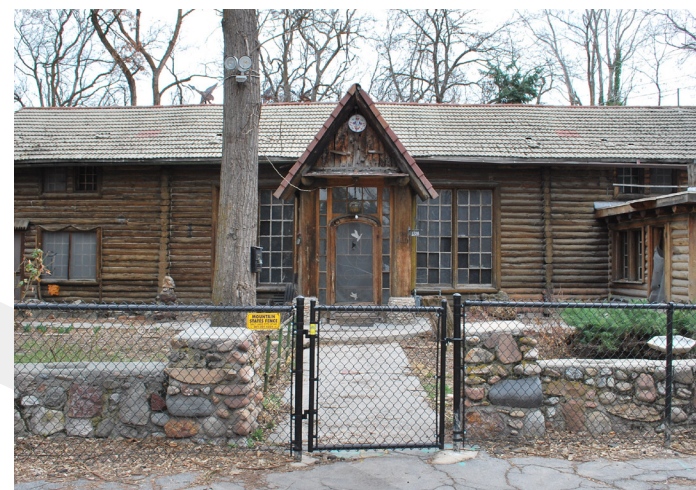
Figure 3-7. View looking at the front yard of the Allen House from the fountain space.

*The Allen House Front Yard* - Located between the fountain and the Allen House, a low stone wall defines the perimeter of the domestic front yard of the Allen House. The tree canopy inside the wall creates an overhead plane extending over a portion of the front yard and the fountain.

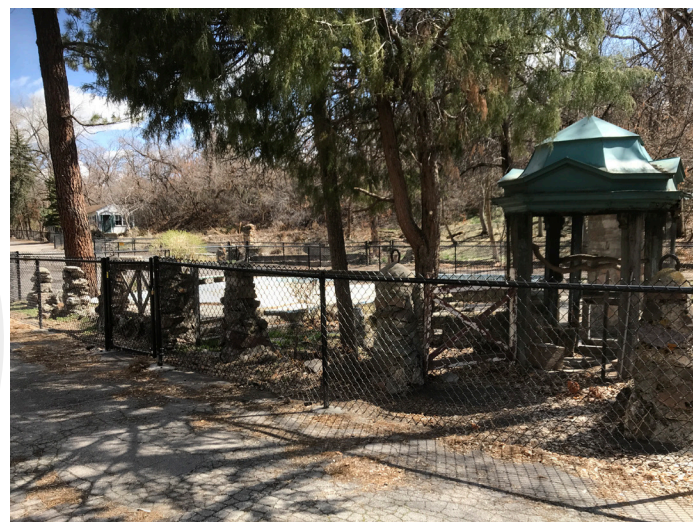
Figure 3-9. View looking south-east across the pool area with the rest of Central Allen Park visible in the background.

*The Pool* - Just east of the Allen House the driveway splits creating an island of green which contains a paved patio space, and an organic shaped pool. The transition of ground plane material from the driveway pavement to the grassy area and concrete adjacent to the pool defines the space which is then reinforced by remnants of a fence, columns, and larger trees and shrubs defining the vertical planes

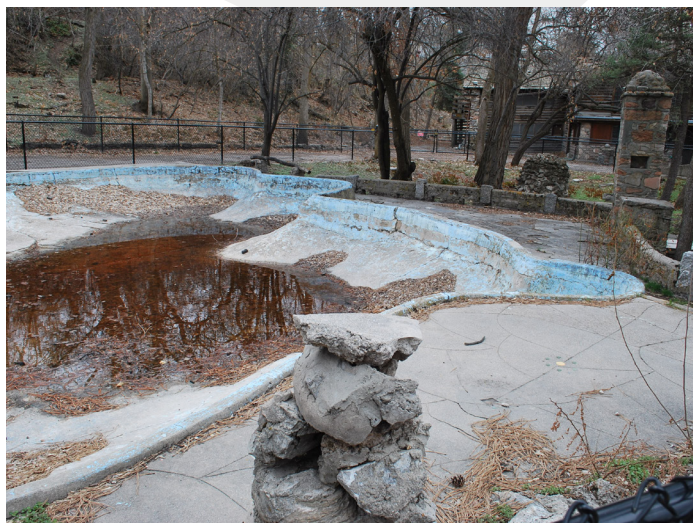
Figure 3-10. View looking southwest across the pool area.

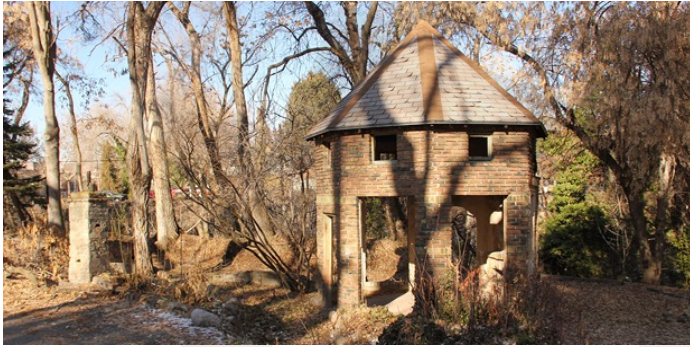
Figure 3-15. Gazebo

16. Gazebo - This structure is the remnant turret of the former Peacock building. It is a 1.5-story octagonal shaped brick structure with an octagonal turret roof (Figure 3-15).

**The Peacock** - Along the north side of the north driveway between the driveway and the creek, a small, recessed space centers around the remnant turret of the former Peacock building referred to in this document as the gazebo.

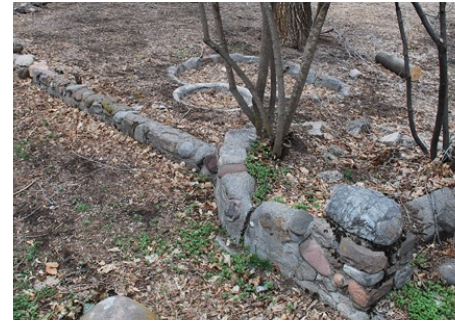
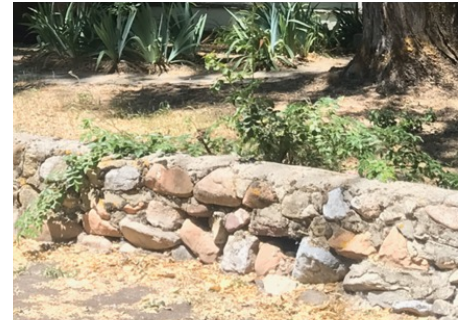
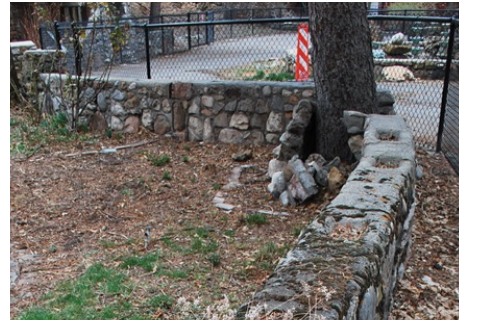
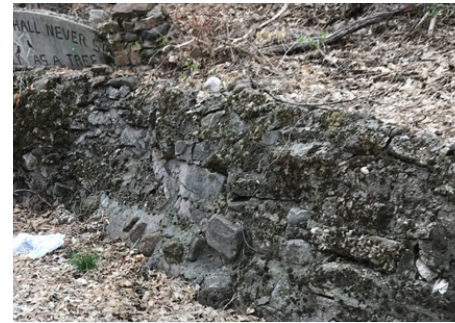
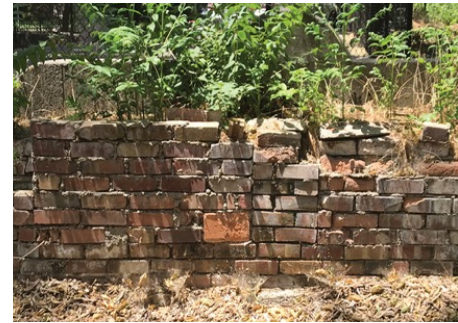
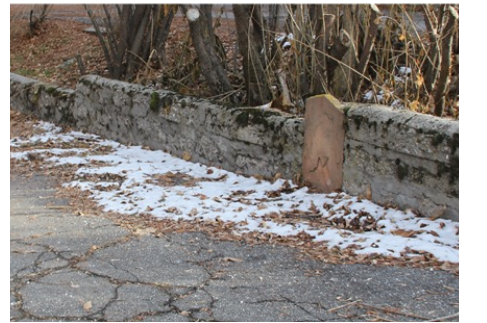
Figure 3-16. Wall Photos

There are a large number of walls located throughout the Study Area used to articulate landscape spaces and as retaining walls to mitigate grade changes (see Figure 3-16). For the purposes of this inventory work, we are classifying any linear masonry element over eighteen inches or three courses in height as a wall. Shorter linear features are classified as edging. The walls present on the site include freestanding and retaining walls as follows:

- Walls, mortared stone: Walls composed of various types of stone including mainly river rock, but in some areas also cut stone including granite and sandstone, mortared together.
- Walls, mortared rubble: Walls composed of various materials including stone, brick, and/or recycled concrete mortared together.
- Walls, concrete: Walls cast in concrete including freestanding, retaining, and driveway barriers, occasionally combined with other elements such as brick or stone.
- Walls, dry stack stone: Walls including retaining and freestanding walls composed of various types of stone that are dry stacked (not mortared in place).
- Walls, timber: Retaining walls composed of heavy timber.

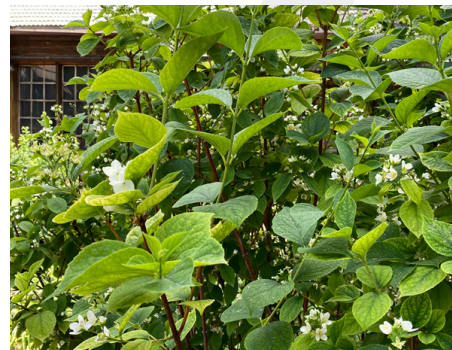
Figure 3-20. Large Shrubs Photos

Sweet Mock Orange  
*Philadelphus coronarius*

the site, along with snowberry (*Symphoricarpos albus*). Examples of this vegetation are visible in Figure 3-20.

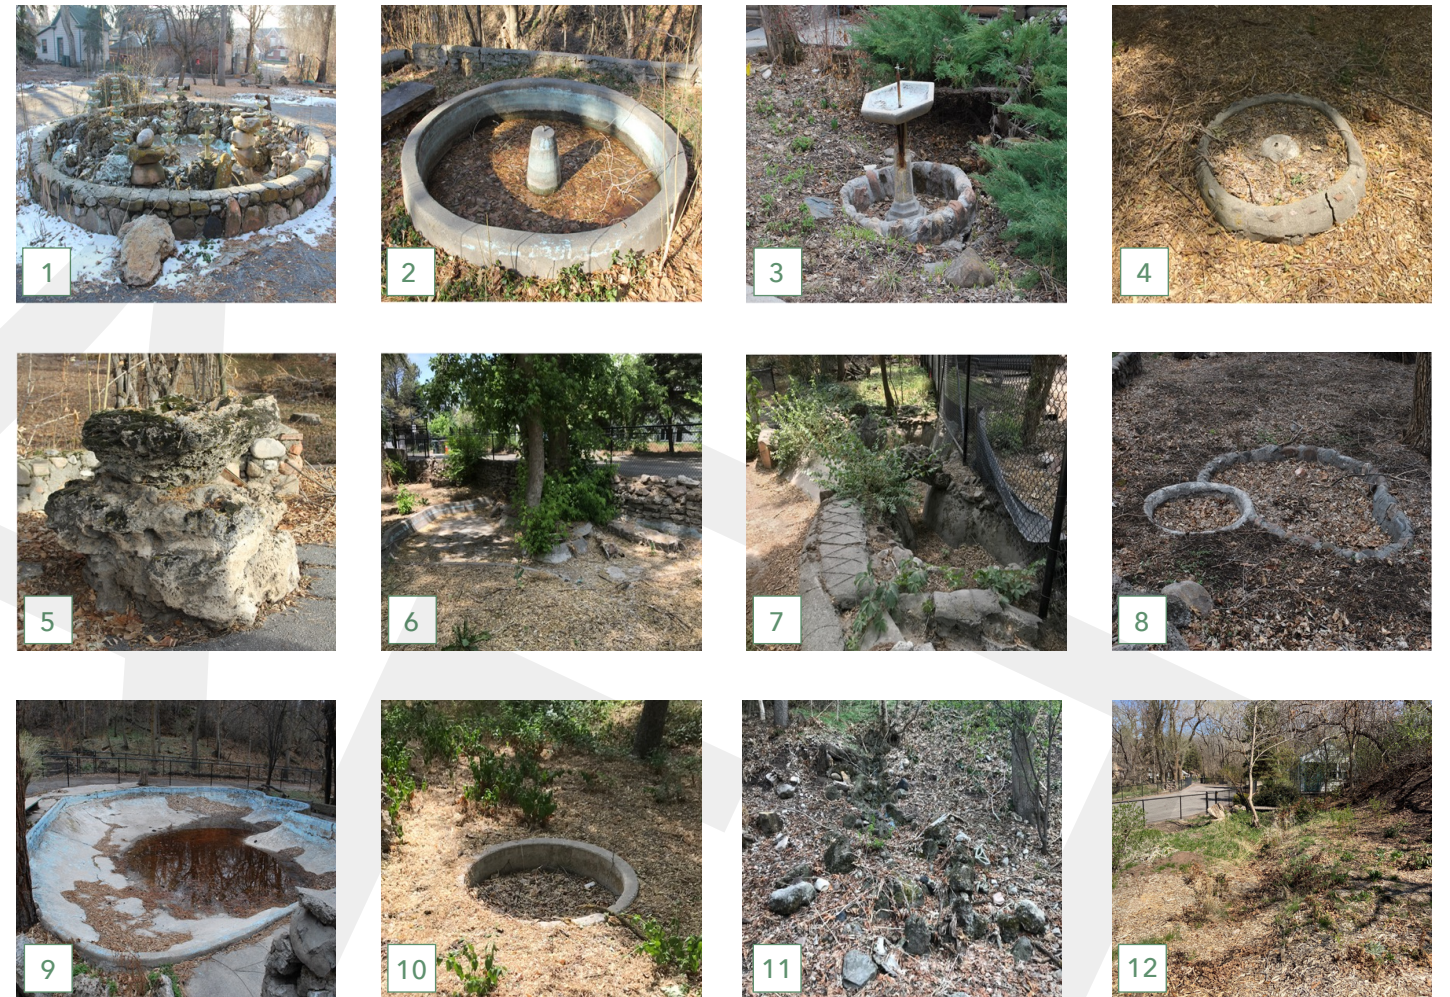
Figure 3-26. Fountains, Pools & Waterfalls

2. Small Fountain - North of the Allen House is the small fountain. It is a round cast concrete structure that is approximately 8' in diameter, with a conical spout fixture at its center. It is painted blue on both the exterior and interior, though the paint has faded with time and wear.

3. Bird Bath - The bird bath is set in the Allen House front yard, along the path leading up to the front entrance. It shows signs of structural leaning as well as rusting around the plumbing fixture. The top pool and pedestal are made from cast concrete, and they stand about 3.5' tall within a 3' diameter mortared stone pool set in-ground.

pools lined with mortared rocks. It is about 9' tall and around 4' across. There are no plumbing fixtures currently, but remnants of blue paint on the concrete pools indicate the waterfall may have primarily been a decorative element that collected rainwater, similar to a bird bath.

12. Kennedy Ditch - A remnant of the Kennedy Ditch which historically passed through the Allen Park site.

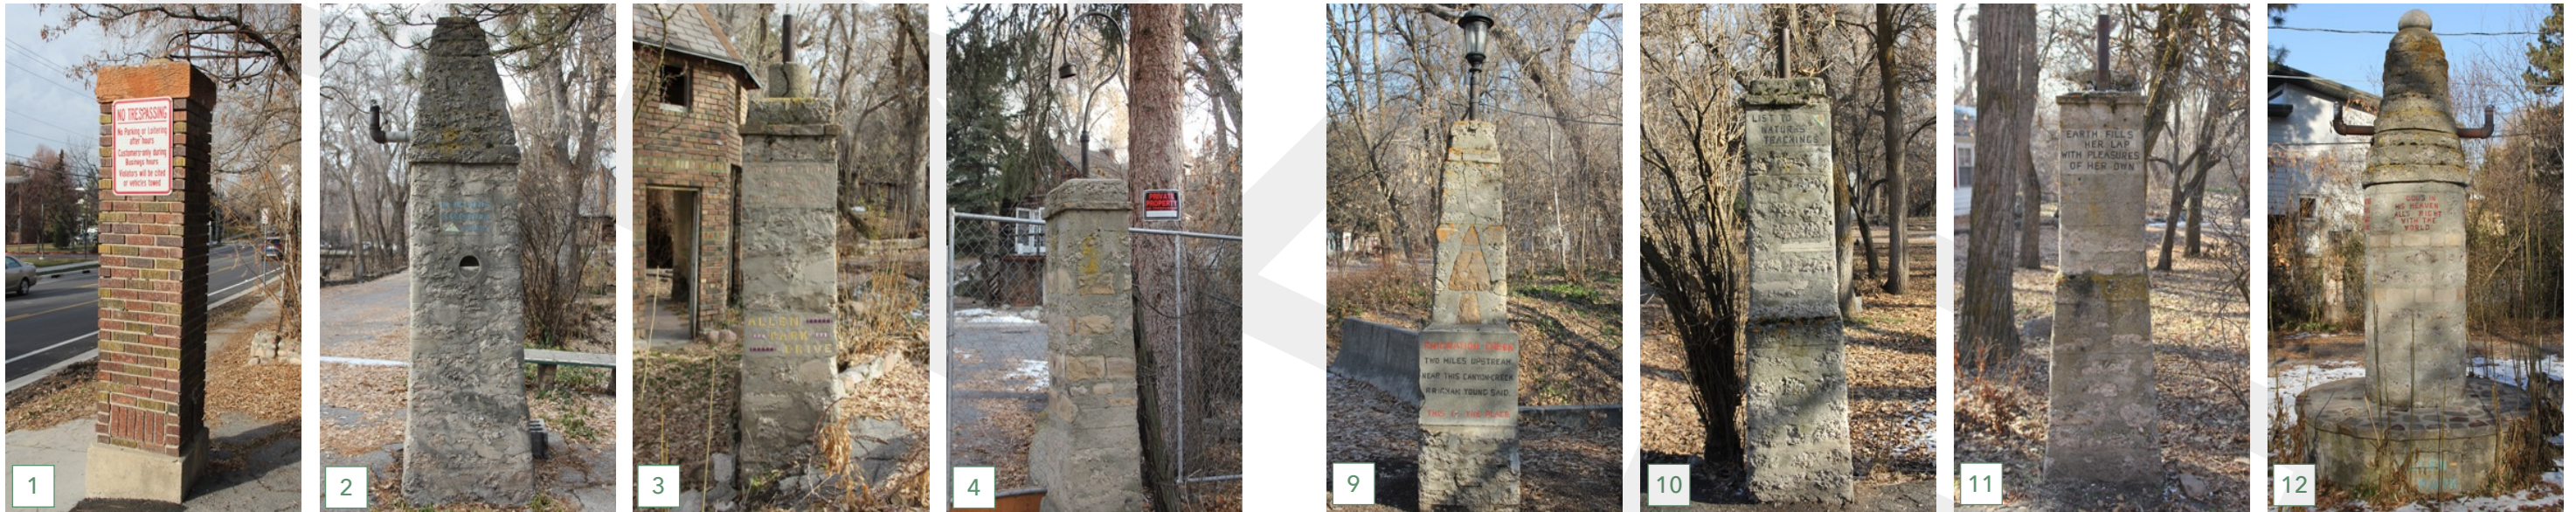
Figure 3-28. Light Pillars

These singular vertical masonry elements are repeated throughout the study area and are located mainly along the central driveway. They are generally articulated as a vertical square column, include tile mosaic ornamentation, and have an integrated light fixture or metal conduit embedded into them that formerly included light fixtures. Figure 3-28 includes photos of the light pillar artwork at Allen Park with numbering to correlate with the map on page 39.

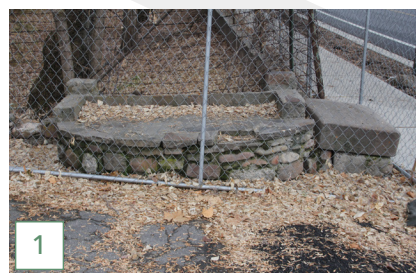
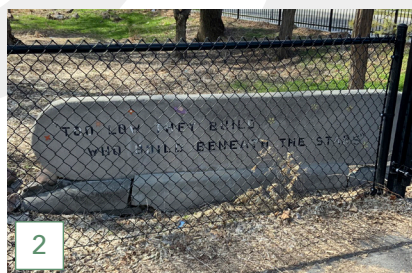
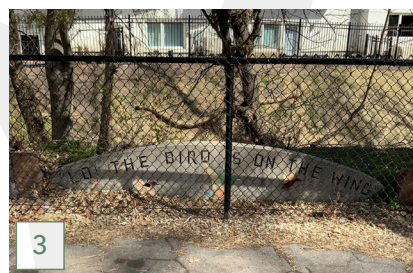
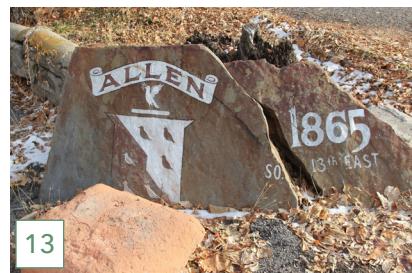
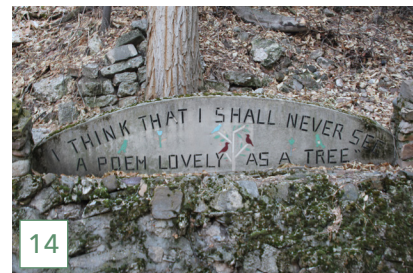
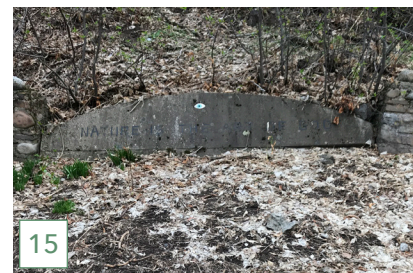
Figure 3-30. Monument Photos

These unique artworks consist of vertically positioned cast concrete panels with various tile mosaic patterns depicting images and phrases generally relating to nature, poetry, and philosophy. Figure 2-28 is a photo index of the artwork monuments at Allen Park. The following general shapes of the cast panels are repeated throughout the site, although each one is unique in terms of imagery and words:

- Monument, base (missing at entry)
- Monument, arched
- Monument, rectangular
- Monument, V-shaped
- Monument, rounded rectangle
- Monument, round
- Monument, square arch
- Monument, signage

- Preserve and restore monuments.
- A few of the monuments have become partially buried at their bases (see Figure 3-30 for examples). Clear soil and debris from the bases of monuments, as well as adjust localized grading to provide positive drainage away from these features.

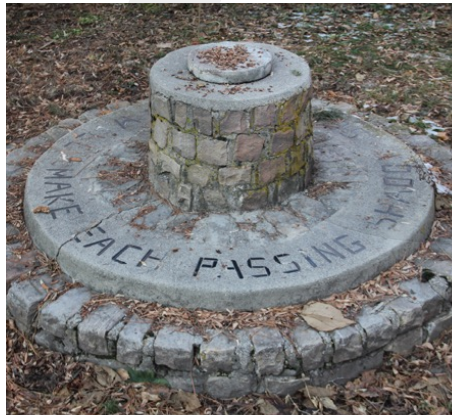
Sundial

- Other artworks, sundial: Located in the front yard of the Allen House, this composite circular element features a wide masonry base topped with a concrete ring embedded with a tile mosaic. On top of this rests a short-mortared stone column. The mosaic reads "...make each passing shadow" implying that the purpose of this piece may have been solar related such as a sundial.

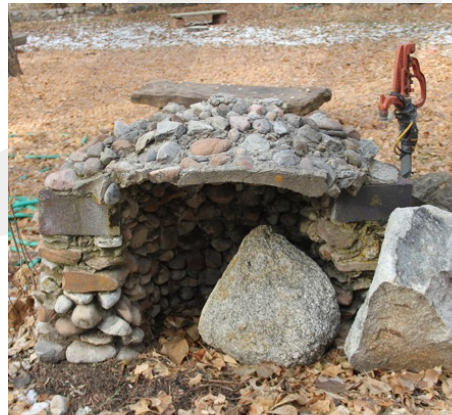
Small river rock sculptures

- Other artworks, small river rock sculptures: Two small river-rock dome-like features exist on the site, a half-dome located at the far southeast end of the 'living room' space, and another located in the swimming pool garden space. These are composed of smaller sized mortared river rocks.
- Other artworks, animal statue: This feature appears to be a horse cast out of concrete. Its head is missing.

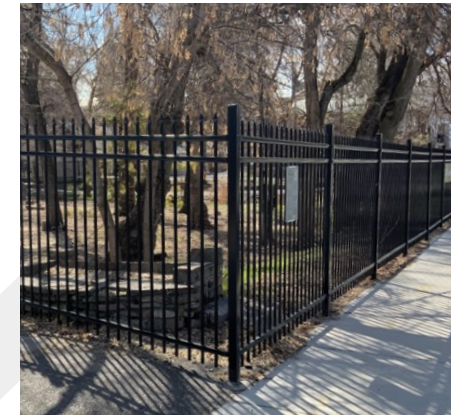
6' decorative metal

- Fence, 6' decorative metal: This 6' high decorative black metal fence is located along the east perimeter of the property and includes gates at each driveway access.
- Fence, 4' black vinyl-coated chain link: This 4' black vinyl-coated chain link fence generally follows the perimeter of the central access drive, and contains a series of locked gates, to limit access to the site.
- Fence, 3' wire mesh.

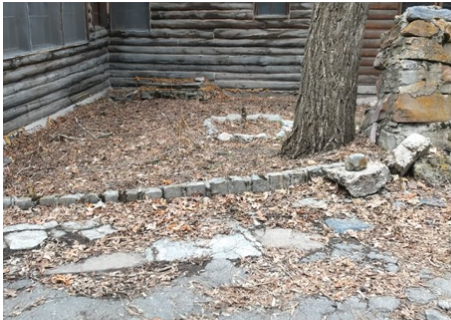
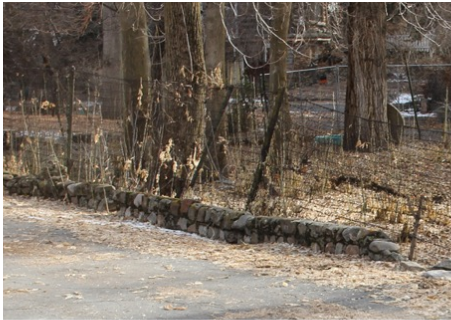
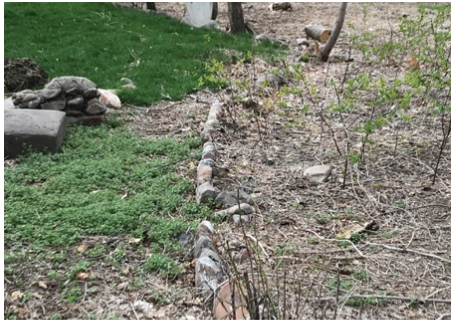
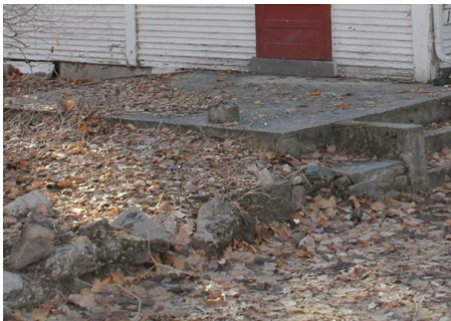
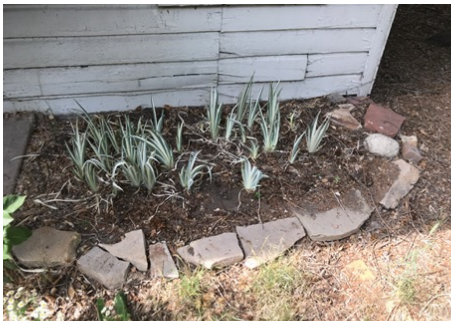
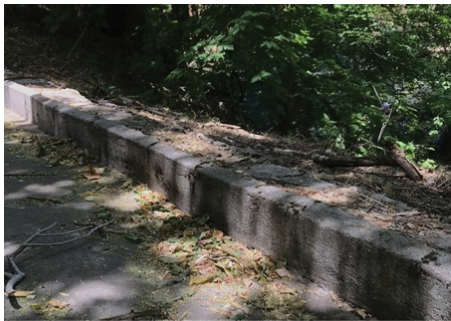
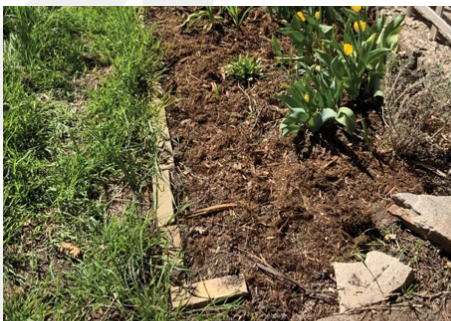
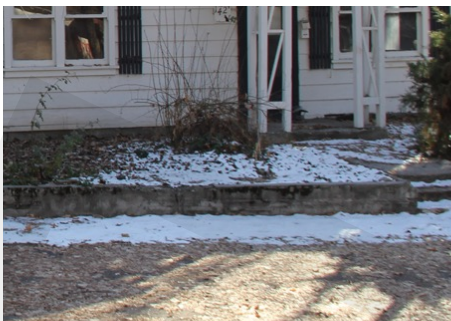
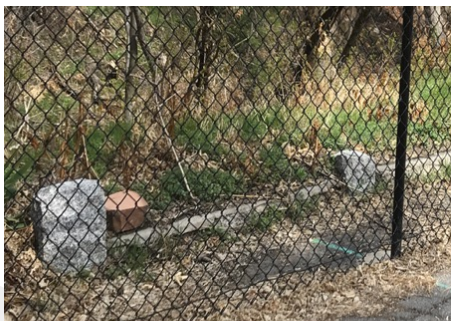
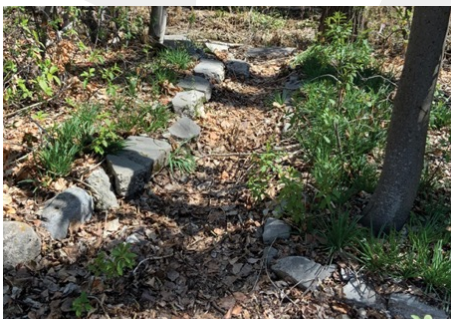
Figure 3-34. Edging Photos

The study area also contains a large number and variety of edging materials. Edging usually appears in more manicured spaces such as along the fronts of houses to define foundation planting beds, along driveway or pathway edges as a curb, and in some instances to define a trail. The following types of edging can be found throughout the study area:

- Edging, mortared stone: Composed of various types of stone including mainly river rock, but in some areas also cut stone including granite and sandstone, mortared together.
- Edging, loose stone: Composed of various types of stone fit loosely together along the ground-surface to define an edge.
- Edging, mortared brick: Composed of brick mortared together to define a planter area or edge.
- Edging, loose brick: Edging composed of brick dry fit together along the ground plane or partially embedded in the ground-surface to define an edge.
- Edging, concrete: Cast concrete along the ground-plane used to define an edge.
- Edging, composite: Some combination of the various edging types in one area.

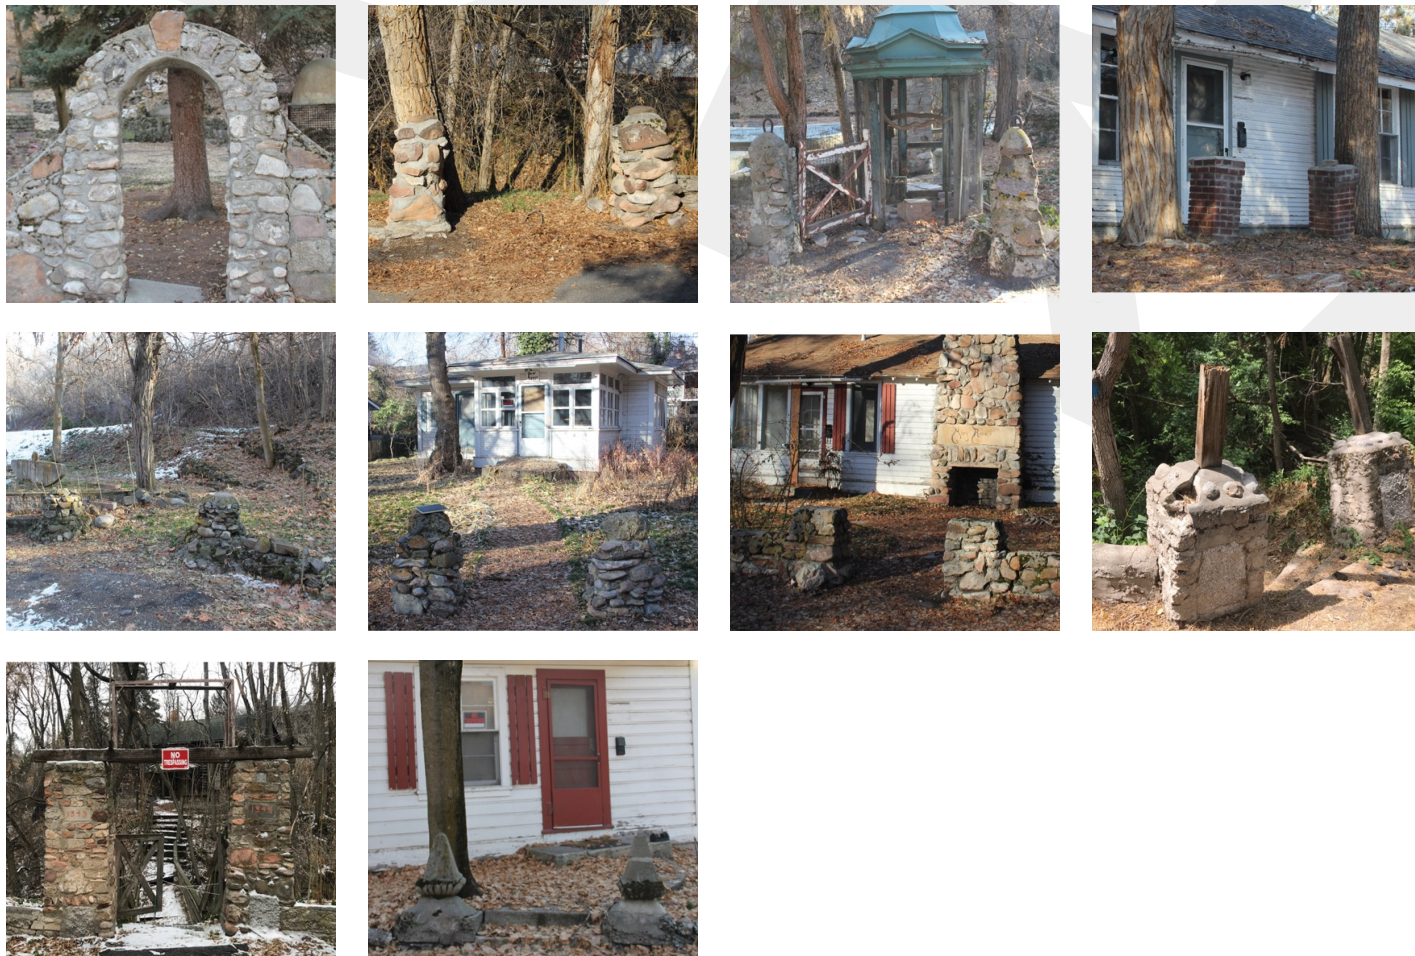
Figure 3-35. Gateway Photos

For the purposes of this report, gateways are vertical features delineating openings in walls or over/across pathways demarcating passageway. They typically indicate an entrance to or a transition between two distinct spaces or sub-spaces. We noted the following repeated types of gateway features in the study area.

- Gateway, pillars with posts and beam: Stone pillars at the base of vertical posts, supporting a horizontal member over an opening.
- Gateway, tall stone pillars with wooden lintel: Tall, masonry, mortared stone pillars flanking an opening with a wooden lintel spanning the opening.
- Gateway, cast concrete pillars: Decorative cast concrete elements, usually combined with some masonry component, flanking the sides of an opening.
