# ALLEN PARK CULTURAL LANDSCAPE REPORT

Salt Lake City, Utah  
September 2022

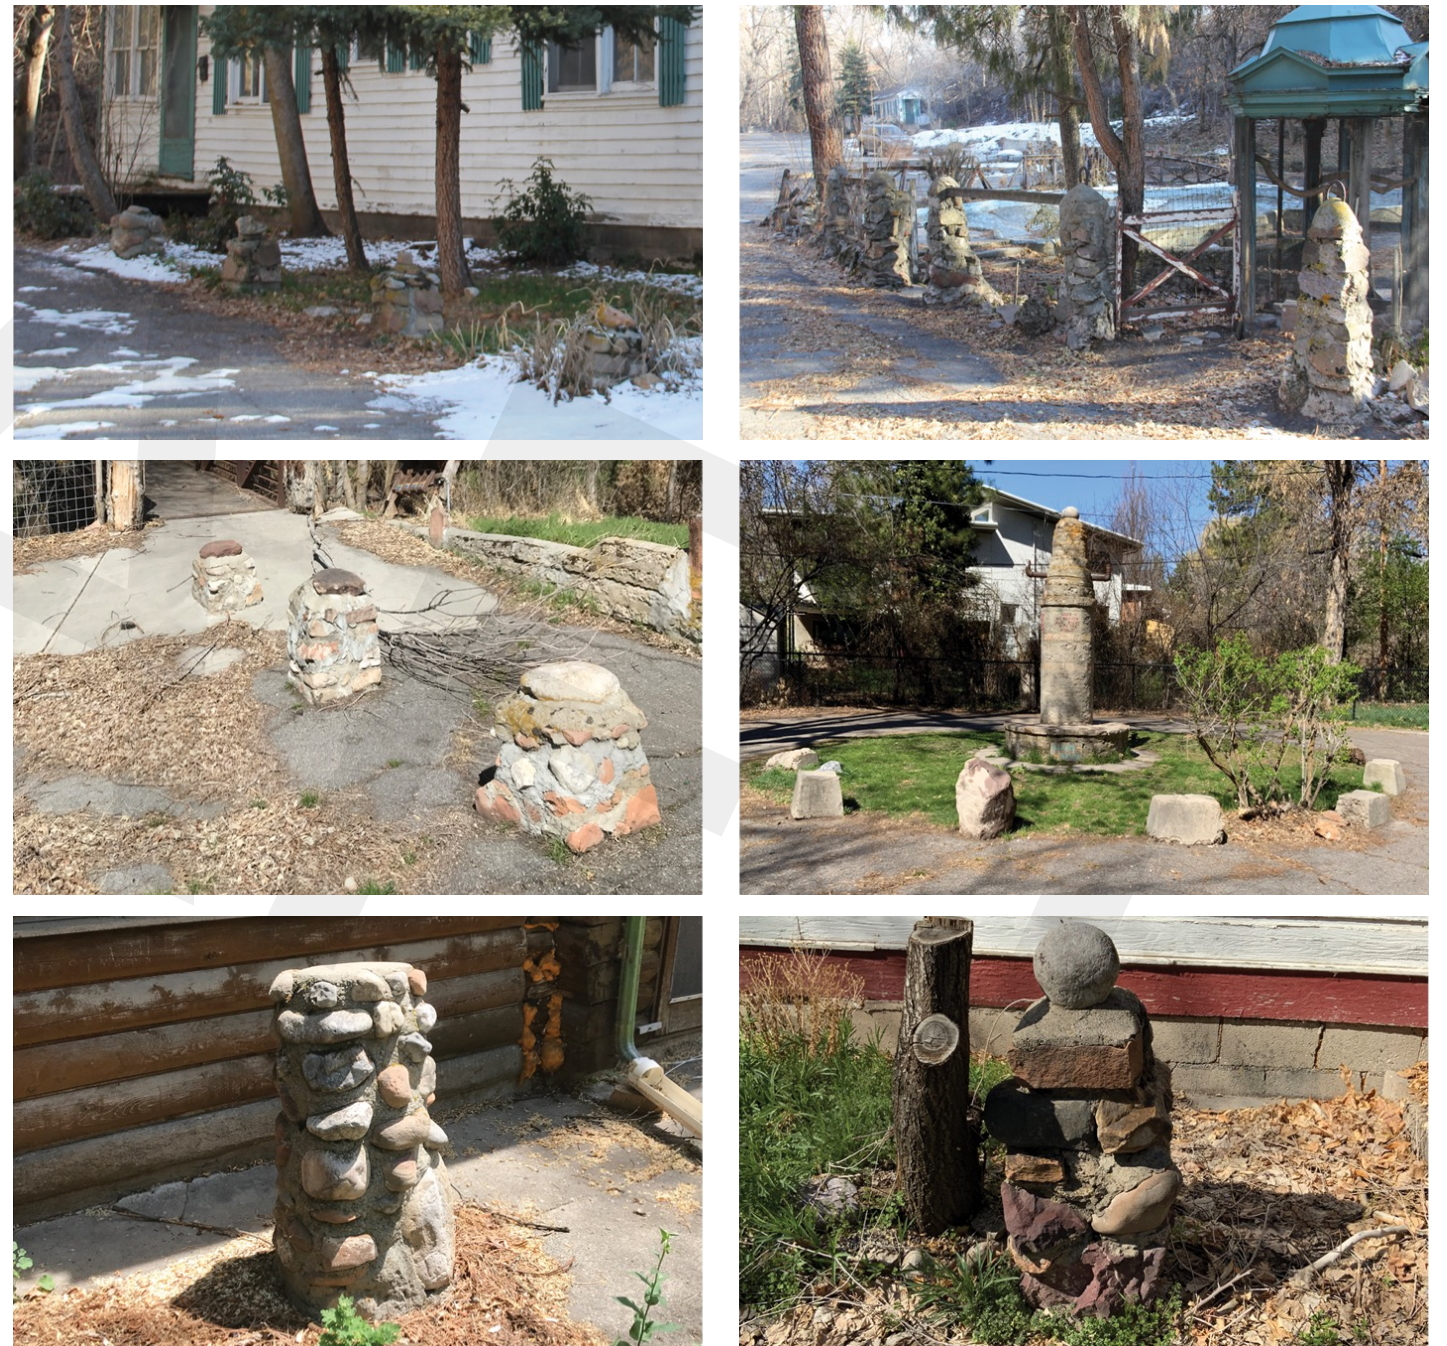
Figure 3-36. Bollard & Pillar Photos

- Bollards, boulders or blocks: Large natural or cut stones placed singularly or in rows to delineate and buffer an edge.
- Masonry pillars: These are similar to the mortared stone pillars appearing at gateways and used as bollards but appear singularly and are not associated with either a driveway or an opening.

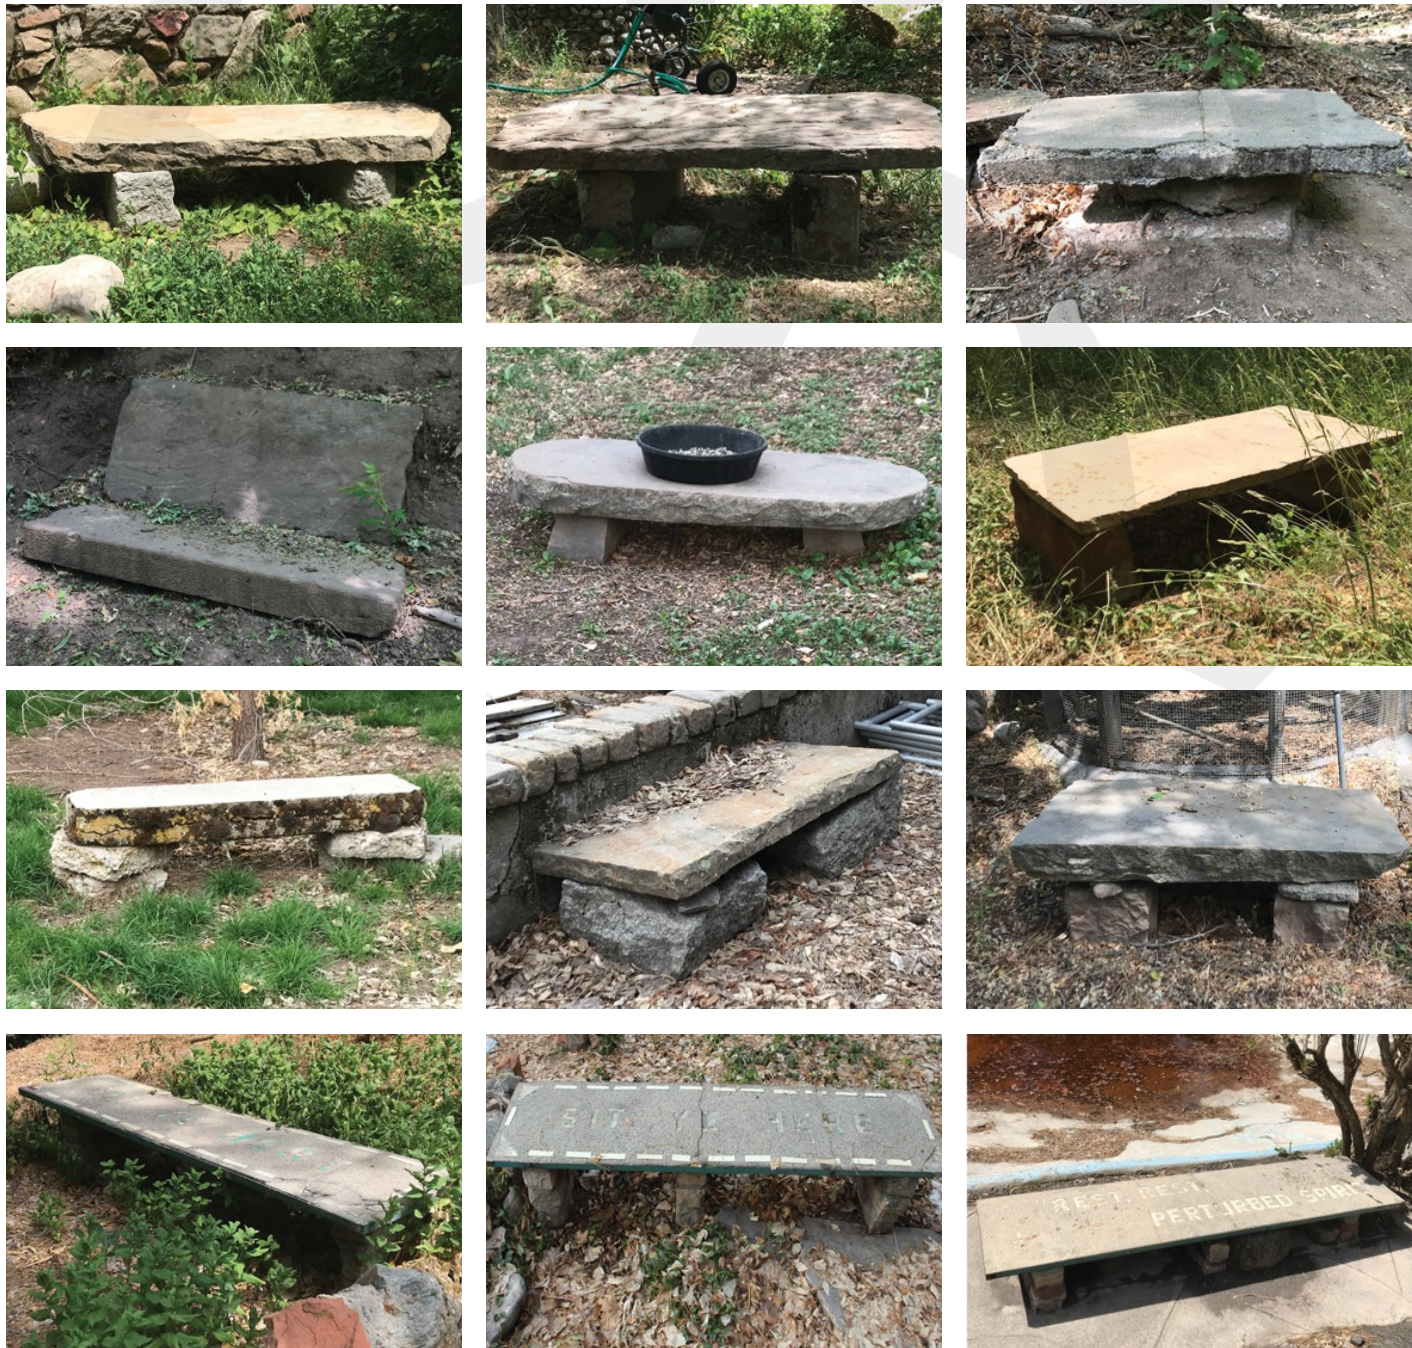
Figure 3-37. Bench Photos

The study area contains numerous benches, which are typically located in and around points of interest. In some places they appear in multiples, like the 'living room' space, and in other places they are singularly placed.

- Bench, slab: large slabs of stone or recycled concrete resting across two columns of smaller stones.
- Bench, artwork mosaic: The seat portion of these benches is cast in concrete, and ornamented with mosaic tiles, similar in construction and appearance to the monument artworks, but articulated as a horizontal bench surface.

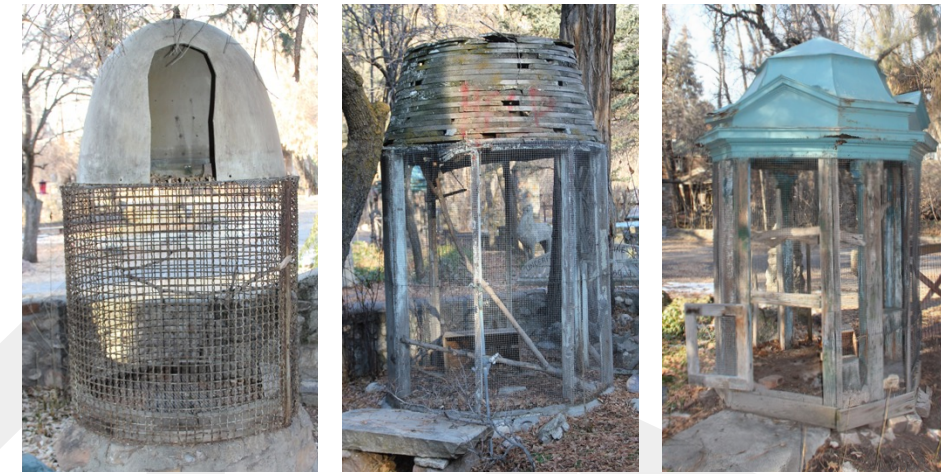
Figure 3-38. Bird Cage Photos

The study area contains several bird cages. Although the form, structure, materials, and articulation of these vary somewhat they are all constructed as permanent landscape features that have a sculptural quality.

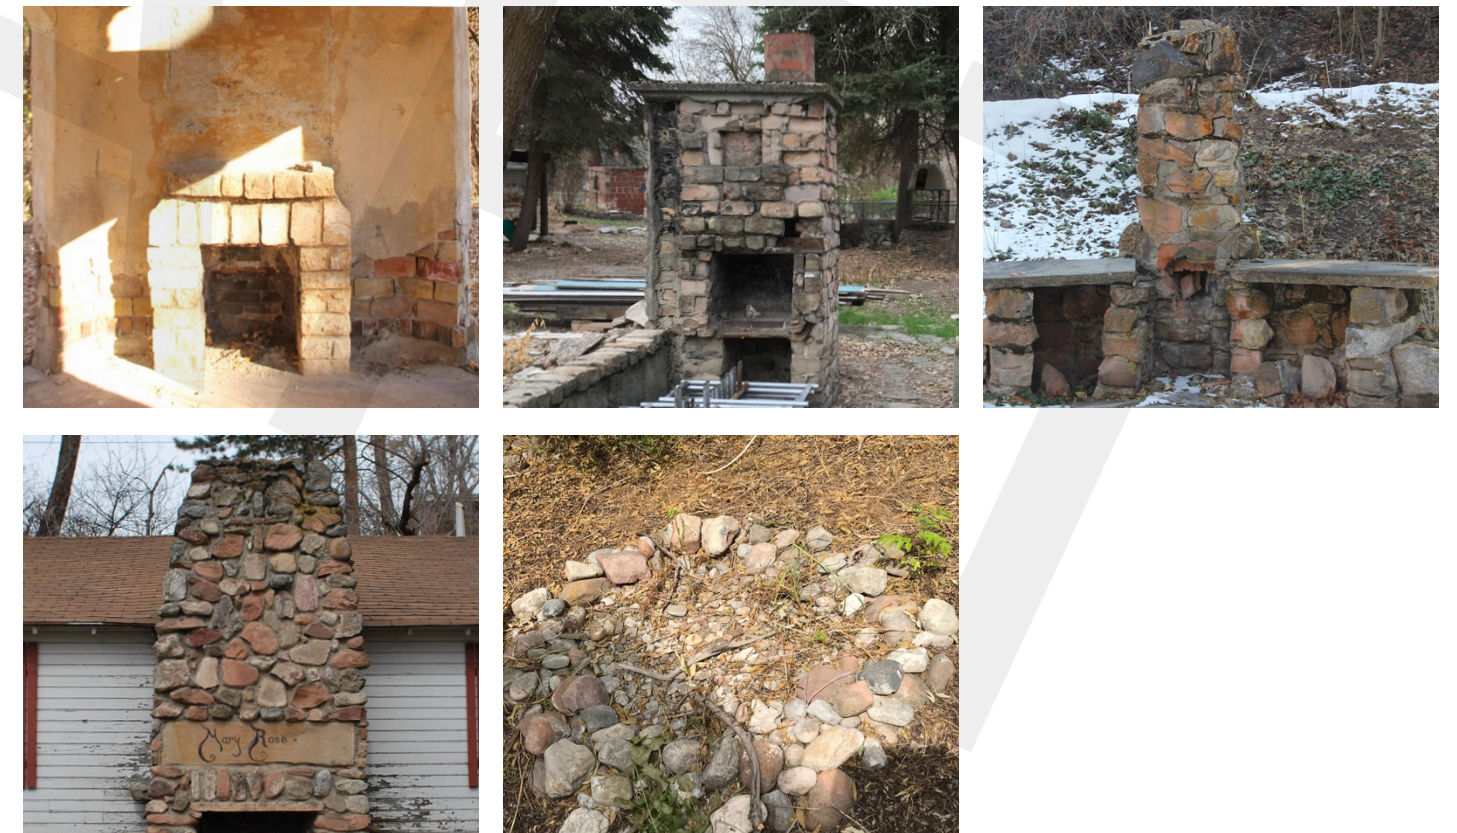
Figure 3-39. Fireplace Photos

The Allen Park Study Area contains several fire-specific features including outdoor fireplaces as well as simple fire rings:

- Fireplaces, fire rings – Circular elements on the ground surface delineating a space for a fire, consisting of stone or cast in concrete.
- Fireplaces, masonry – Freestanding outdoor fireplaces mortared brick or stone.

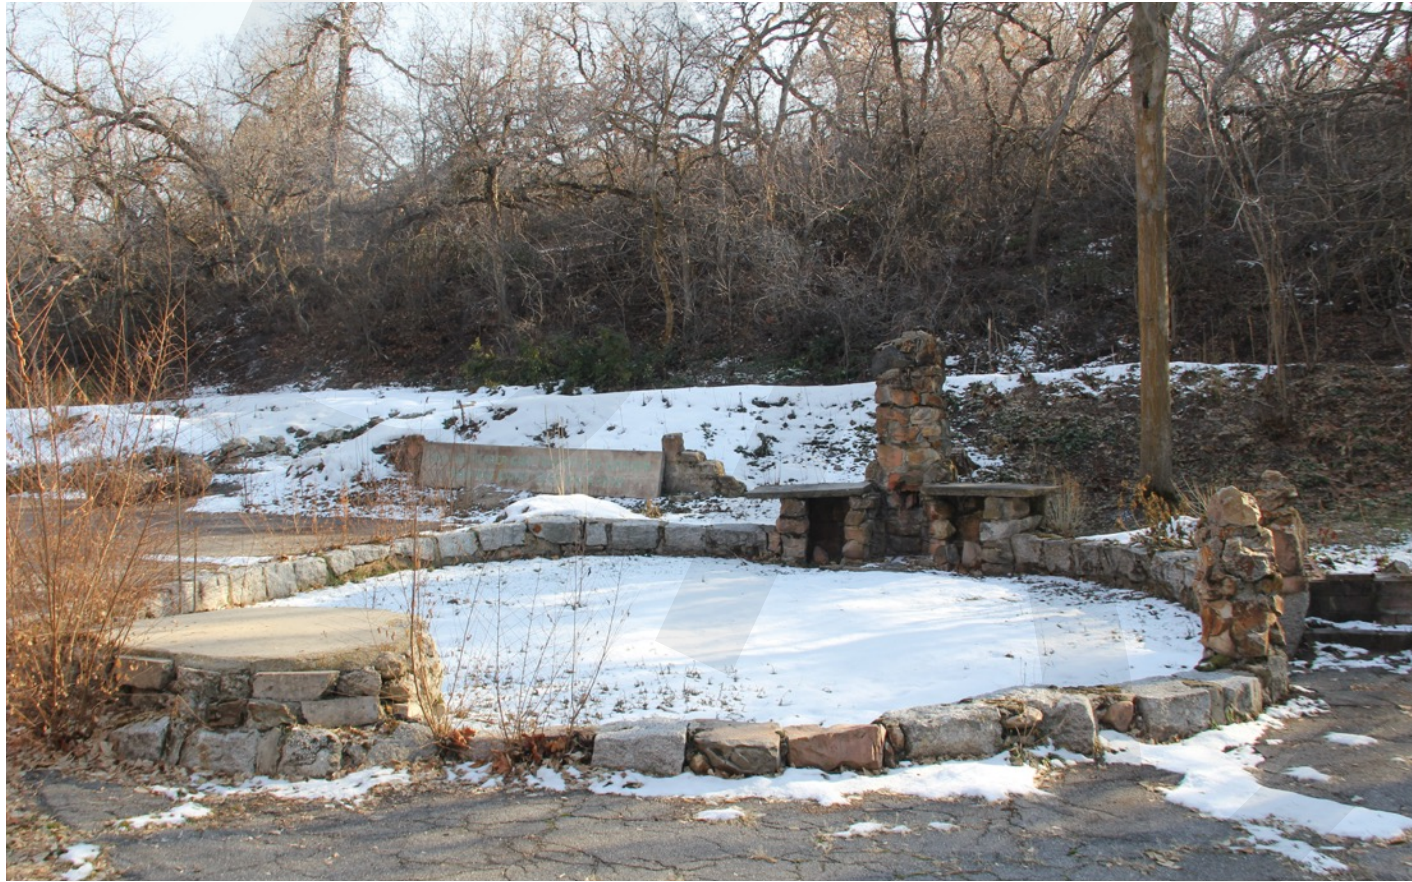
Figure 3-40. Dining Circle Photos

*Dining Circle* - Stone wall perimeter with integrated masonry fireplace on the south side, and built-in stone dining table at north side.

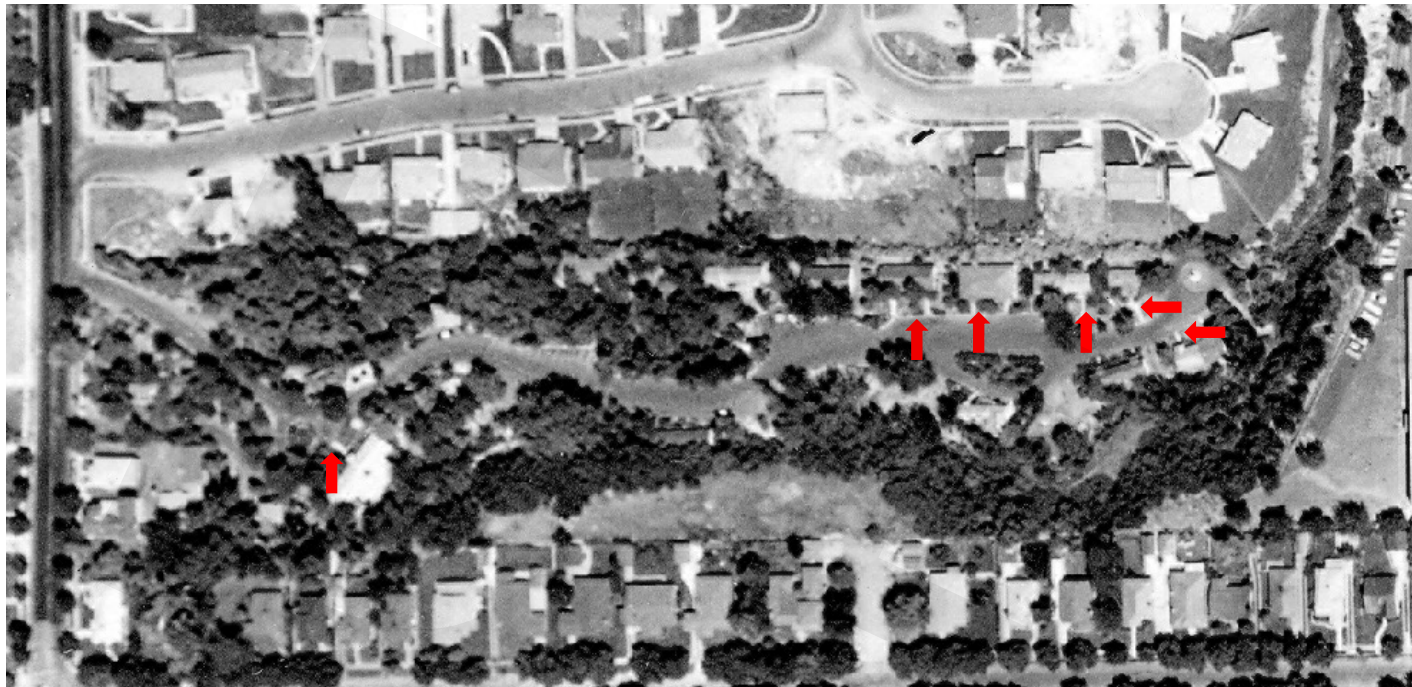
Figure 4-3. 1958 aerial photo depicting pathways at the Allen House and village area.

Data sources documenting pathways at Allen Park during the period of significance are limited, but at least some such pathways are visible in a 1958 aerial image of the property (see Figure 4-3). Photographs of the property from the 1940s and 1950s depict many of these pathways, at least in part (see Figure 4-5). The pathways are highlighted by such features as stone, concrete, or brick entry posts or columns or breaks in stone or concrete walls flanked by concrete decorations such as urns and

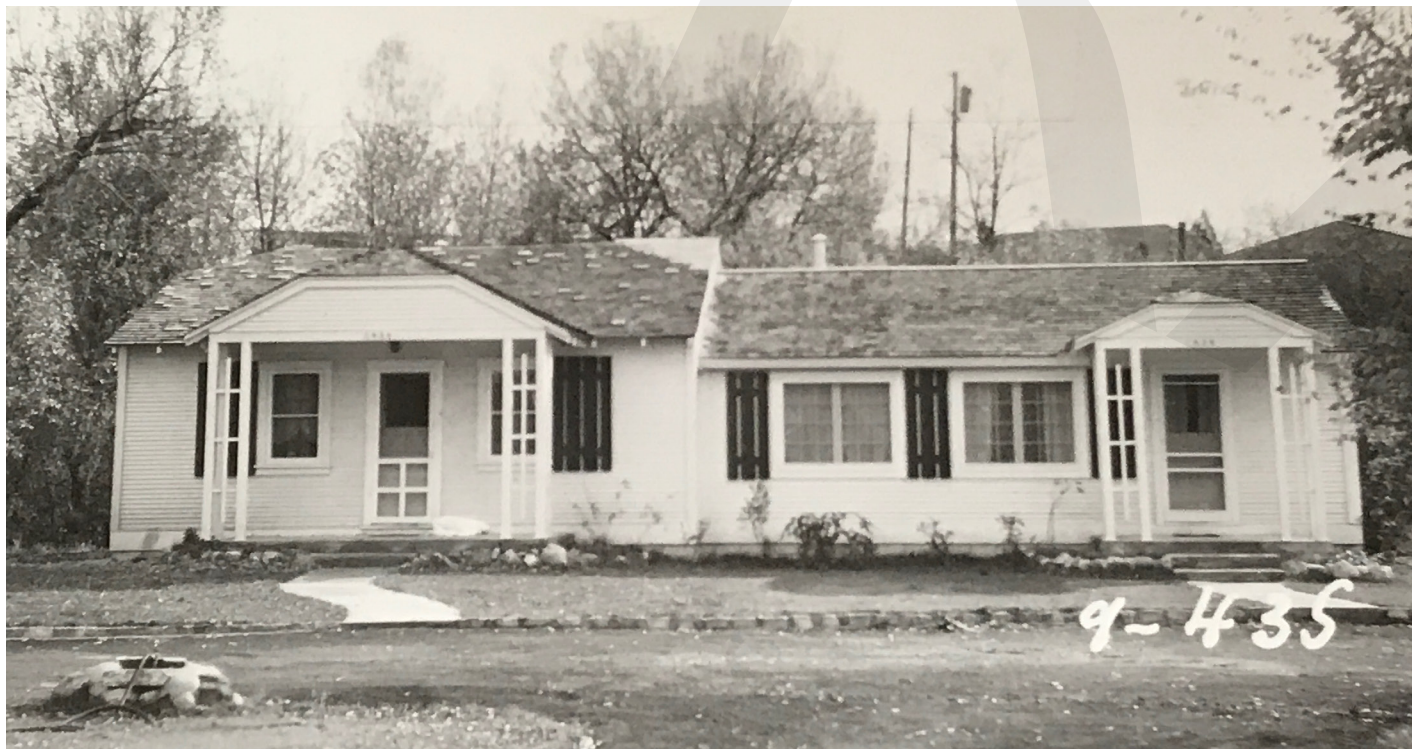
Figure 4-4. Ca. 1941 tax assessor photo depicting pathways at the 1434 -1436 East cottage.

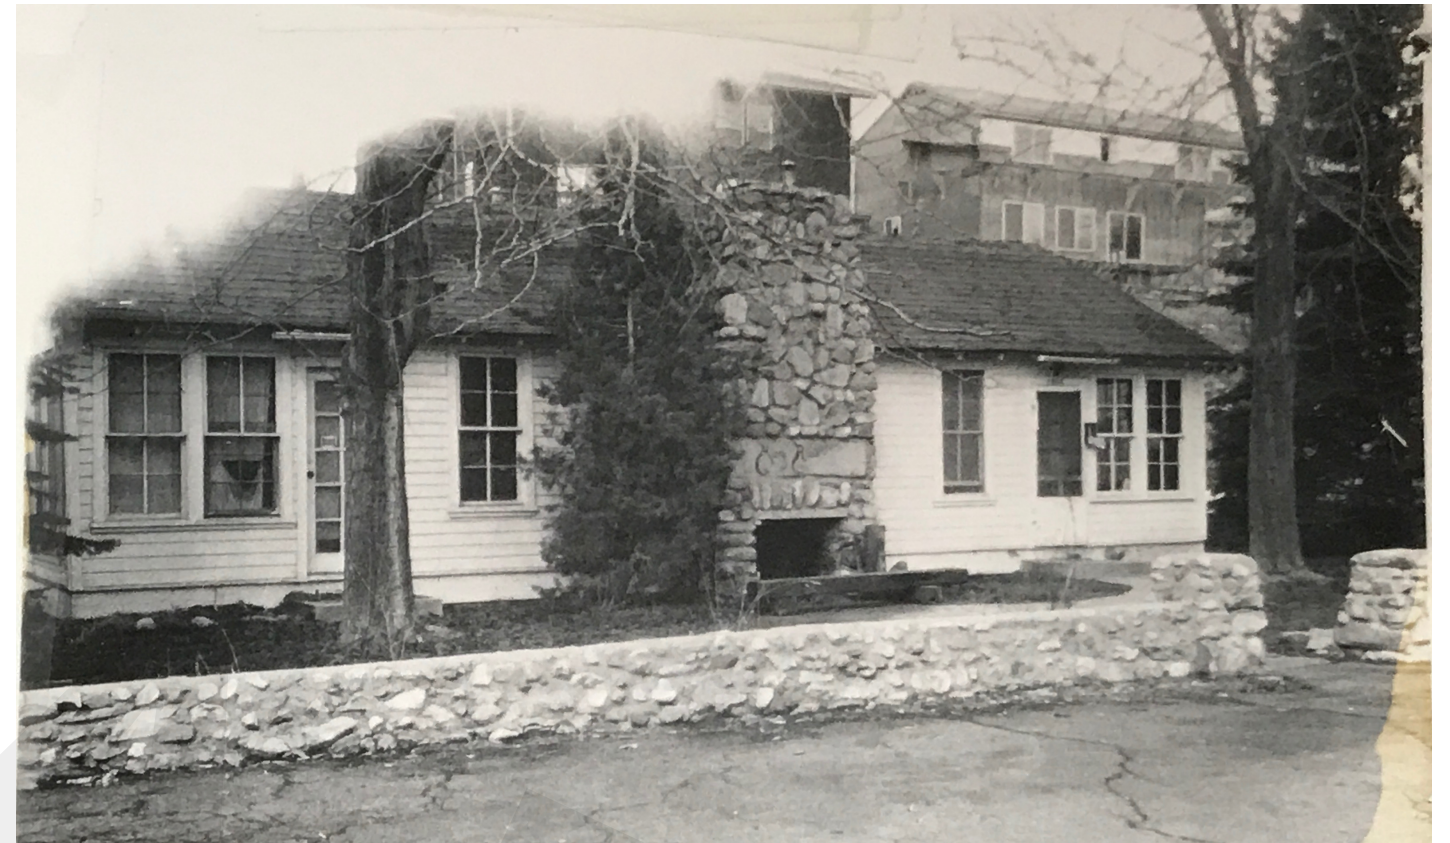
Figure 4-7. Ca. 1948 photo of the Mary Rose cottage and its stone wall.

A small number of the walls present on the property during the 2021 site inventory appear in historical photographs of the property. Generally, the walls that remain today and are visible in historical photographs are consistent with their design and materials from the period of significance. See Figure 4-7 and Figure 4-8 for an example of the historical and current nature of the wall features.

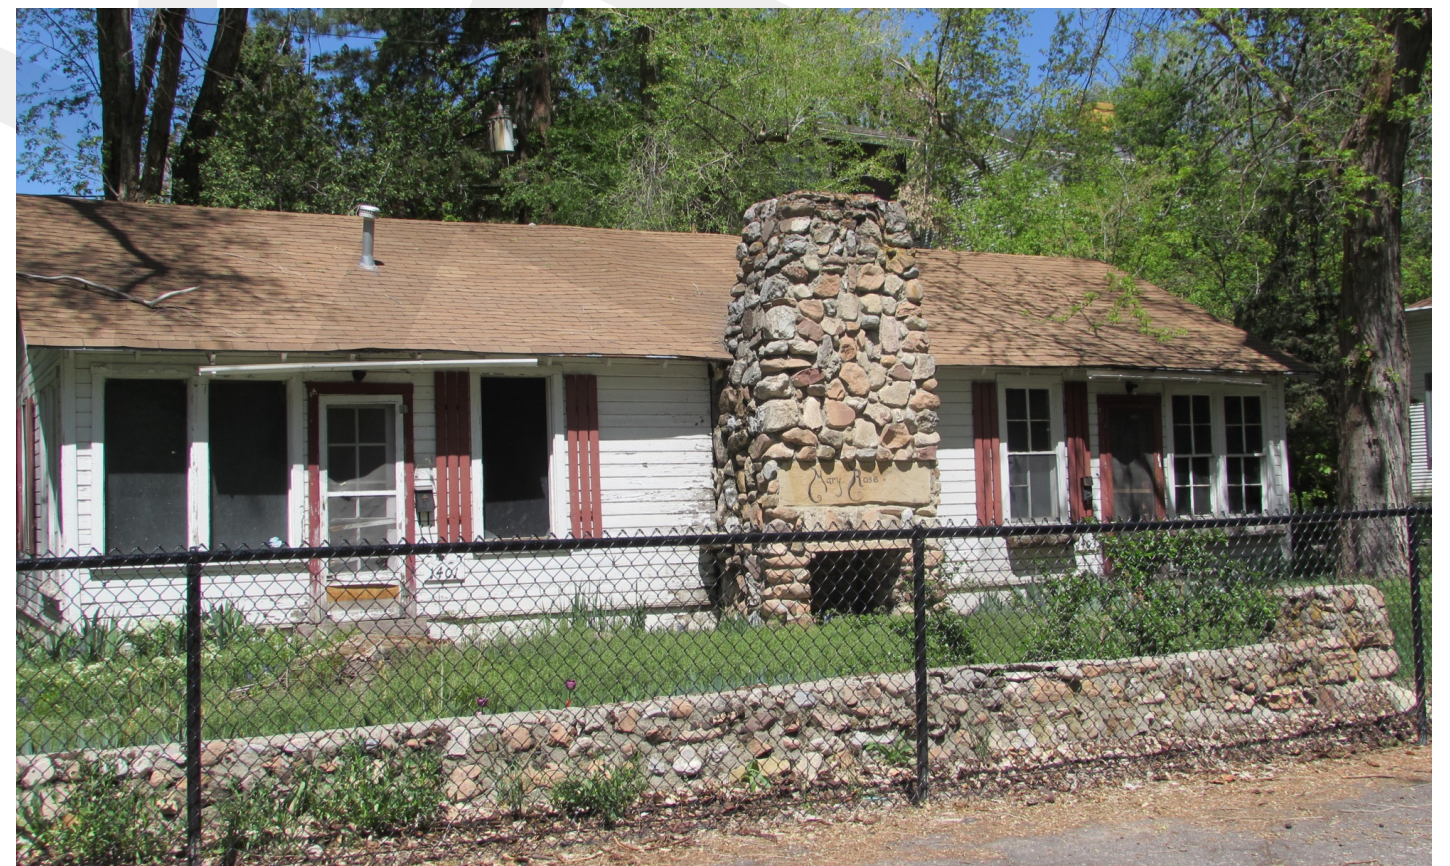
Figure 4-8. 2021 comparative photo of the Mary Rose cottage and its stone wall.

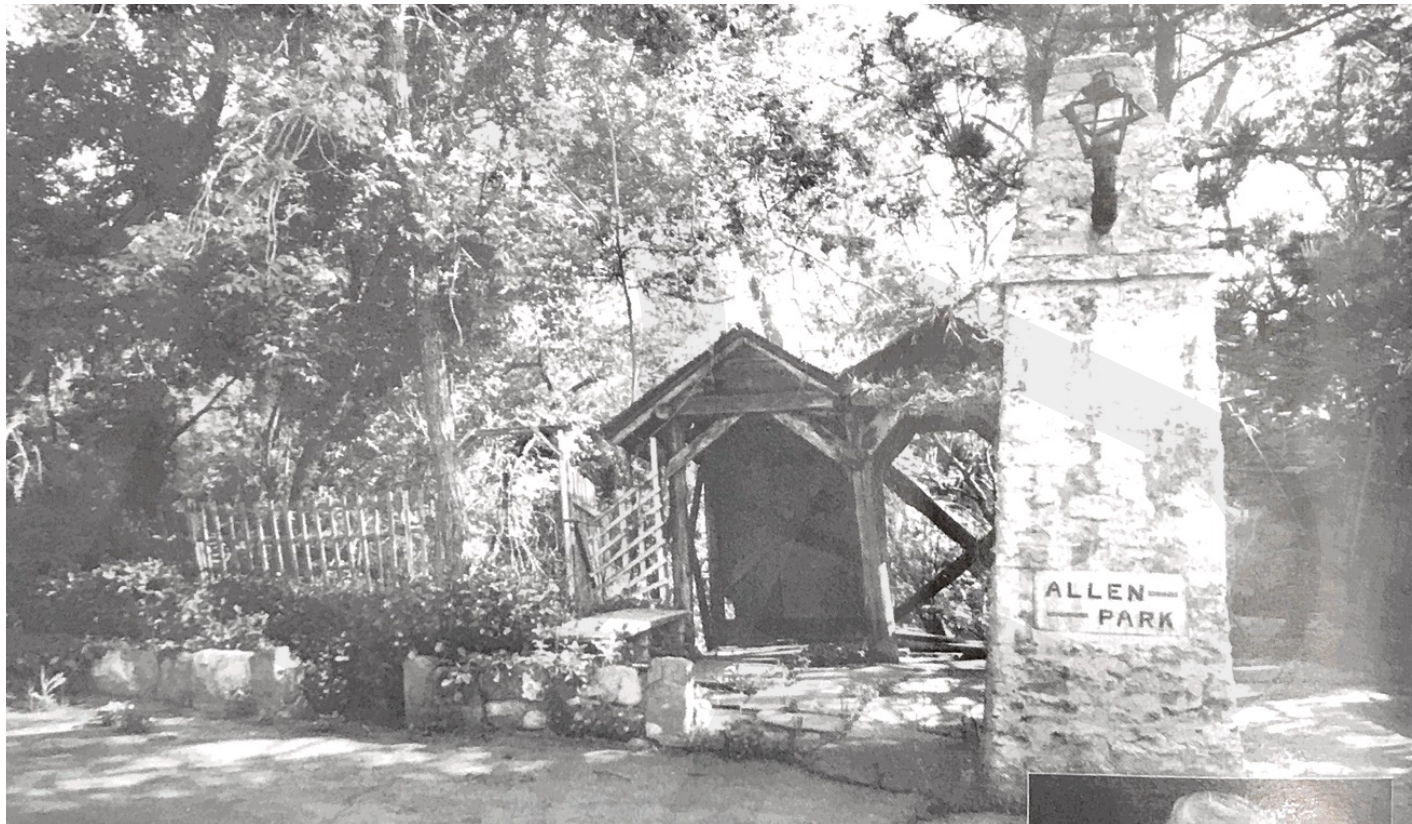
Figure 4-9. Ca. 1986 image of a light pillar and wood gazebo located northwest of the Allen House.

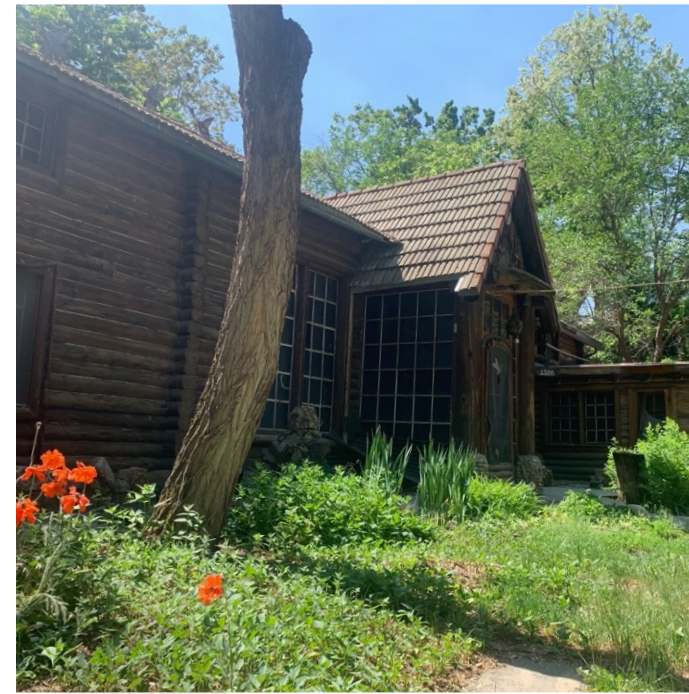
Figure 4-13. 2021 comparative photo of Allen House showing lawn and garden spaces.

In a 2021 photo (Figure 4-13) the irises are still visible. A peony and rose bush on the south side of the main entry walk mimic the form of

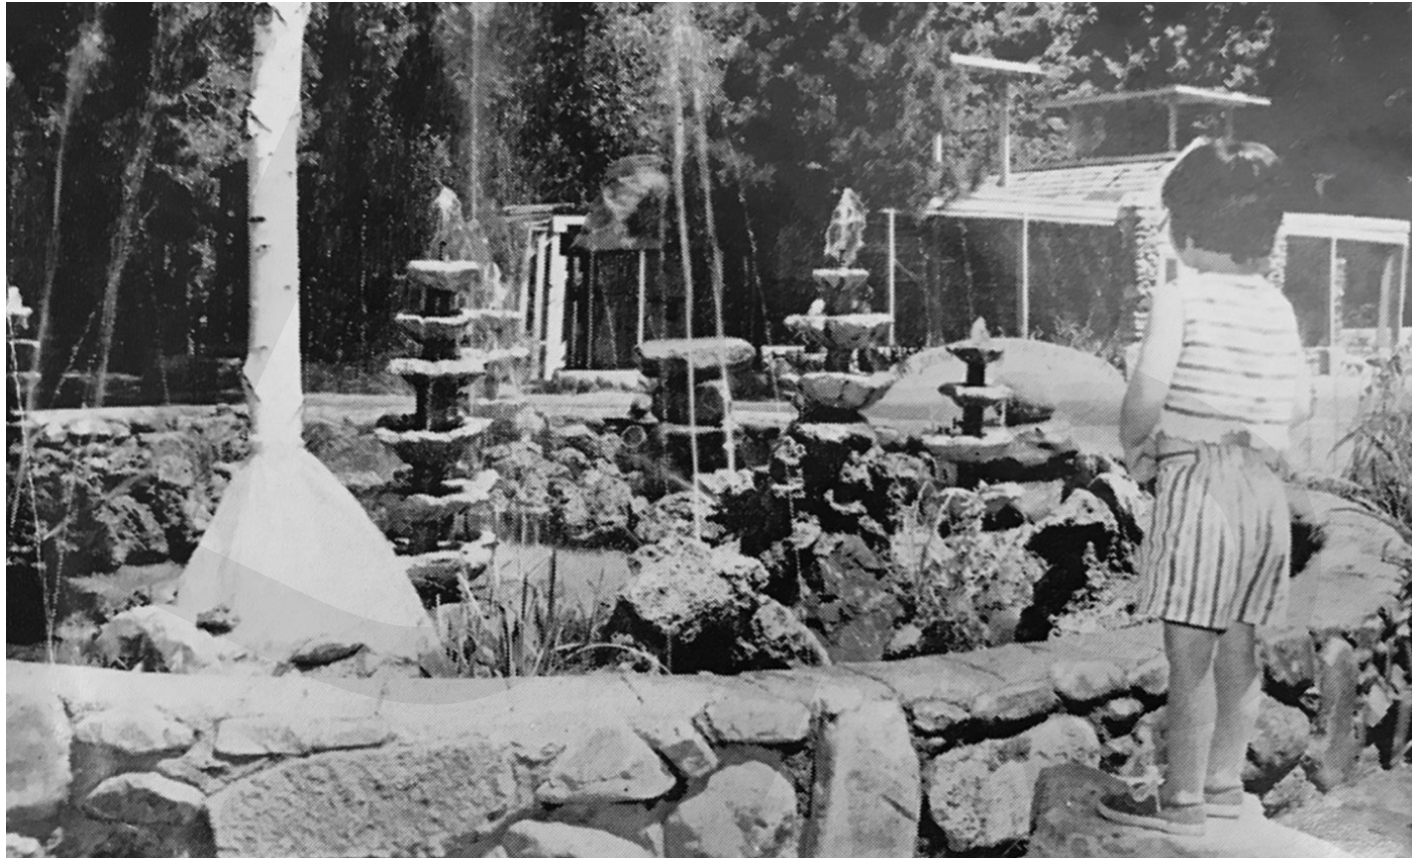
Figure 4-14. Ca. 1961 view looking at central roundabout fountain.

*Analysis* - Very little evidence was discovered in terms of a comparative data from the historical period. A few of the larger water features, such as the central roundabout fountain and swimming pool, are minimally discernible in aerial images of the area. Among the few images available, one from ca. 1961 depicts much of the central roundabout fountain (see Figure 4-14) and one from ca. 1950 that partially depicts the small concrete fountain north of the Allen House (see Figure 4-15). Comparing the central fountain as shown in the ca. 1961 photo with its current condition (see Figure 4-16) indicates that the feature substantially retains its historical integrity. The only changes of note are that the tops

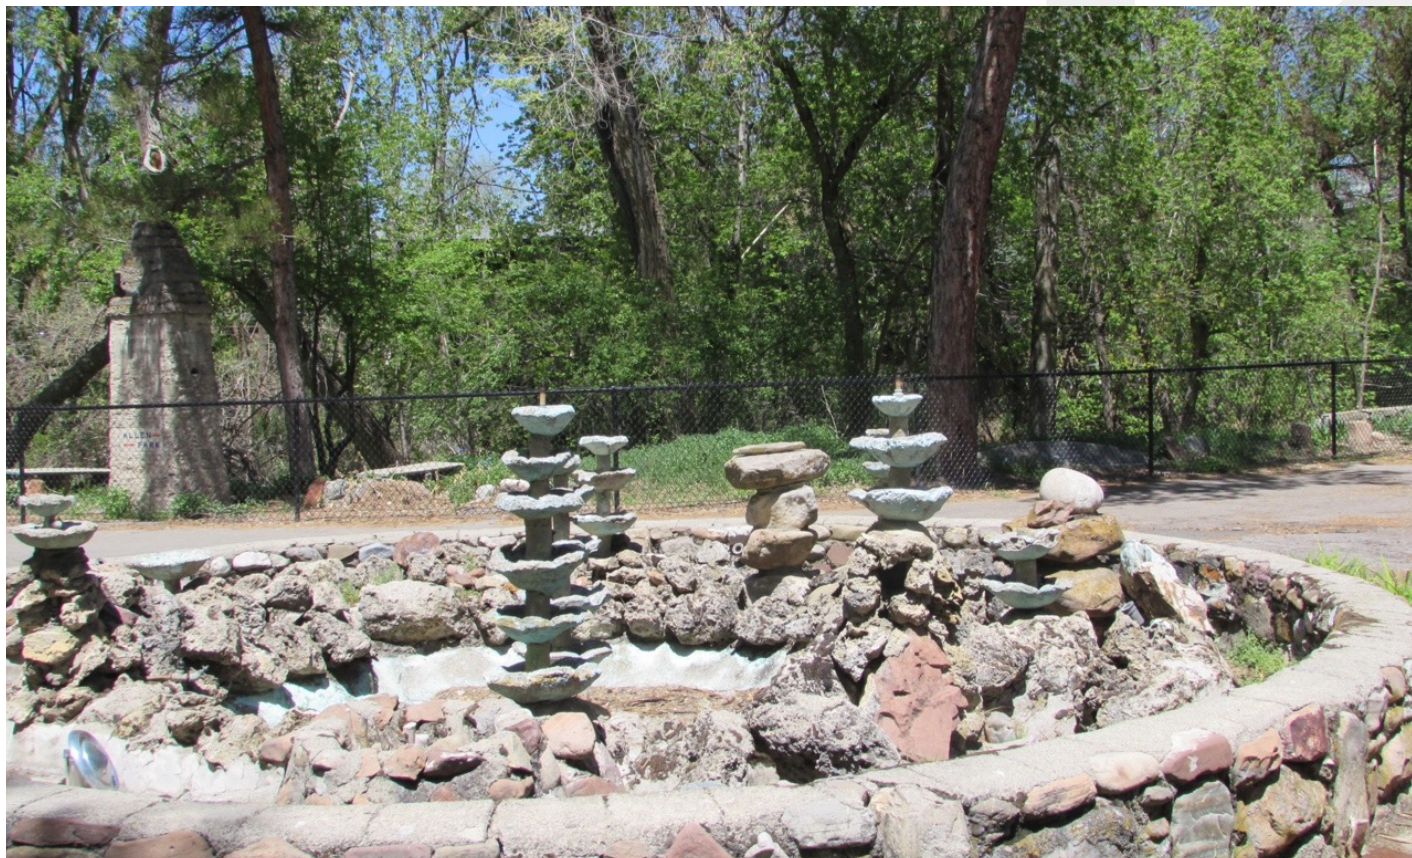
Figure 4-16. 2021 comparative view looking at central roundabout fountain.

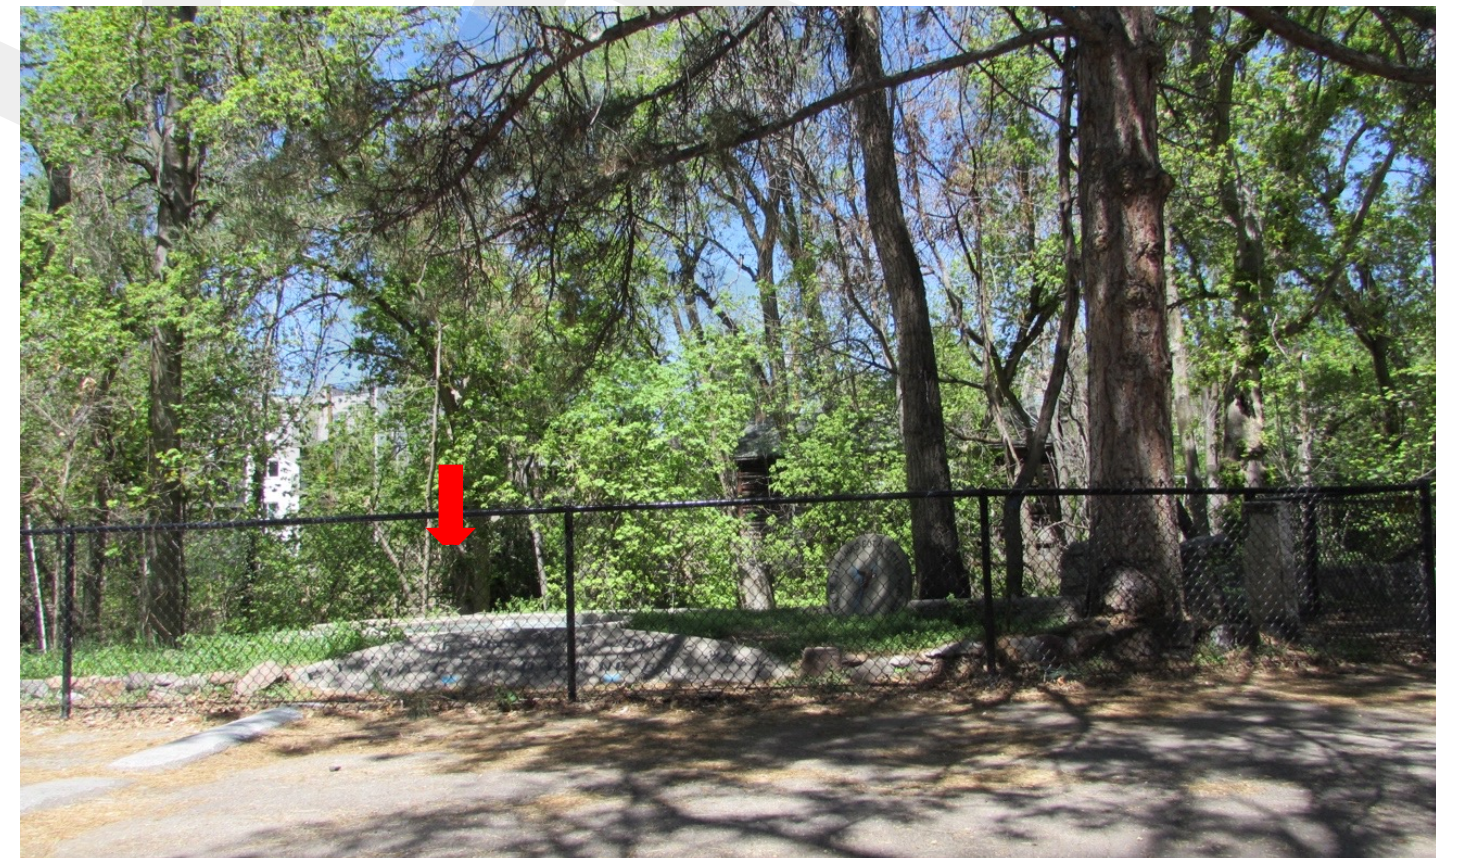
Figure 4-17. 2021 comparative view depicting concrete fountain north of Allen House.

of two of the fountain "towers" have broken off, and an aspen tree once located in the southwest quadrant of the fountain has been removed. The small fountain north of the Allen House also substantially retains integrity with the primary change in the feature being limited to the loss of the metal fountain spout that projected upward from the center of the concrete pedestal in the middle of the fountain (see Figure 4-17 for the present-day comparative view).

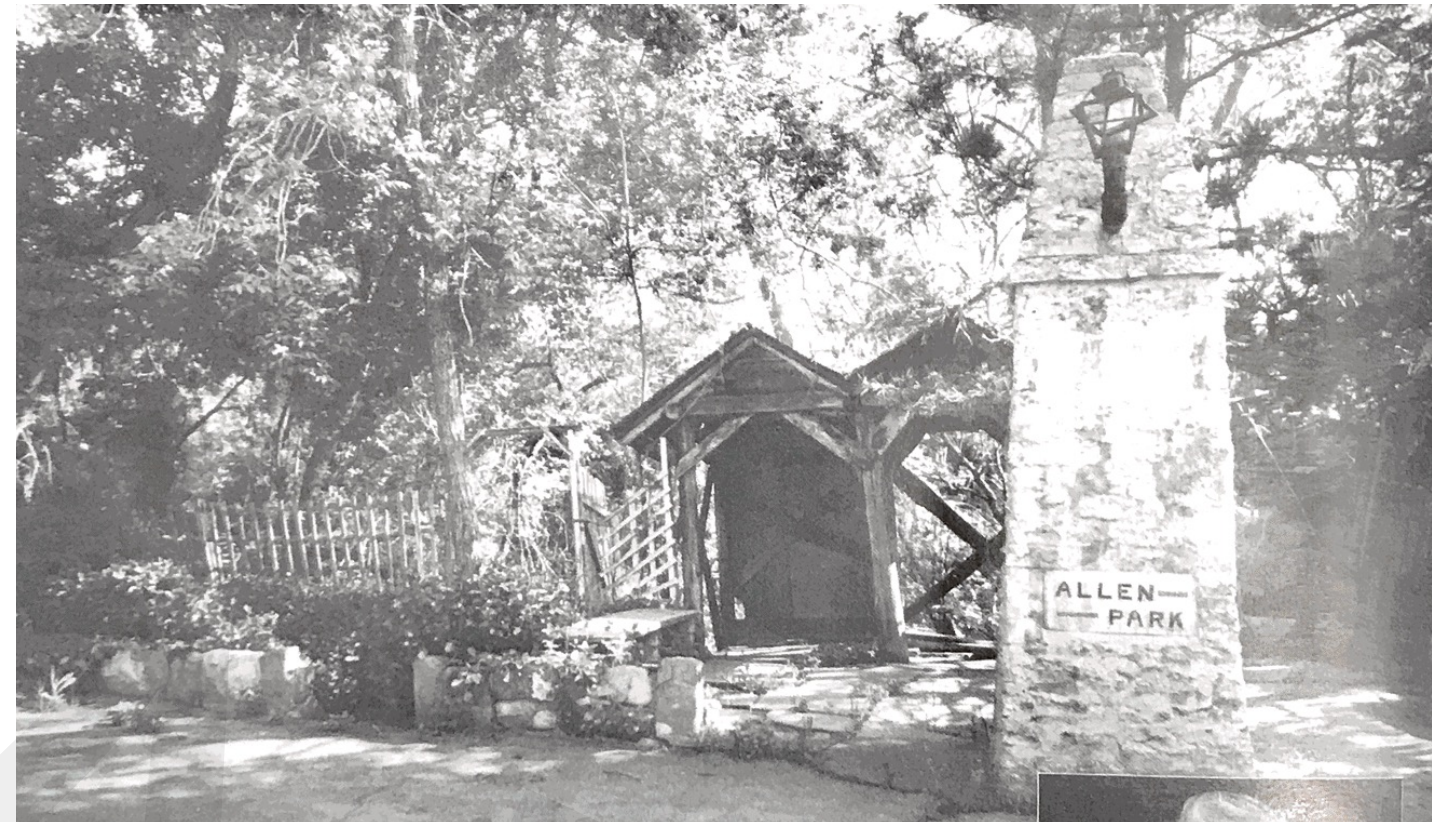
Figure 4-18. Ca. 1986 image of a light pillar located northwest of the Allen House.

The only notable change to the light pillars is that the lamp fixtures themselves, though not the connecting armature, has been removed (see Figure 4-18 and Figure 4-19 for a comparison of one historical light pillar to its current condition). Ten of these pillars include either incised or tile mosaic art in the form of text or images of animals, plants, or people, and, as such, they are considered artworks as much as they are light installations.

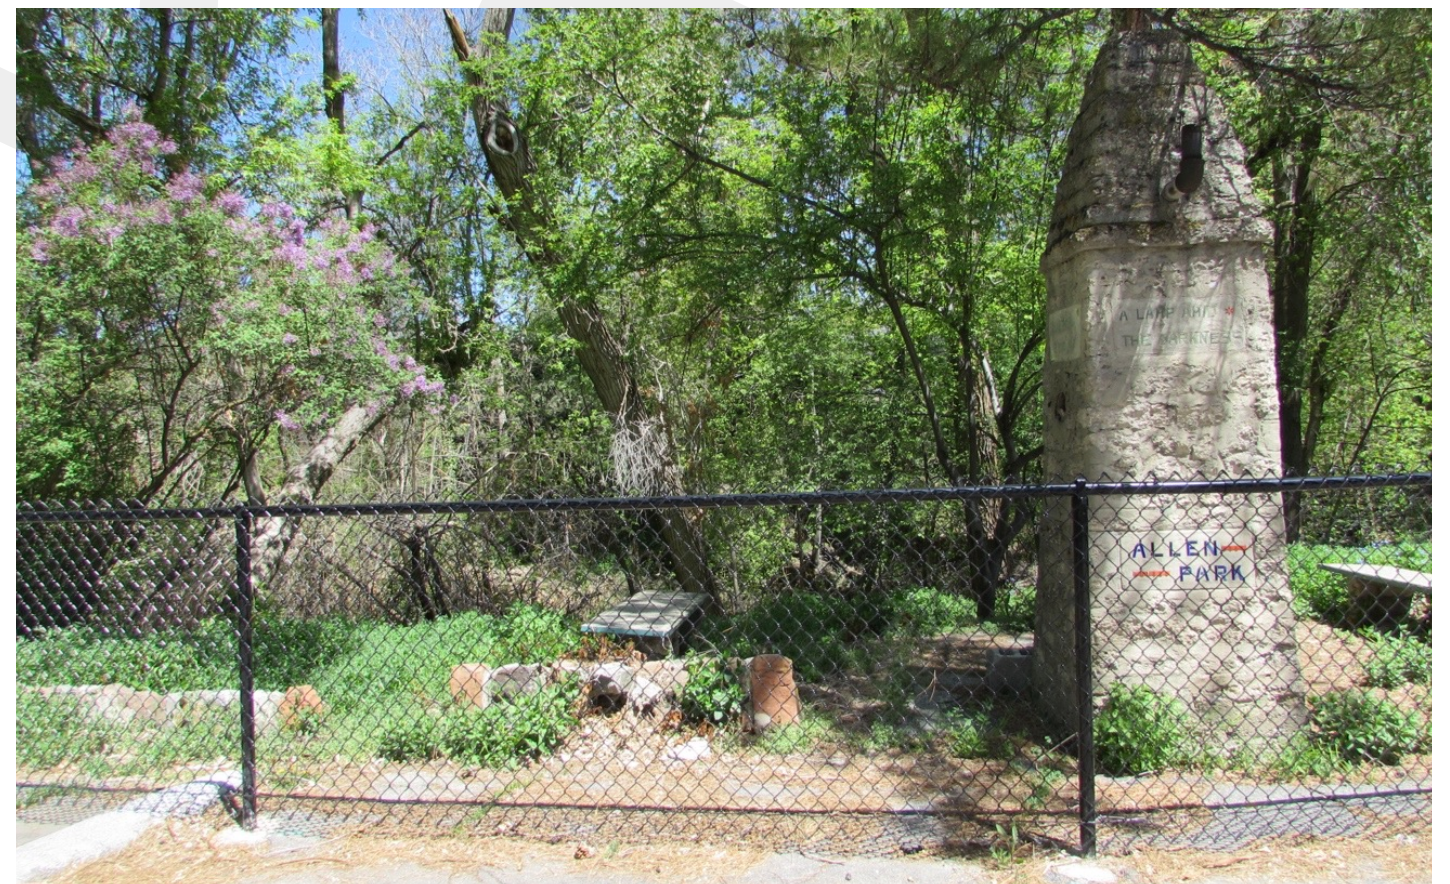
Figure 4-19. 2021 comparative view depicting light pillar northwest of Allen House.

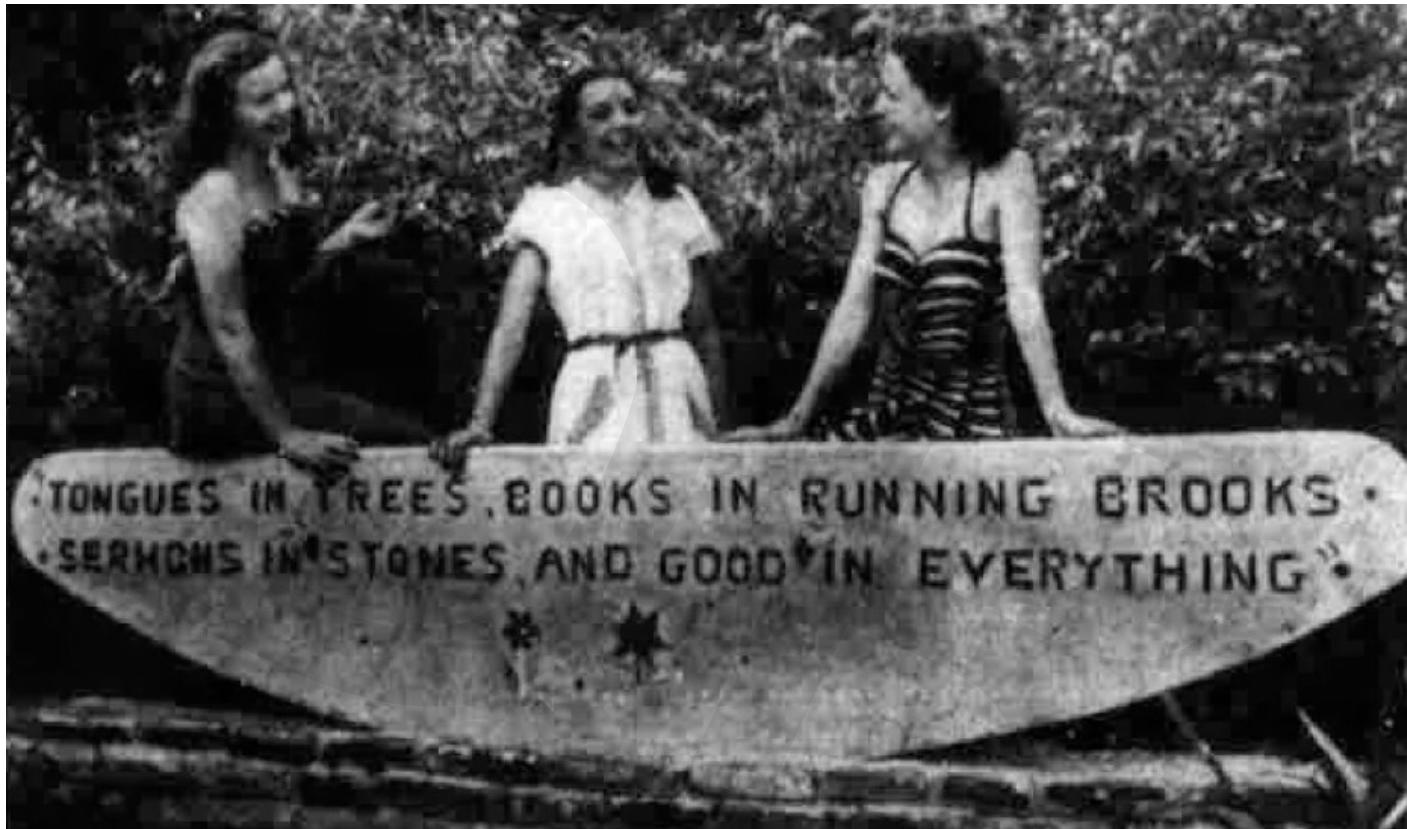
Figure 4-20. Ca. 1949 image of monument northeast of Allen House.

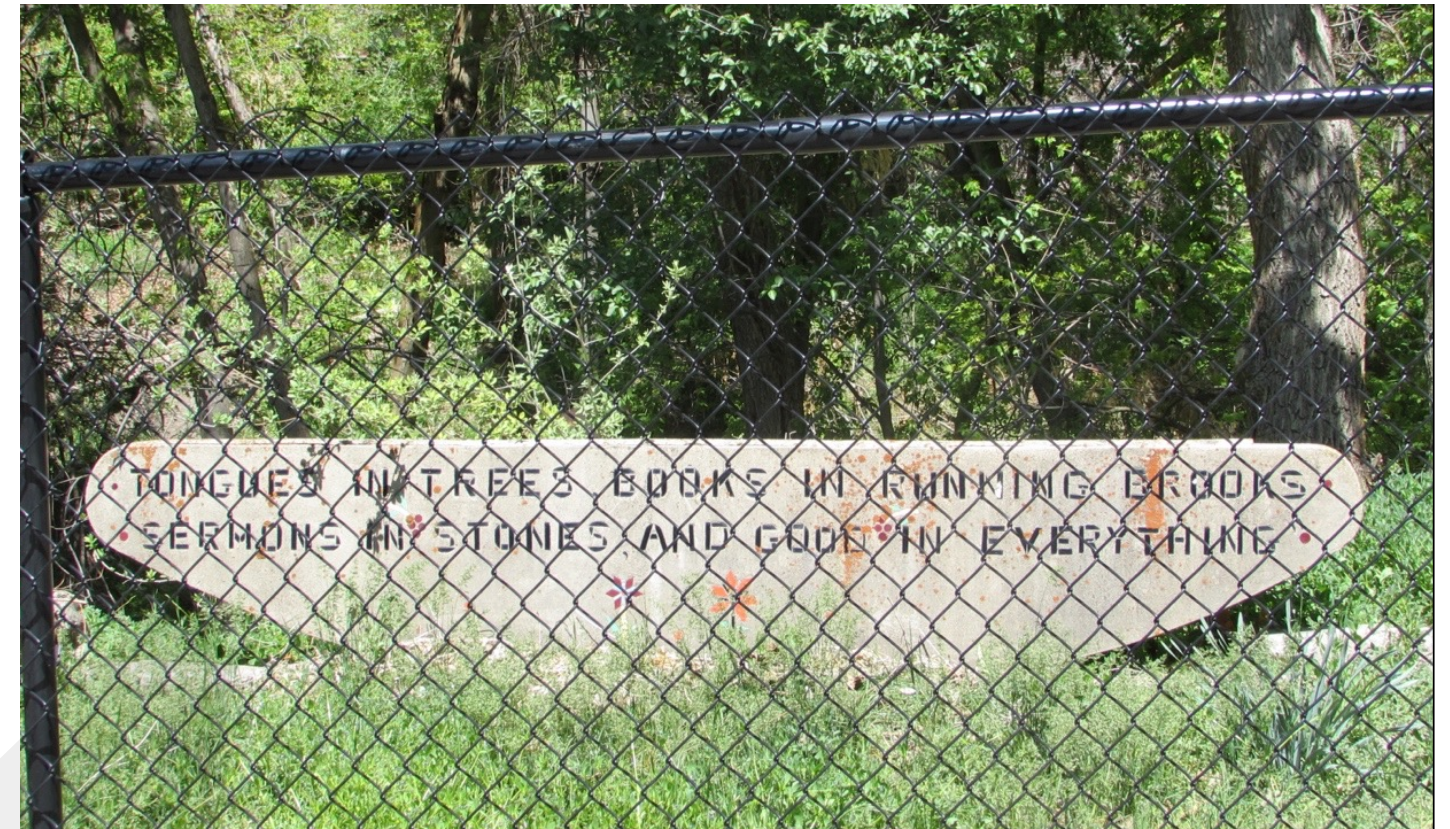
Figure 4-21. 2021 comparative view of monument northeast of Allen House.

tile mosaic patterns depicting images and phrases. While they show signs of limited deterioration due to weathering, they remain substantially intact. All extant monuments are believed to have been constructed during the period of significance, though no specific documentation of such exists for these features. A few of the monuments have become partially buried at their bases (see Figure 4-20 and Figure 4-21 for an example) due to such factors as the build-up of the driveway/road, sediment accumulation, or accumulation of vegetation and a thick duff layer.
