# ALLEN PARK CULTURAL LANDSCAPE REPORT

Salt Lake City, Utah  
September 2022

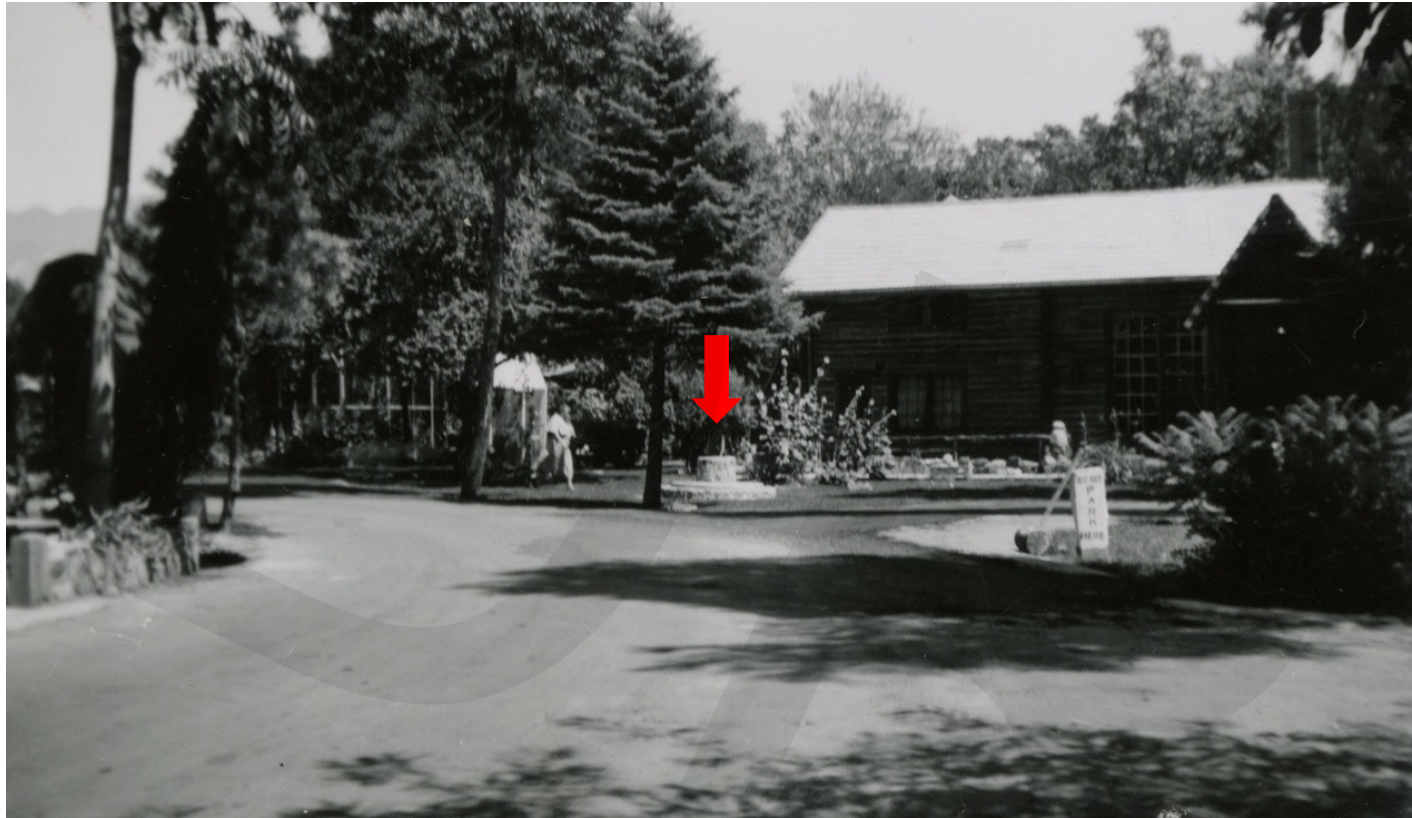
Figure 4-22. Ca. 1950 photo of Allen Park with the sundial in front of the Allen House.

sculpture near the swimming pool. Of these features, historical photographs used in a comparative analysis only depict the sundial (see Figure 4-22) and one of the two dome-like features (see Figure 4-24). Present day views of these two features (see Figure 4-23 and Figure 4-25) suggest they retain a high degree of historical integrity. The half-dome feature appears partially buried due to the built up paving that has raised the elevation of Allen Park Drive since 1950. No historical images of the second dome feature or the singular masonry pillars have been located; however, they are presumed from their current condition to have been constructed during the historical period and to retain reasonable integrity of location, design, materials, workmanship, setting, feeling, and association. All the other artworks currently present on the property are considered contributing features to the significance of the overall historical landscape.

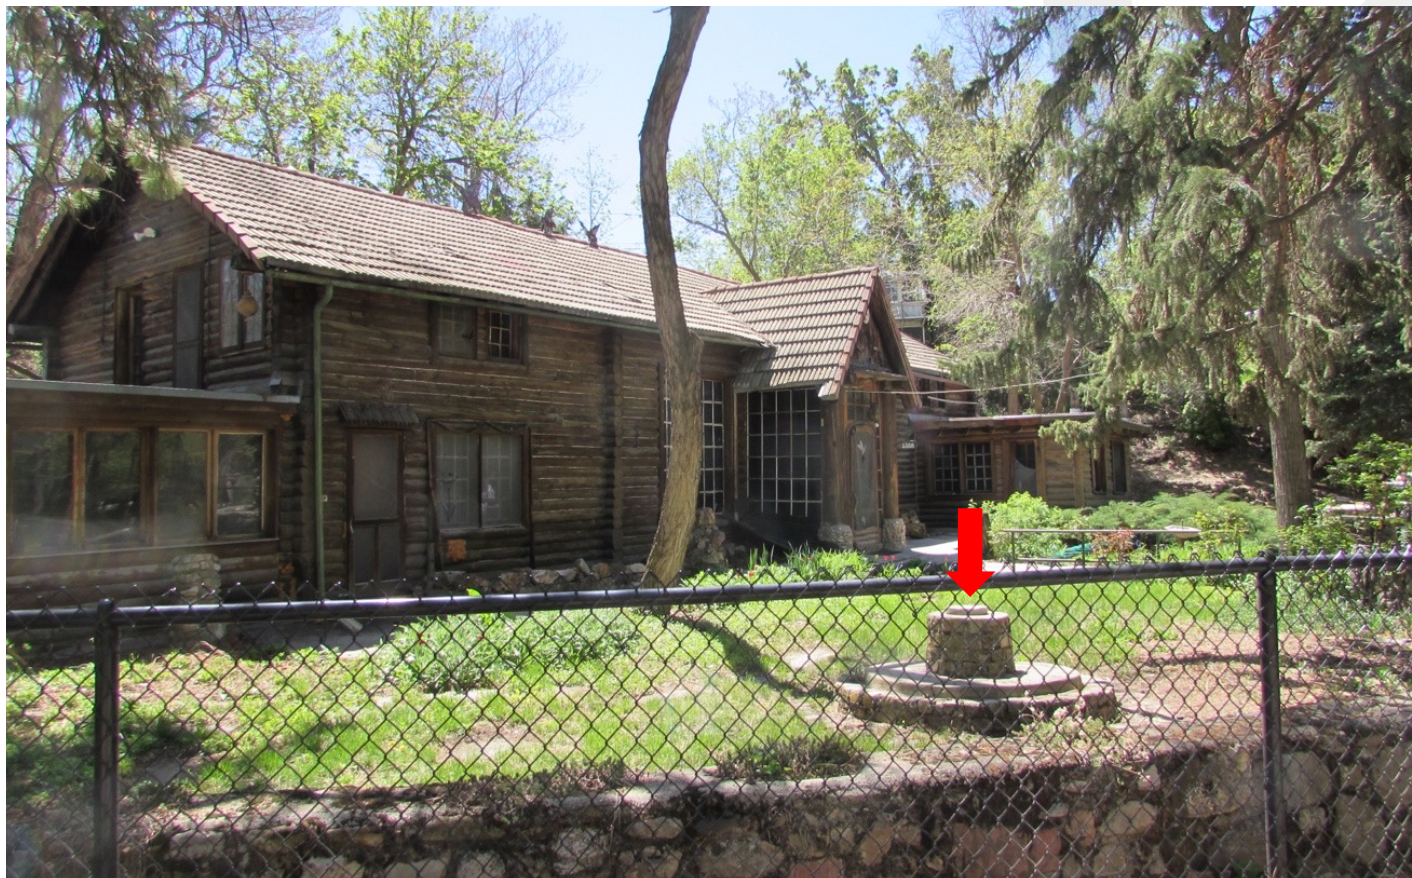
Figure 4-23. 2021 comparative photo of sundial.

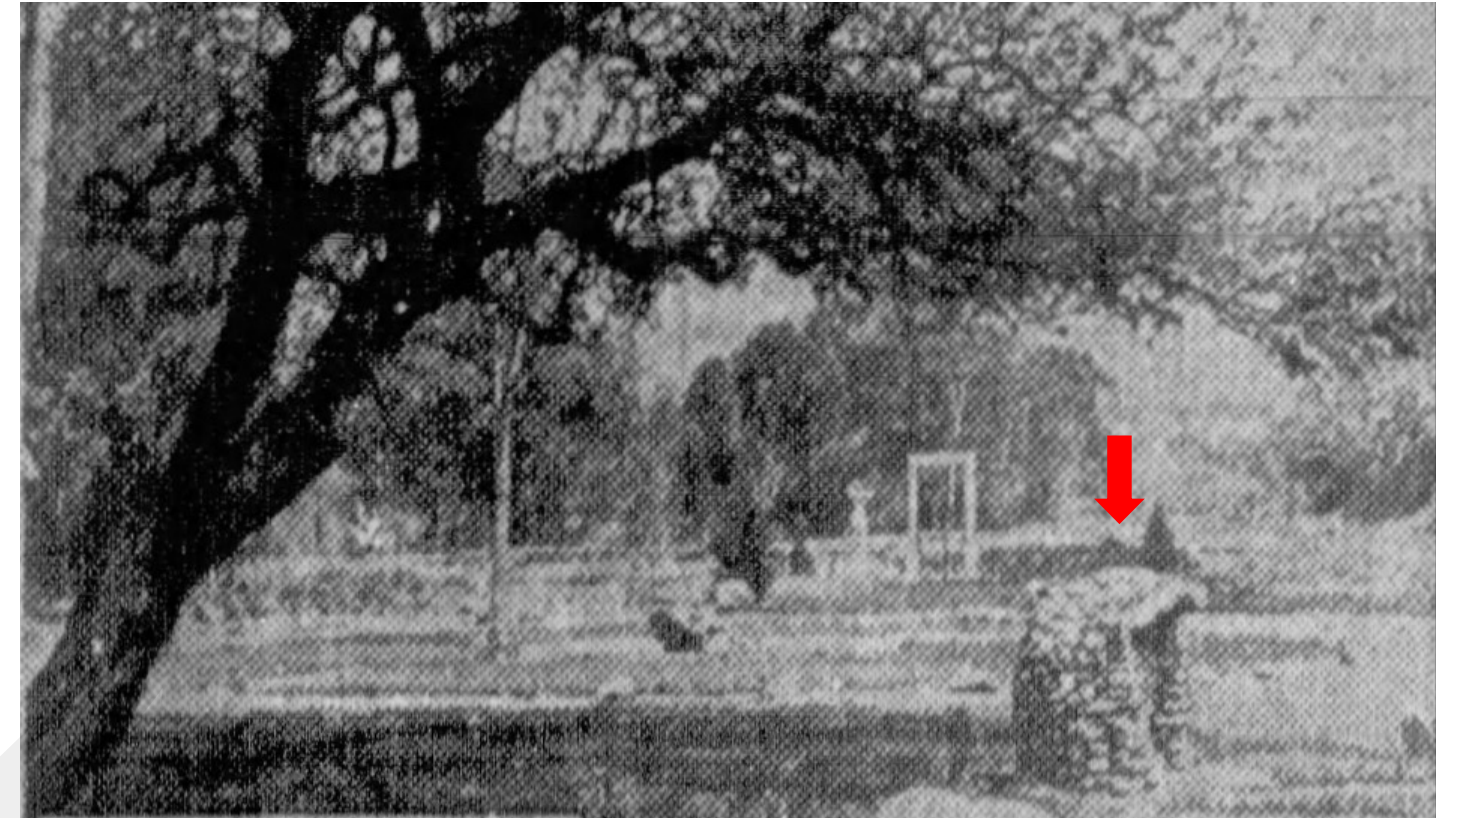
Figure 4-24. Photo from ca. 1932 newspaper article showing half-dome feature.

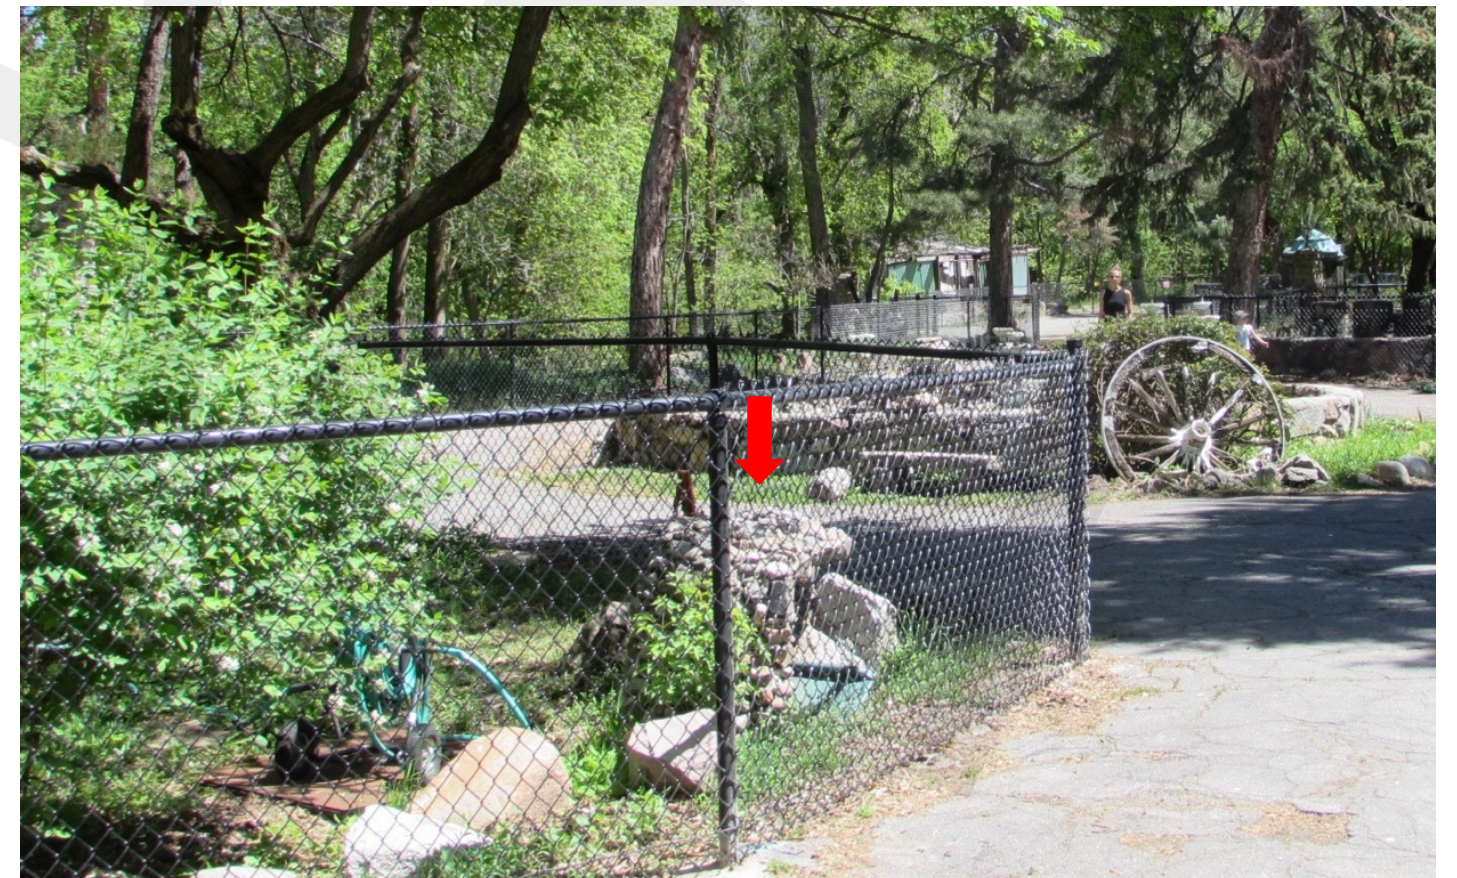
Figure 4-25. 2021 comparative photo of half-dome feature.

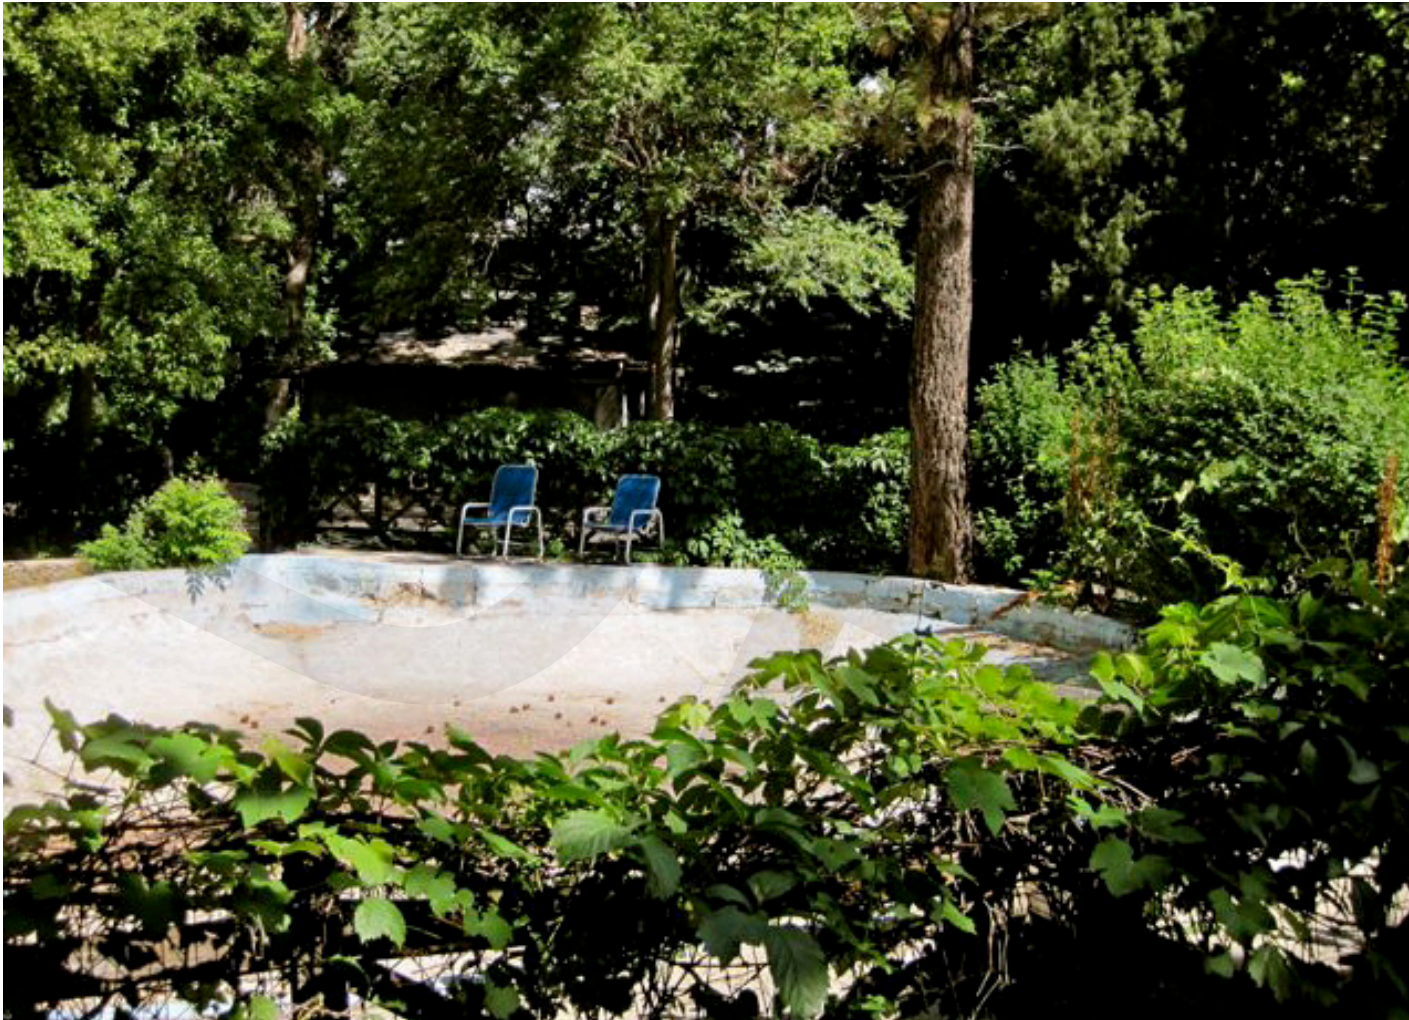
Figure 5-3. July 2012 photo of pool area showing extant fence and vegetation creating a strong sense of vertical enclosure in the pool area.
