# Staff Report

**To:** Salt Lake City Historic Landmark Commission  
**From:** Anthony Riederer - Principal Planner  
(801) 535-7625 or anthony.riederer@slcgov.com  
**Date:** April 20, 2017  
**Re:** Petition PLNHLC2017-00015, Demolition of the Residential Structure at 245 W. Bishop Place

## DEMOLITION OF A CONTRIBUTING STRUCTURE IN A LOCAL HISTORIC DISTRICT

**PROPERTY ADDRESS:** 245 W. Bishop Place

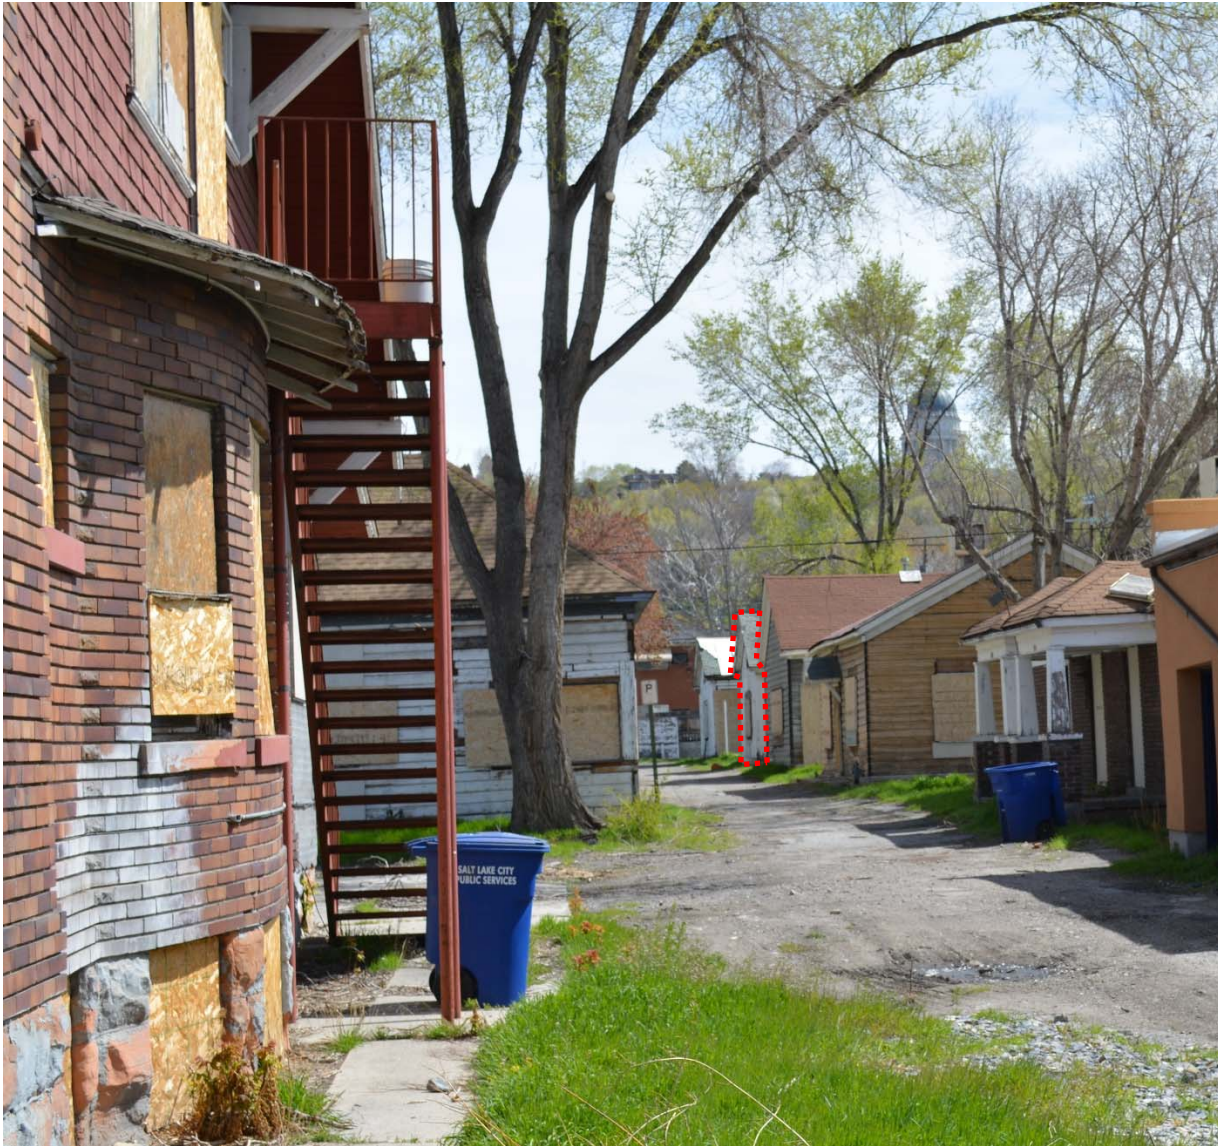
The subject property is one of a number on the south side of Bishop Place that, on account of their consistent front yard setbacks, are clearly visible from 300 West.

View from sidewalk along 300 West, Subject Structure highlighted

The ability to, from the public way, look down Bishop Place and understand some of the historic pattern of development common to the area is a feature that contributes significantly to the character of the Capitol Hill Historic District.

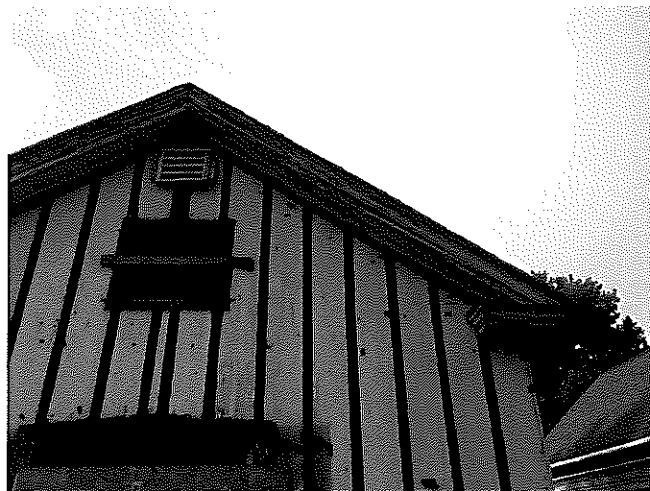
The siding has deteriorated and is missing in certain areas:

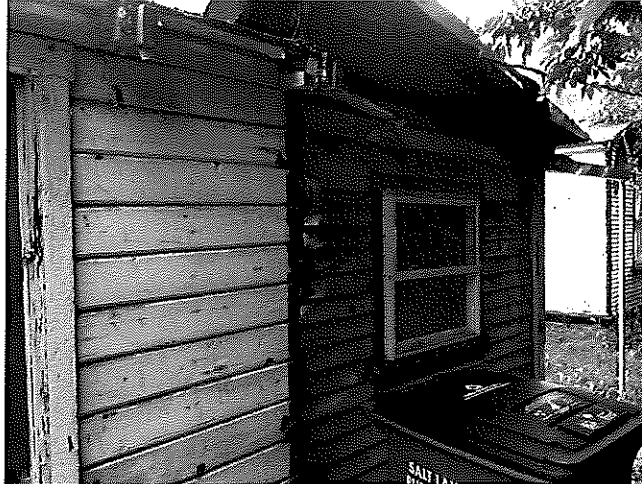
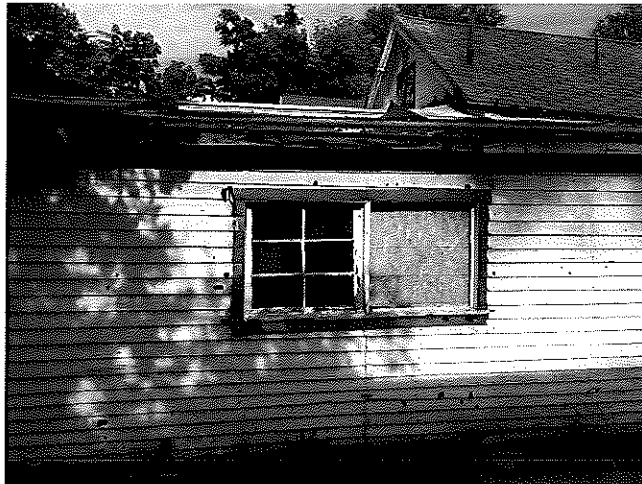
Additionally, the original door and roof have been replaced with inexpensive substitutes that lack historic character. A poorly constructed addition also detracts from any historic elements:

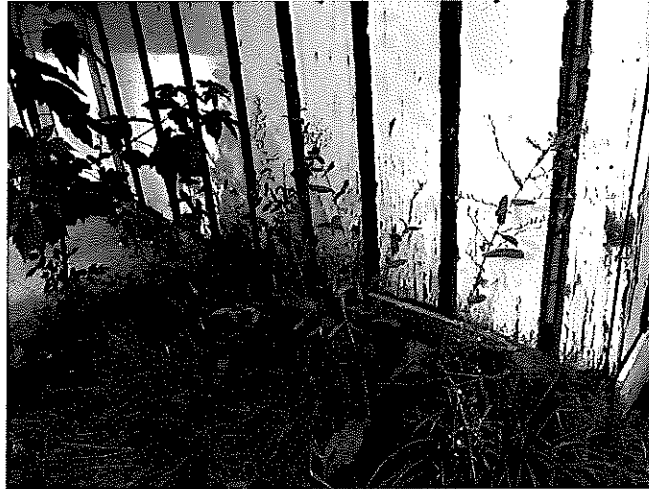
This home, like many others on Bishop Place, has deteriorated past the point of restoration. First, it lacks a foundation. Some effort appears to have been made many decades ago to create a foundation by installing a cement-like product as a footing. This was accomplished by digging 4 to 6 inches below grade and pouring the cement-like product 4-6 inches above the wood base of the home, as shown in this photograph:

Contrary to the intention, this provided no structural support for the home. To properly create footings for 245 Bishop, under the direction of a licensed engineer, IRES would need to undertake significant excavation, attempt to remove the cement-like material, and create new footings with rebar and cement. Alternatively, IRES could lift each home up and create a foundation or footing. Given the deteriorated state of the home, either effort would likely result in the collapse of the existing home.

Second, the lumber within the home has eroded, leaving floor beams, support studs and beams, and trusses in a dangerous condition. The home is sagging and leaning as a result of this deteriorating.

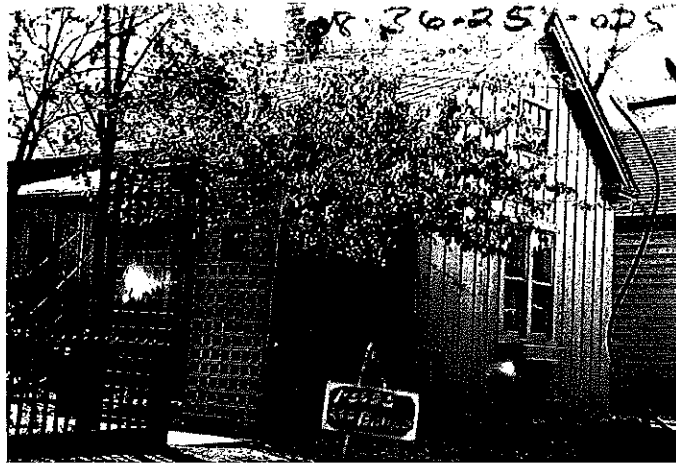
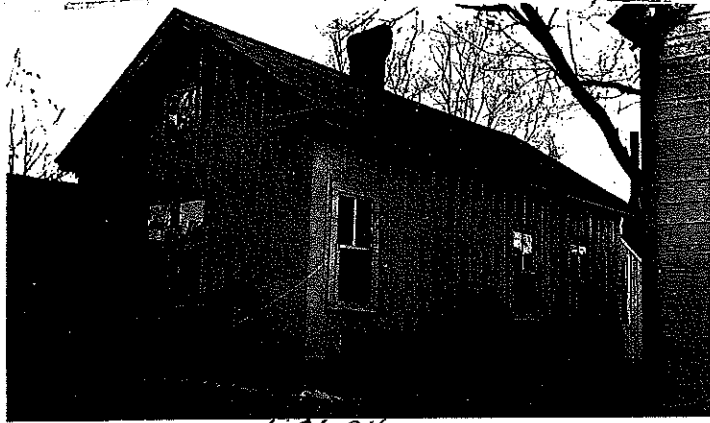
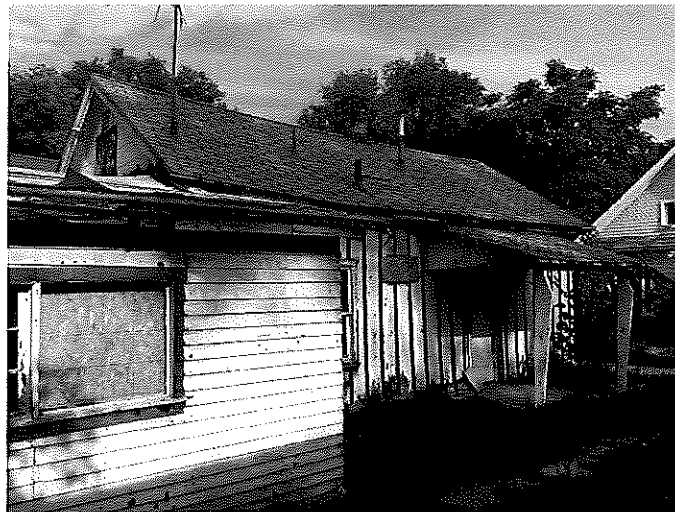
Two historic photographs of the home show that the only remaining historic element of the home is the siding, which is deteriorating and unable to be preserved because of the years of neglect, rot, and lack of foundation:
