Part 4: 1st Avenue Historic Residential

#### Specific Request #9-14: 1st Avenue Historic Homes Minor Alteration Permits for Contributing Structures

# Elks Block Redevelopment

March 4, 2021

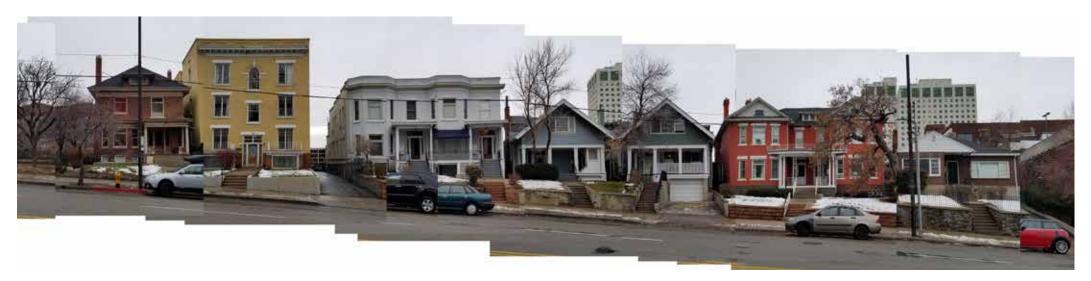
Streetscene View - North Elevation

These homes are a left over remnants of the single family neighborhood that emerged when The Avenues was forming at the turn of the prior century. Over the course of the past 100 years, redevelopment has occurred on all sides of the existing homes leaving them as stand alone vestiges of the prior neighborhood patterns. All of the homes have been converted to multi-family rental units and have been heavily renovated in their interiors and rear elevations. The front elevations retain the character of the original design and construction.

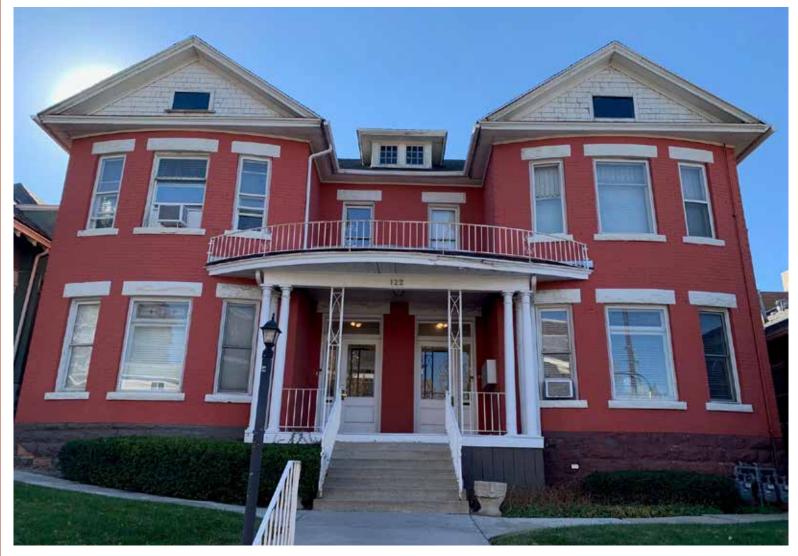
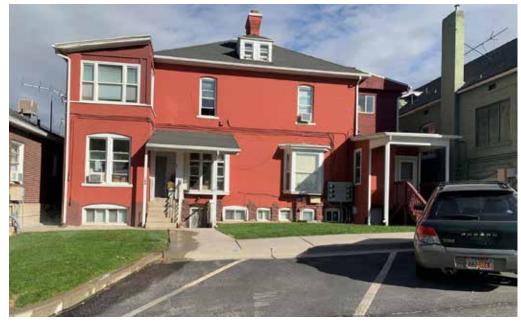
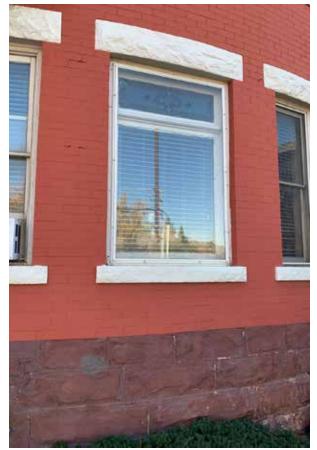
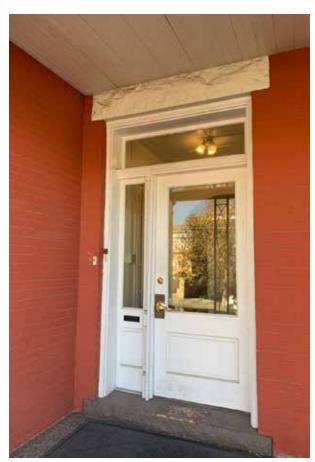
#### 122-124 E. 1st Avenue

The multi-family structure at 122 and 124 E 1st Avenue was built in 1902. The use is residential and is two-story with a basement. The stoop and entry of the painted brick and wood frame home is set above the street elevations. The roof is shingle material in hip and gable form with shed and hip dormers.

The proposed minor alteration is to repair deteriorated porch and wood trim features, and to repaint the exterior. The windows and doors will be stripped of paint and refinished in paint. It is expected that the interior will receive some minor modifications to improve the livability of the residential units.

The stone wall and stairs in the front yard along the streetscape will remain in place. Shrubs and groundcovers will be replaced with new material to add texture and color to the front yard landscape. The lawn in front will remain in place.

The REQUEST: Minor Alteration permit for exterior elevation enhancements that include repainting the exterior, reroofing, repairing the stone retaining wall along sidewalk, and upgrading the front yard landscape.

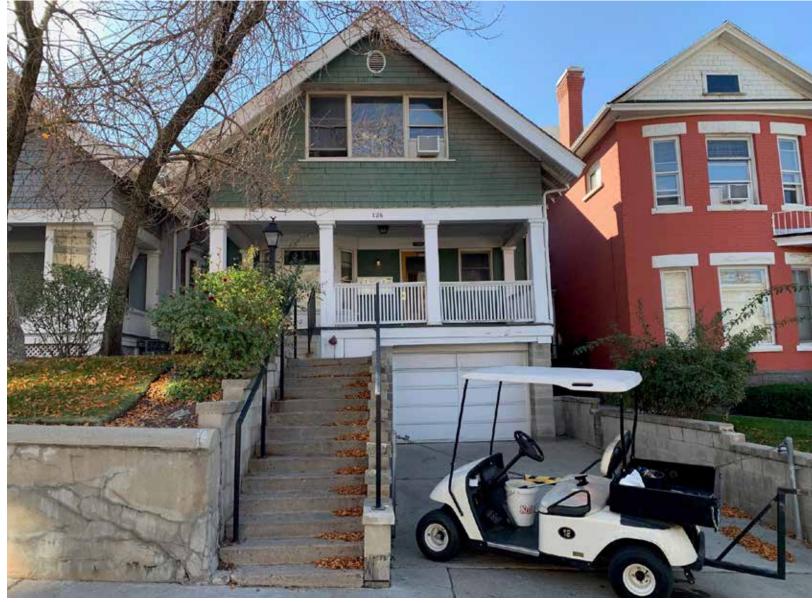
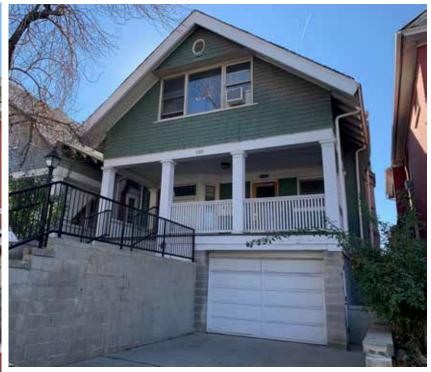
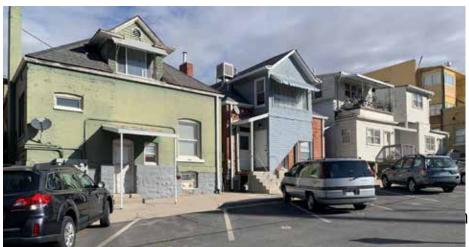
The proposed minor alteration is to repair deteriorated porch and wood trim features, and to repaint the exterior. The windows and doors will be stripped of paint and refinished in paint. It is expected that the interior will receive some minor modifications to improve the livability of the residential units.

The cast-in-place concrete wall and stairs in the front yard along the streetscape will remain in place and be repaired without changing the character. Shrubs and groundcovers will be replaced with new material to add texture and color to the front yard landscape. The lawn and trees in the shared yard with 128 will remain in place.

The REQUEST: Minor Alteration permit for exterior elevation enhancements that include repainting the exterior, reroofing, repairing the retaining walls along sidewalk and driveway, and upgrading the front yard landscape.

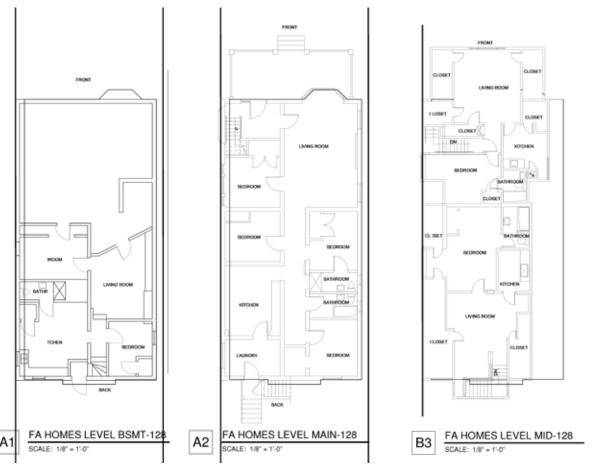
1st Avenue Residential Request - 128 E 1st Avenue

The proposed minor alteration is to repair deteriorated porch and wood trim features, and to repaint the exterior. The windows and doors will be stripped of paint and refinished in paint. It is expected that the interior will receive some minor modifications to improve the livability of the residential units.

The cast-in-place concrete wall and stairs in the front yard along the streetscape will remain in place and be repaired without changing the character. Shrubs and groundcovers will be replaced with new material to add texture and color to the front yard landscape. The lawn and trees in the shared yard with 126 will remain in place.

The REQUEST: Minor Alteration permit for exterior elevation enhancements that include repainting the exterior, reroofing, removal of stair addition on porch, repairing the stone retaining wall along sidewalk, and upgrading the front yard landscape.

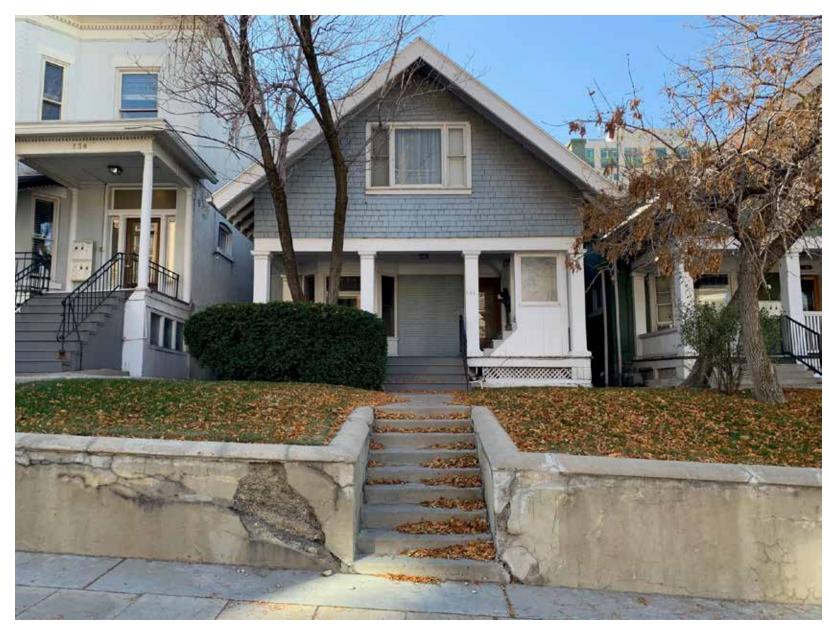
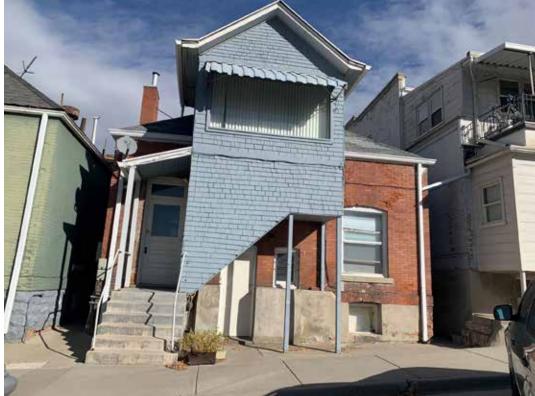
1st Avenue Residential Existing Conditions - 128 E 1st Avenue

The multi-family structure at 128 E 1st Avenue was built in 1908. The use is residential and is one and a half-story with a basement. The front porch and entry of the wood shingle and brick home is set above the street elevations. The roof is shingle material in gable form with gable dormers.

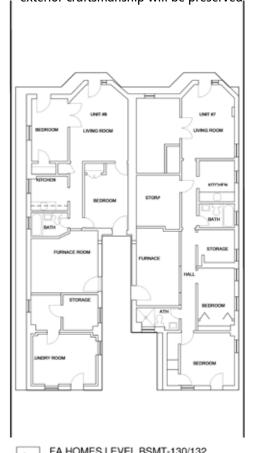
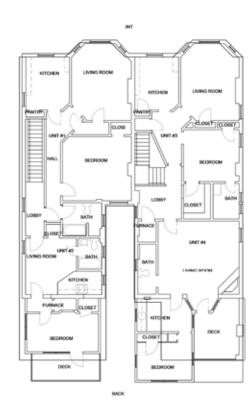
FA HOMES LEVEL MID-130/132 SCALE: 1/8" = 1'-0"

The multi-family structure at 130-132 E 1st Avenue was built in 1902. The use is residential and is two-story with a basement. The facade and exterior walls are made of brick. two bay windows are psecial features on the front elevation. The two front porches and entries of the brick home is set above the street elevations. The roof is flat with parapet wall extending above a dentil detailed beltline.

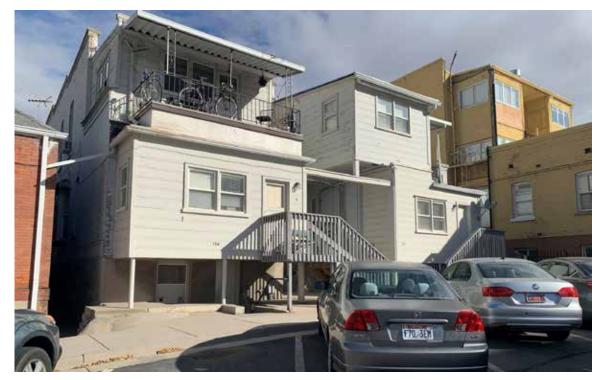
1st Avenue Residential Existing Conditions - 130/132 E 1st Avenue

The REQUEST: Minor Alteration permit for exterior elevation enhancements that include repainting the exterior, repair the flat roof, repairing the stone retaining wall along sidewalk, and upgrading the front yard landscape.

The proposed minor alteration is to repair deteriorated porch and wood trim features, and to repaint the exterior. The windows and doors will be stripped of paint and refinished in paint. It is expected that the interior will receive some minor modifications to improve the livability of the residential units.

The stone wall and stairs in the front yard along the streetscape will remain in place and be repaired without changing the character. Shrubs and groundcovers will be replaced with new material to add texture and color to the front yard landscape. Existing rose bushes will remain in place. The lawn in the front yard will remain in place.

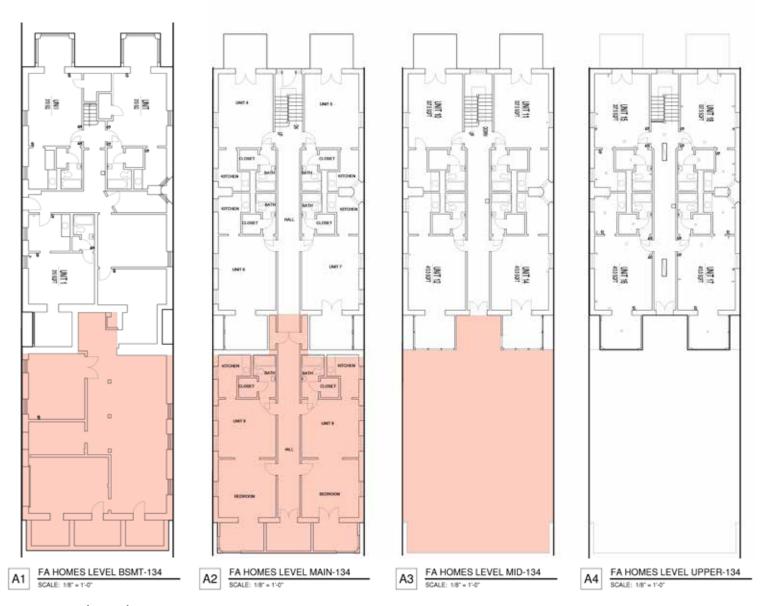
The south addition will be removed to expose the original construction on the south elevation. The south addition is not readily visible from a public way or open space. Where it is visible from the open space to the east, it is considered a negative visual impact due the scale and poor fit into the block.

The cast-in-place concrete wall and stairs in the front yard along the streetscape will remain in place and be repaired without changing the character. Shrubs and groundcovers will be replaced with new material to add texture and color to the front yard landscape. The lawn in the front yard will remain in place.

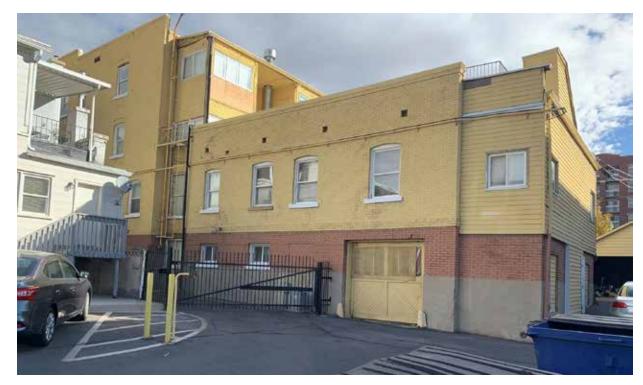
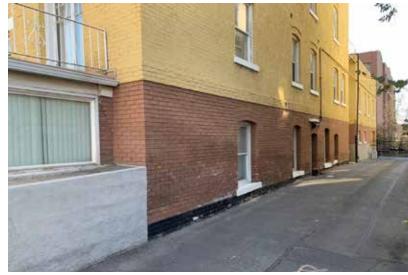
1st Avenue Residential Existing Conditions - 134 E 1st Avenue

The multi-family structure at 134 E 1st Avenue was built in 1909. The two-story addition on the south end of the original building was built after original construction and before 1937. The use is residential and is three-story with a basement. The facade and exterior walls are made of brick. The front elevation is symetrical with a arched feature window on the third floor stairwell. The roof is flat with parapet wall extending above a wood detailed cornice.

The 4-story residential building at 134 E 1st Avenue was built in 1909 at a time when the Avenues District was emerging as a desirable living environment for early professions, civic leaders, and working class residents. Somewhere between 1911 and 1937, a 2-story addition was added onto the south elevation of the original structure. The addition was built with brick and wood siding on the exterior, similar to the original structure.

The proposed minor alteration is to repair deteriorated wood trim features, and to repaint the exterior. The windows and doors will be stripped of paint and refinished in paint. It is expected that the interior will receive some major to minor modifications to bring the structure within code conformance and to improve the livability of the residential units.

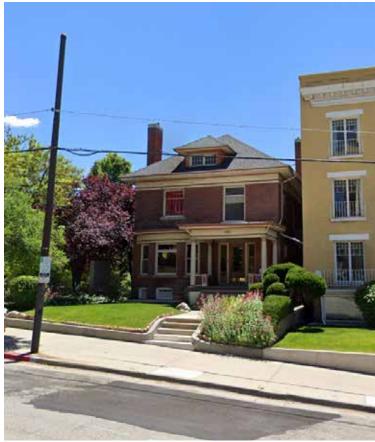
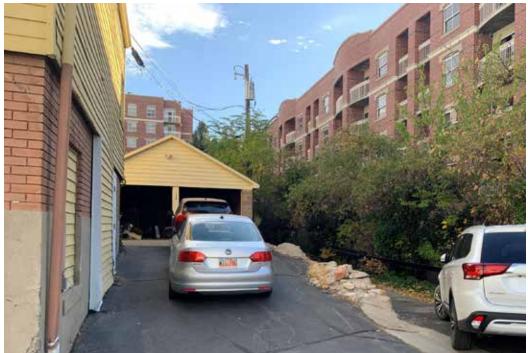
1st Avenue Residential Existing Conditions - 136 E 1st Avenue

The multi-family structure at 136 E 1st Avenue was built in 1905. The one-story garage on the south portion of the lot was built along with the original construction in 1905. The use is residential and is two-story with a basement. The facade and exterior walls are made of brick. The front elevation is assymetrical with a bay window off the first floor living space. The roof is shingle material in hip roof form above a wood detailed cornice.

Around 1905, a detached private garage was built for the private residence at 136 E 1st Avenue. The structure is designated as a "Non-contributing" building based on the NRHP survey.

The condition of the structure is fair to poor. The request is to remove the garage structure to allow for the creation of additional surface parking, and an pedestrian access connection to the Brigham Young Memorial site.

The proposed minor alteration is to repair deteriorated porch and wood trim features, and to repaint the exterior trim. Brick will be cleaned and repointed grout if needed. The windows and doors will be stripped of paint and refinished in paint. It is expected that the interior will receive some minor modifications to improve the livability of the residential units.

The low cast-in-place concrete wall and stairs in the front yard along the streetscape will remain in place and be repaired without changing the character. Shrubs and groundcovers will be replaced with new material to add texture and color to the front yard landscape. The lawn will remain in place.

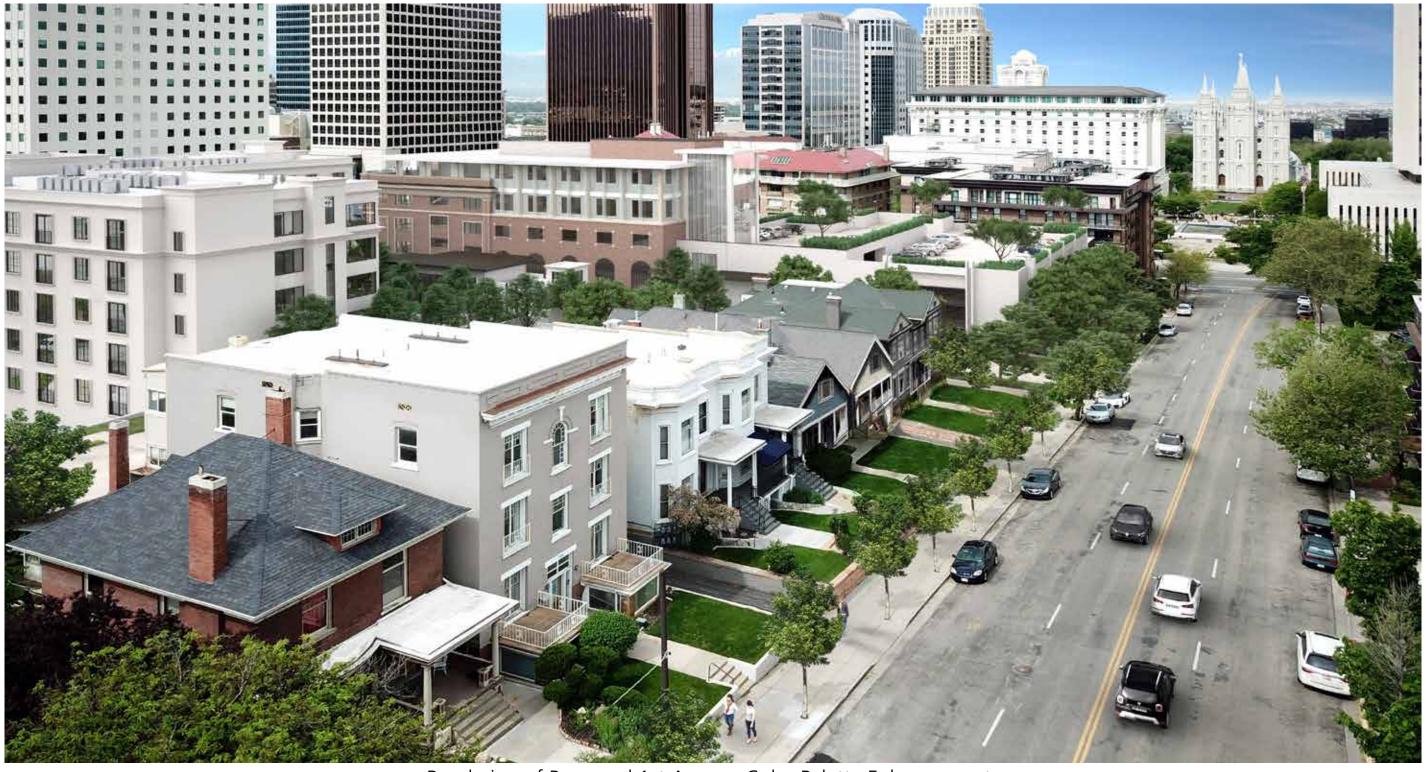
Rendering of Proposed 1st Avenue Color Palette Enhancements

The requests for Minor Alterations is to make improvements to the livable environments and to refresh the exterior presentation to the street. In some cases, repairs will be made to deteriorated features with the proposed detailing to match the existing. New paint color palettes will be applied to each structure.
