Part 4: 1st Avenue Historic Residential

Specific Request #9-14: 1st Avenue Historic Homes Minor Alteration Permits for Contributing Structures

Elks Block Redevelopment

March 4, 2021

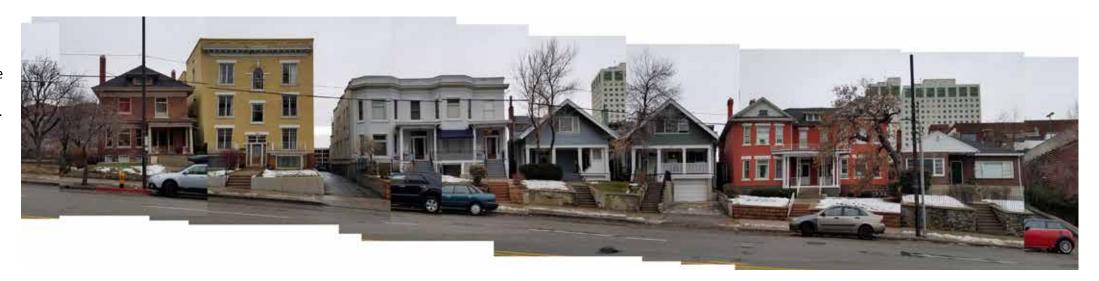
Streetscene View - North Elevation

These homes are a left over remnants of the single family neighborhood that emerged when The Avenues was forming at the turn of the prior century. Over the course of the past 100 years, redevelopment has occurred on all sides of the existing homes leaving them as stand alone vestiges of the prior neighborhood patterns. All of the homes have been converted to multi-family rental units and have been heavily renovated in their interiors and rear elevations. The front elevations retain the character of the original design and construction.

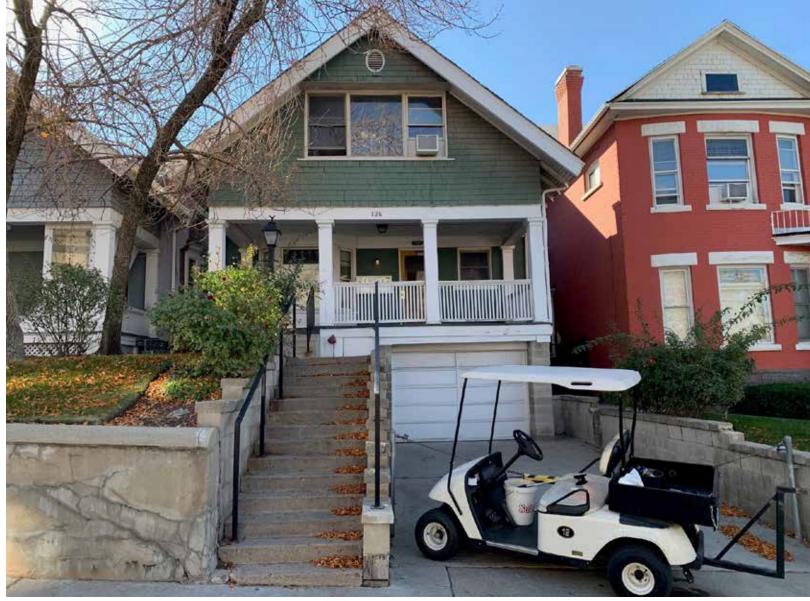
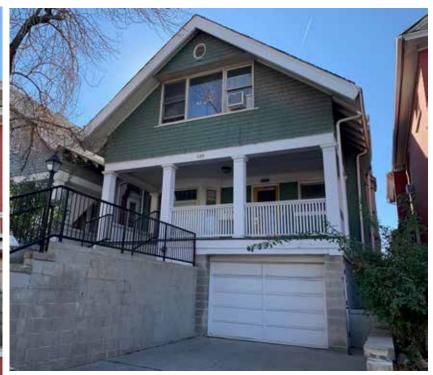
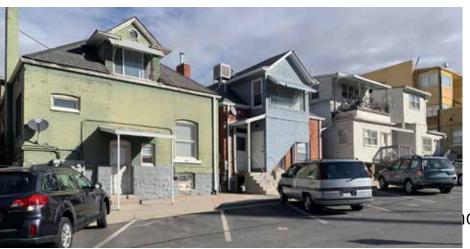
The multi-family structure at 128 E 1st Avenue was built in 1908. The use is residential and is one and a half-story with a basement. The front porch and entry of the wood shingle and brick home is set above the street elevations. The roof is shingle material in gable form with gable dormers.

The proposed minor alteration is to repair deteriorated porch and wood trim features, and to repaint the exterior. The windows and doors will be stripped of paint and refinished in paint. It is expected that the interior will receive some minor modifications to improve the livability of the residential units.

The cast-in-place concrete wall and stairs in the front yard along the streetscape will remain in place and be repaired without changing the character. Shrubs and groundcovers will be replaced with new material to add texture and color to the front yard landscape. The lawn and trees in the shared yard with 126 will remain in place.

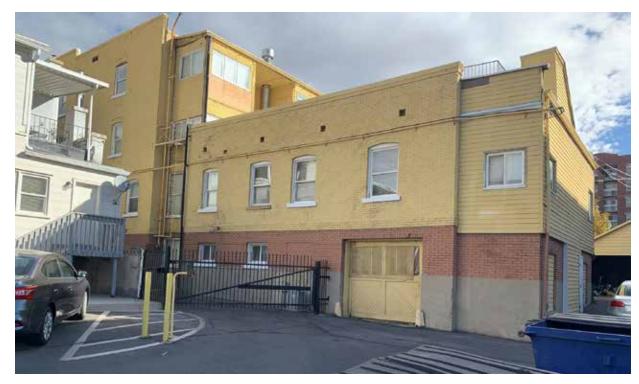
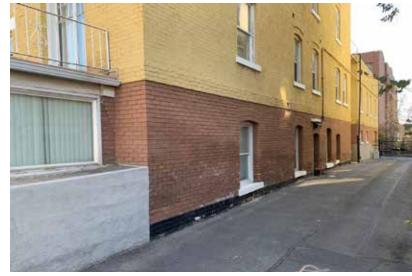
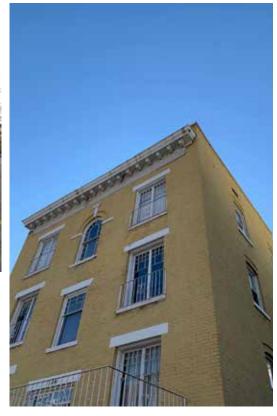
1st Avenue Residential Existing Conditions - 134 E 1st Avenue

The multi-family structure at 134 E 1st Avenue was built in 1909. The two-story addition on the south end of the original building was built after original construction and before 1937. The use is residential and is three-story with a basement. The facade and exterior walls are made of brick. The front elevation is symetrical with a arched feature window on the third floor stairwell. The roof is flat with parapet wall extending above a wood detailed cornice.

The south addition will be removed to expose the original construction on the south elevation. The south addition is not readily visible from a public way or open space. Where it is visible from the open space to the east, it is considered a negative visual impact due the scale and poor fit into the block.

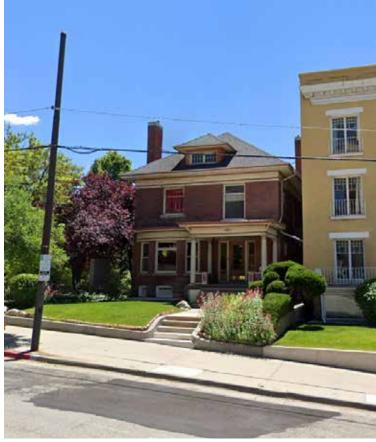
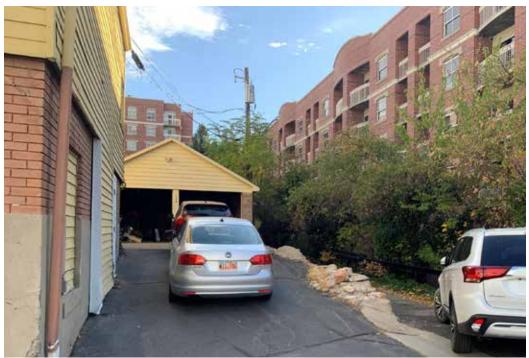
1st Avenue Residential Existing Conditions - 136 E 1st Avenue

The multi-family structure at 136 E 1st Avenue was built in 1905. The one-story garage on the south portion of the lot was built along with the original construction in 1905. The use is residential and is two-story with a basement. The facade and exterior walls are made of brick. The front elevation is assymetrical with a bay window off the first floor living space. The roof is shingle material in hip roof form above a wood detailed cornice.

The proposed minor alteration is to repair deteriorated porch and wood trim features, and to repaint the exterior trim. Brick will be cleaned and repointed grout if needed. The windows and doors will be stripped of paint and refinished in paint. It is expected that the interior will receive some minor modifications to improve the livability of the residential units.

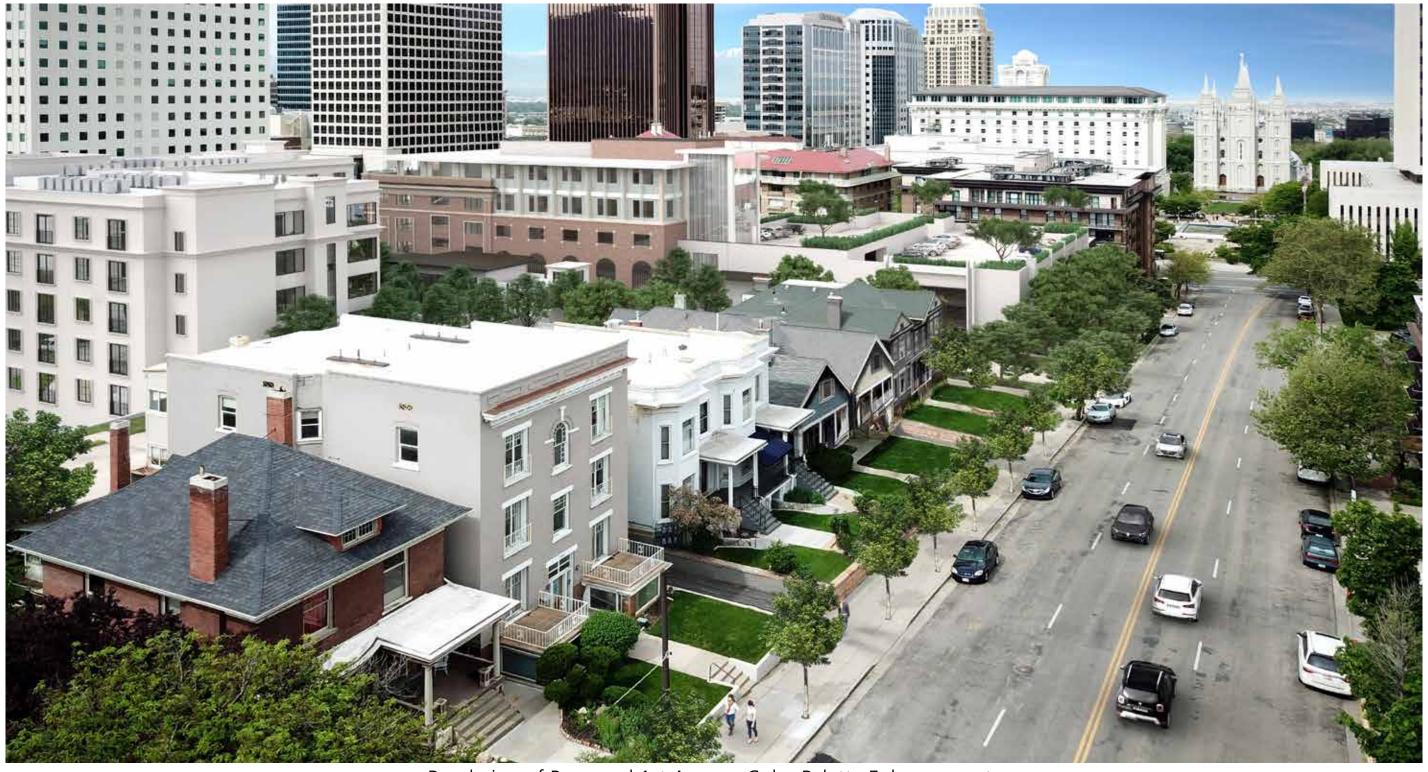
Rendering of Proposed 1st Avenue Color Palette Enhancements

The requests for Minor Alterations is to make improvements to the livable environments and to refresh the exterior presentation to the street. In some cases, repairs will be made to deteriorated features with the proposed detailing to match the existing. New paint color palettes will be applied to each structure.
