Red Butte Creek Oli Kelease Air Monitoring Journal									
Date	Location (Time)	Analyte	Method	Result	GPS Location	Comment			
8/12/10	Miller Park, along Red Butte Creek (1350-1405)	Volatile Organic Compounds (VOCs)	PID	0.0 ppm^1	40°44'46.37"N, 111°50'48.60"W~20 yards from outlet from Miller Park, 10 ft above creek

Red Butte Creek Oil Release Air Monitoring Journal

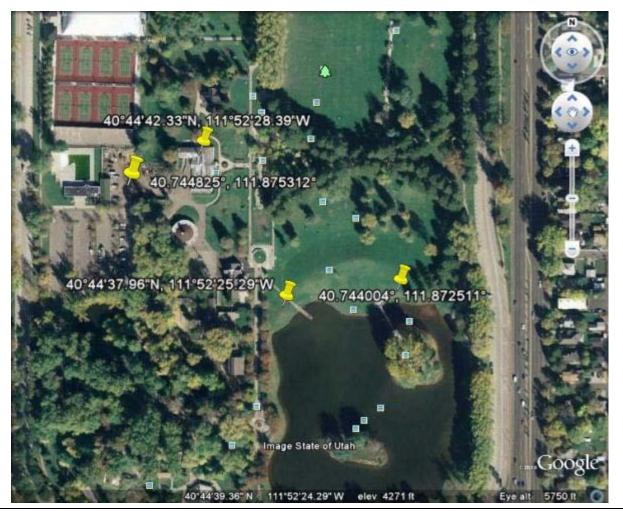
Liberty Park Sample Sites

Red Butte Creek Oil Release Air Monitoring Journal									
Date	Location (Time)	Analyte	Method	Result	GPS Location	Comment			
	1100 East Harvard (1340-1345)	Volatile Organic Compounds (VOCs)	Photo Ionization Detector (PID)	0.0 ppm^1		Sample taken at culvert opening.			
		Volatile Organic Compounds (VOCs)	Photo Ionization Detector (PID)	0.0 ppm^1		North of Harvard where Red Butte Creek goes underneath 1100 East. No odors detected by technician. Water level was Moderate. No crews were working in area.			
		Hydrogen Sulfide (H ₂ S)	QRAEII	0.0 ppm^2	40°44'42.1"N, 111°51'34.0"W				
		Carbon Monoxide (CO)	QRAEII	0.0 ppm					
		Lower Explosive Limit (LEL)	QRAEII	0.0%					
8/12/10	Liberty Park (1315-1325)	Volatile Organic Compounds (VOCs)	Photo Ionization Detector (PID)	0.0 ppm ¹	In between				
		Hydrogen Sulfide (H ₂ S)	QRAEII	0.0 ppm^2	40°44'37.96"N, 111°52'25.29"W	Sampling along the north side of the lake. No odor was detected by technician. Crews were working around lake.

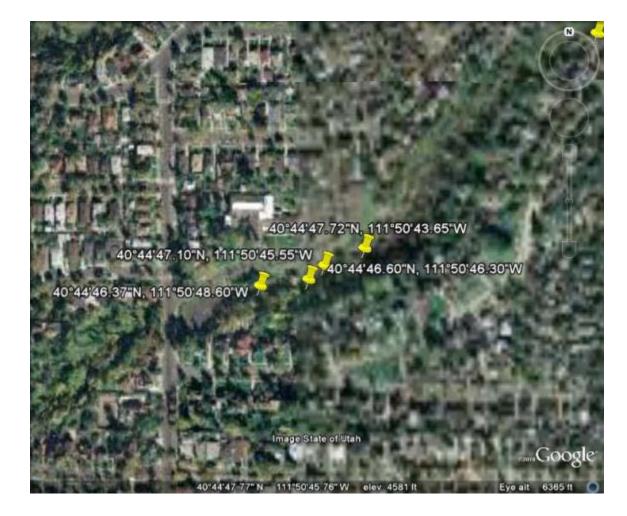
Miller Park Sample Sites

0.0 ppm^1	40°44'46.60"N, 111°50'46.30"W ~50 yards from outlet, on edge of creek				
				0.0 ppm^1	40°44'47.10"N, 111°50'45.55"W	~75 yards from outlet, 2 ft above creek

0.0 ppm^1	40°44'47.72"N, 111°50'43.65"W	At waterfall on bridge, 12 ft above creek			
		Hydrogen Sulfide (H ₂ S)	QRAEII	0.0 ppm ²	No odor detected. Water levels were moderate. No crews working in this area.				
		Carbon Monoxide (CO)	QRAEII	0.0 ppm					
		Lower Explosive Limit (LEL)	QRAEII	0.0%					
	Confluence of Jordan River and Red Butte Creek (1300-1307)	Volatile Organic Compounds (VOCs)	Photo Ionization Detector (PID)	0.0 ppm ¹					
		Hydrogen Sulfide (H ₂ S)	QRAEII	0.0 ppm^2	40°44'29.75"N,	At inlet to Jordan River, 3 ft from water. No odors were detected. Brown/green film is built up around the barriers. No crews working in this area.			
		Carbon Monoxide (CO)	QRAEII	0.0 ppm	111°55'3.68"W				
		Lower Explosive Limit (LEL)	QRAEII	0.0%					
	Garden Park Ward, 1140 East Harvard (1330-1335)	Volatile Organic Compounds (VOCs)	Photo Ionization Detector (PID)	0.0 ppm ¹		At the creek's edge. No crews were working in this area. No odor detected by technician. Water level was moderate.

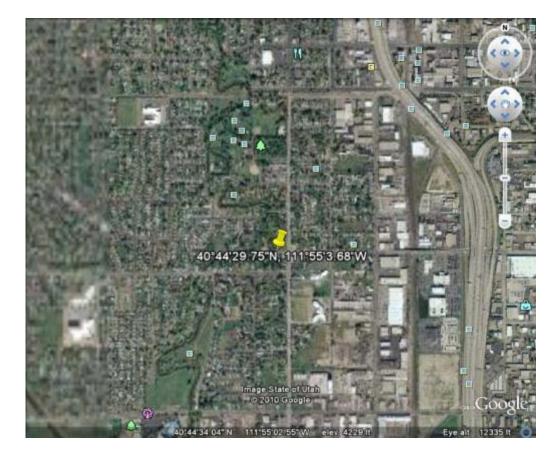
Sample Site at the Jordan River Confluence

Hydrogen Sulfide (H ₂ S)	QRAEII	0.0 ppm ²	40°44'42.01"N,				
		Carbon Monoxide (CO)	QRAEII	0.0 ppm	111°51'29.60"W				
		Lower Explosive Limit (LEL)	QRAEII	0.0%
