HISTORIC LANDMARK COMMISSION STAFF REPORT

1120 E 400 S Major Alterations PLNHLC2014-00884 University Historic District 1120 E 400 South January 15, 2014

This is a request by Andrew Nielson for major alterations to the property located at approximately 1120 E. 400 South, in the University Historic District, and within the R-2 (Single and Two Family Residential) zoning district.

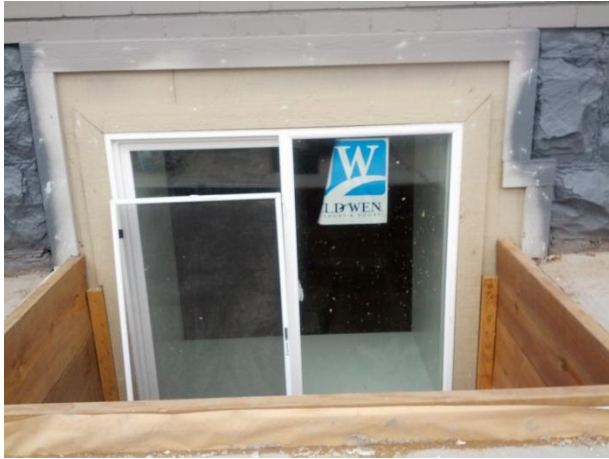
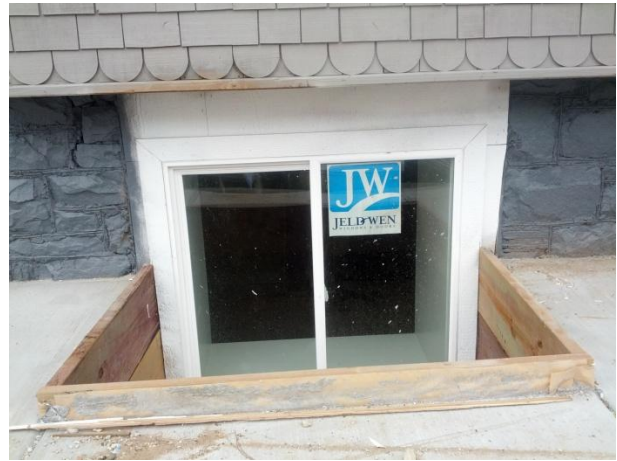
The applicant proposes to make changes to the basement windows that were not installed in accordance with the original COA. The original COA approval was for four new vinyl casement basement windows all measuring 2'6" x 4'0". There were two existing basement windows at the time: one window measured 2'6" by 2'0" and the other measured 3'6" x 3'0". Instead of installing the 4 vinyl casement windows, 3 vinyl sliding basement windows were installed. All the new windows installed measure 4'0" x 4'0". The applicant proposes to keep the same sliding windows instead of the casement windows and proposes to recess these new basement windows by 3.5". The applicant is also proposing to fill in the gaps between the new windows and the sandstone foundation with smooth hardie board trim. The original COA required the applicant to repair the stonework around the windows to match the other existing window. The window wells measure 61" x 39" x 38" (north), 56.75" x 39" x 38" (middle), 61.5" x 39" x 38" (south) and all are made with 2x12s Redwood lined with tar paper.

Sliding vinyl basement windows and redwood window wells that were installed.

The placement of 3 new basement vinyl sliding windows measuring 4'0" x 4'0" changes the character of the property and adversely affects the integrity of the foundation by altering and enlarging openings in the basement foundation which is not necessary to meet egress requirements. Although the new proposal contains 3 basement windows instead of 4, the proposal of 4'0" x 4'0" sliding windows changes the character of the home since the windows on the home are more vertical in nature. The initial COA included the approval for vinyl casement windows measuring 2'6" x 4'0" (which meets egress) to minimize the impact on the original sandstone foundation and maintain the vertical nature of the openings along the west façade of the building as all the historic windows are double hung. The former existing windows measured 2'6" x 2'0" and 3'6" x 3'0". The impact of cutting the original sandstone foundation should have been minimized, which suggested that the width of the openings of the new windows not exceed 2'6". The larger windows do not carry on the vertical character of the home and the larger cuts made in the sandstone adversely affect the original foundation of the home. We would allow new egress windows but they should be installed to preserve the original openings as best as possible and to minimize the damage to the sandstone foundation, in the most sensitive fashion.

The cuts made in the sandstone caused some of the sandstone to crumble around the new openings. A miratex material and scrap wood was used to fill in this space between the foundation and the window openings. This gap filling work completed around the basement windows was not completed in a consistent manner with all three windows and it appears to have been completed in a haphazard manner. Although the applicant proposes to improve what was installed by using hardie board to fill in the gaps between the sandstone and the window openings, it does not resolve the loss of the original sandstone foundation. Any sandstone lost as a result of the new windows should be reinstated to retain the physical integrity of the home.

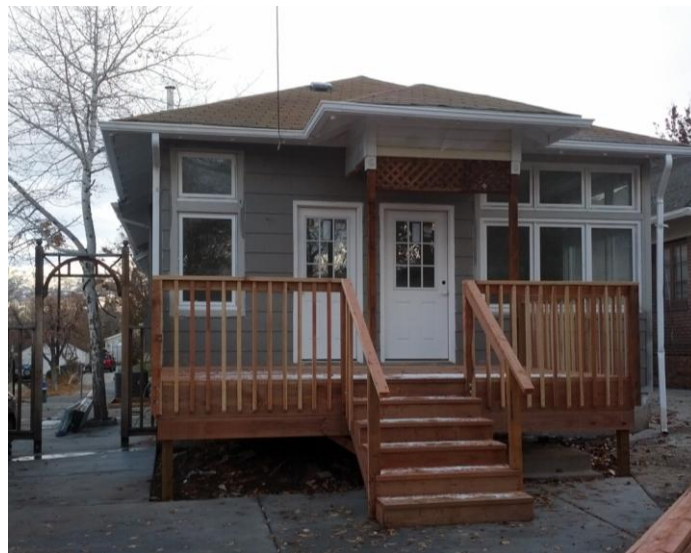
The applicant is asking for approval for changes to the rear addition design that was constructed differently than what was approved in the original Certificate of Appropriateness. The new addition design maintains 8 of the 12 existing windows. Four of the windows were removed and replaced with a new steel door. Also, the French doors originally in the back were removed and replaced with another steel door. The rear of the property contains two steel doors placed directly next to each other. The applicant states that the architect made a mistake in the original drawings and the walls were shifted to the east 6", which moved the wall of the master bedroom (the door to the awning is the door to the master bedroom) to the east and the double doors had to be changed to a single door. The applicant provided a redlined drawing of the shift, but this information should be confirmed with the inspector that this change was necessary. Also, according to the measurements provided by the applicant/contractor, the original proposed door that was to be located at the west corner of the rear addition would have been above grade by 32" which would have changed the original design. However, it is unclear as to why a design was chosen to place two doors next to each other. The existing awning above the former double doors remains.

New rear addition design and new deck

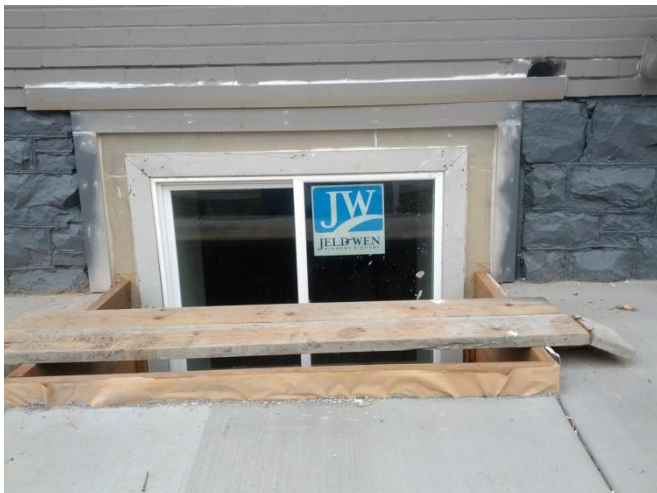
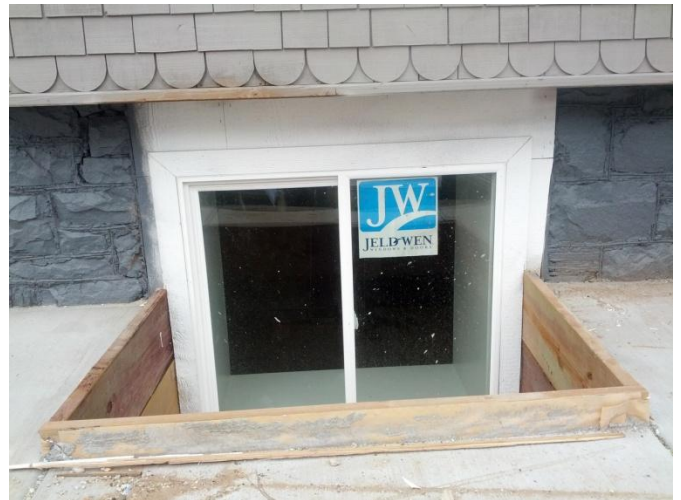
3 New sliding basement windows installed

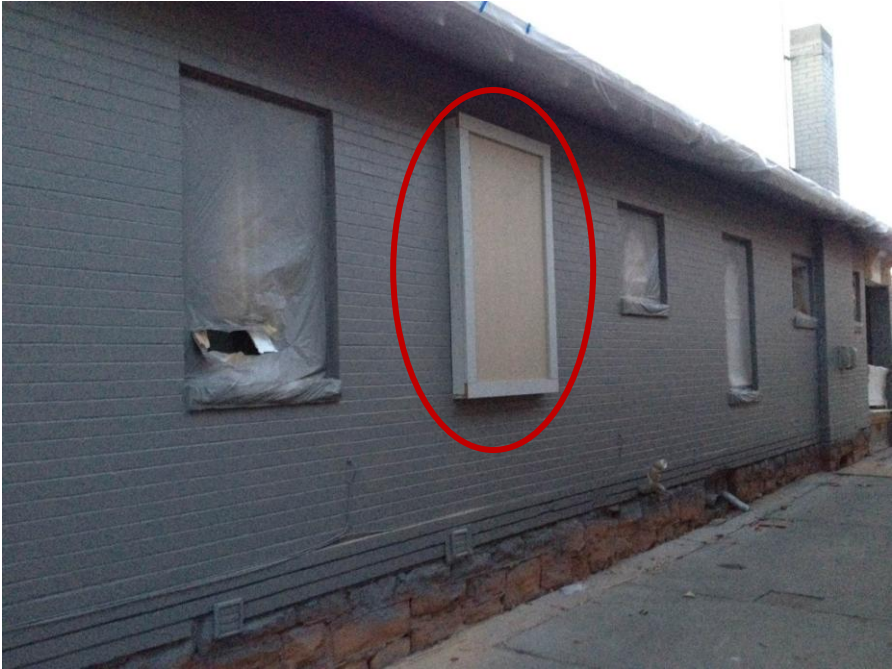
East Elevation

Windows – Covered windows on east and west elevations

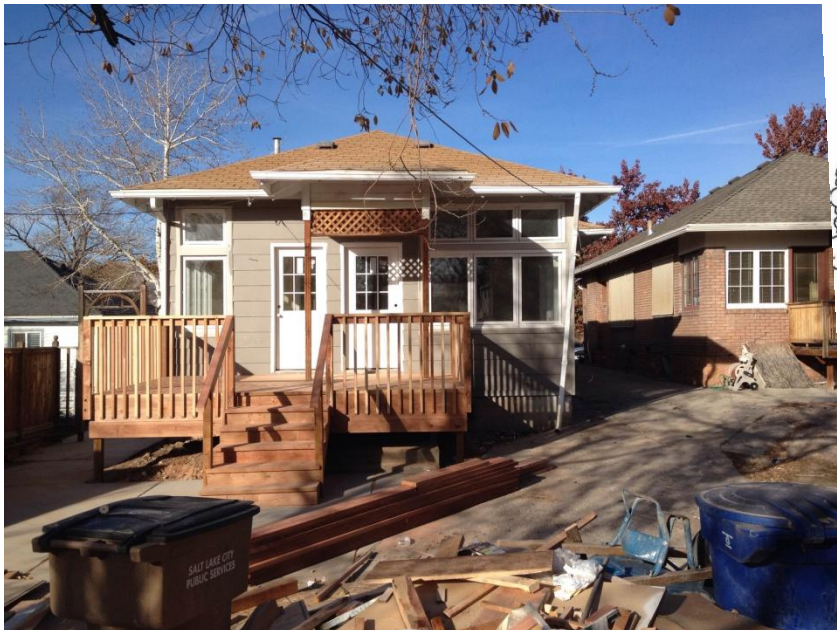
New Rear Addition Alterations and Deck

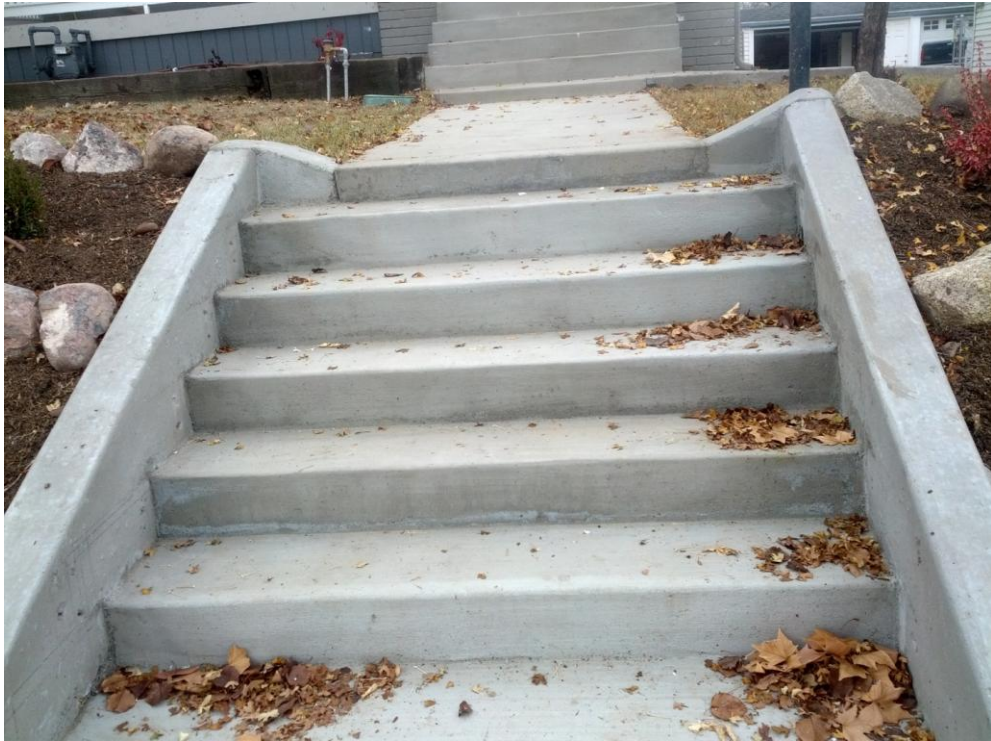
New front step design

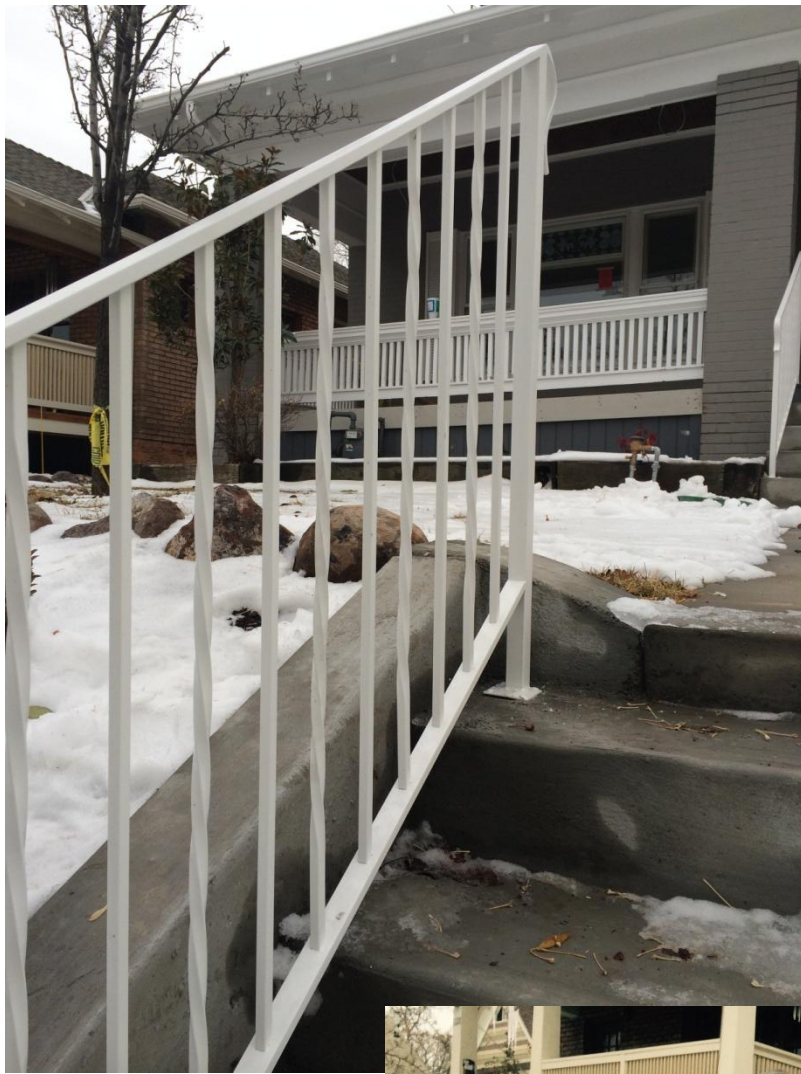
New front painted metal handrails (below)

New painted front metal handrails – front yard handrail does not extend the whole length of stairs

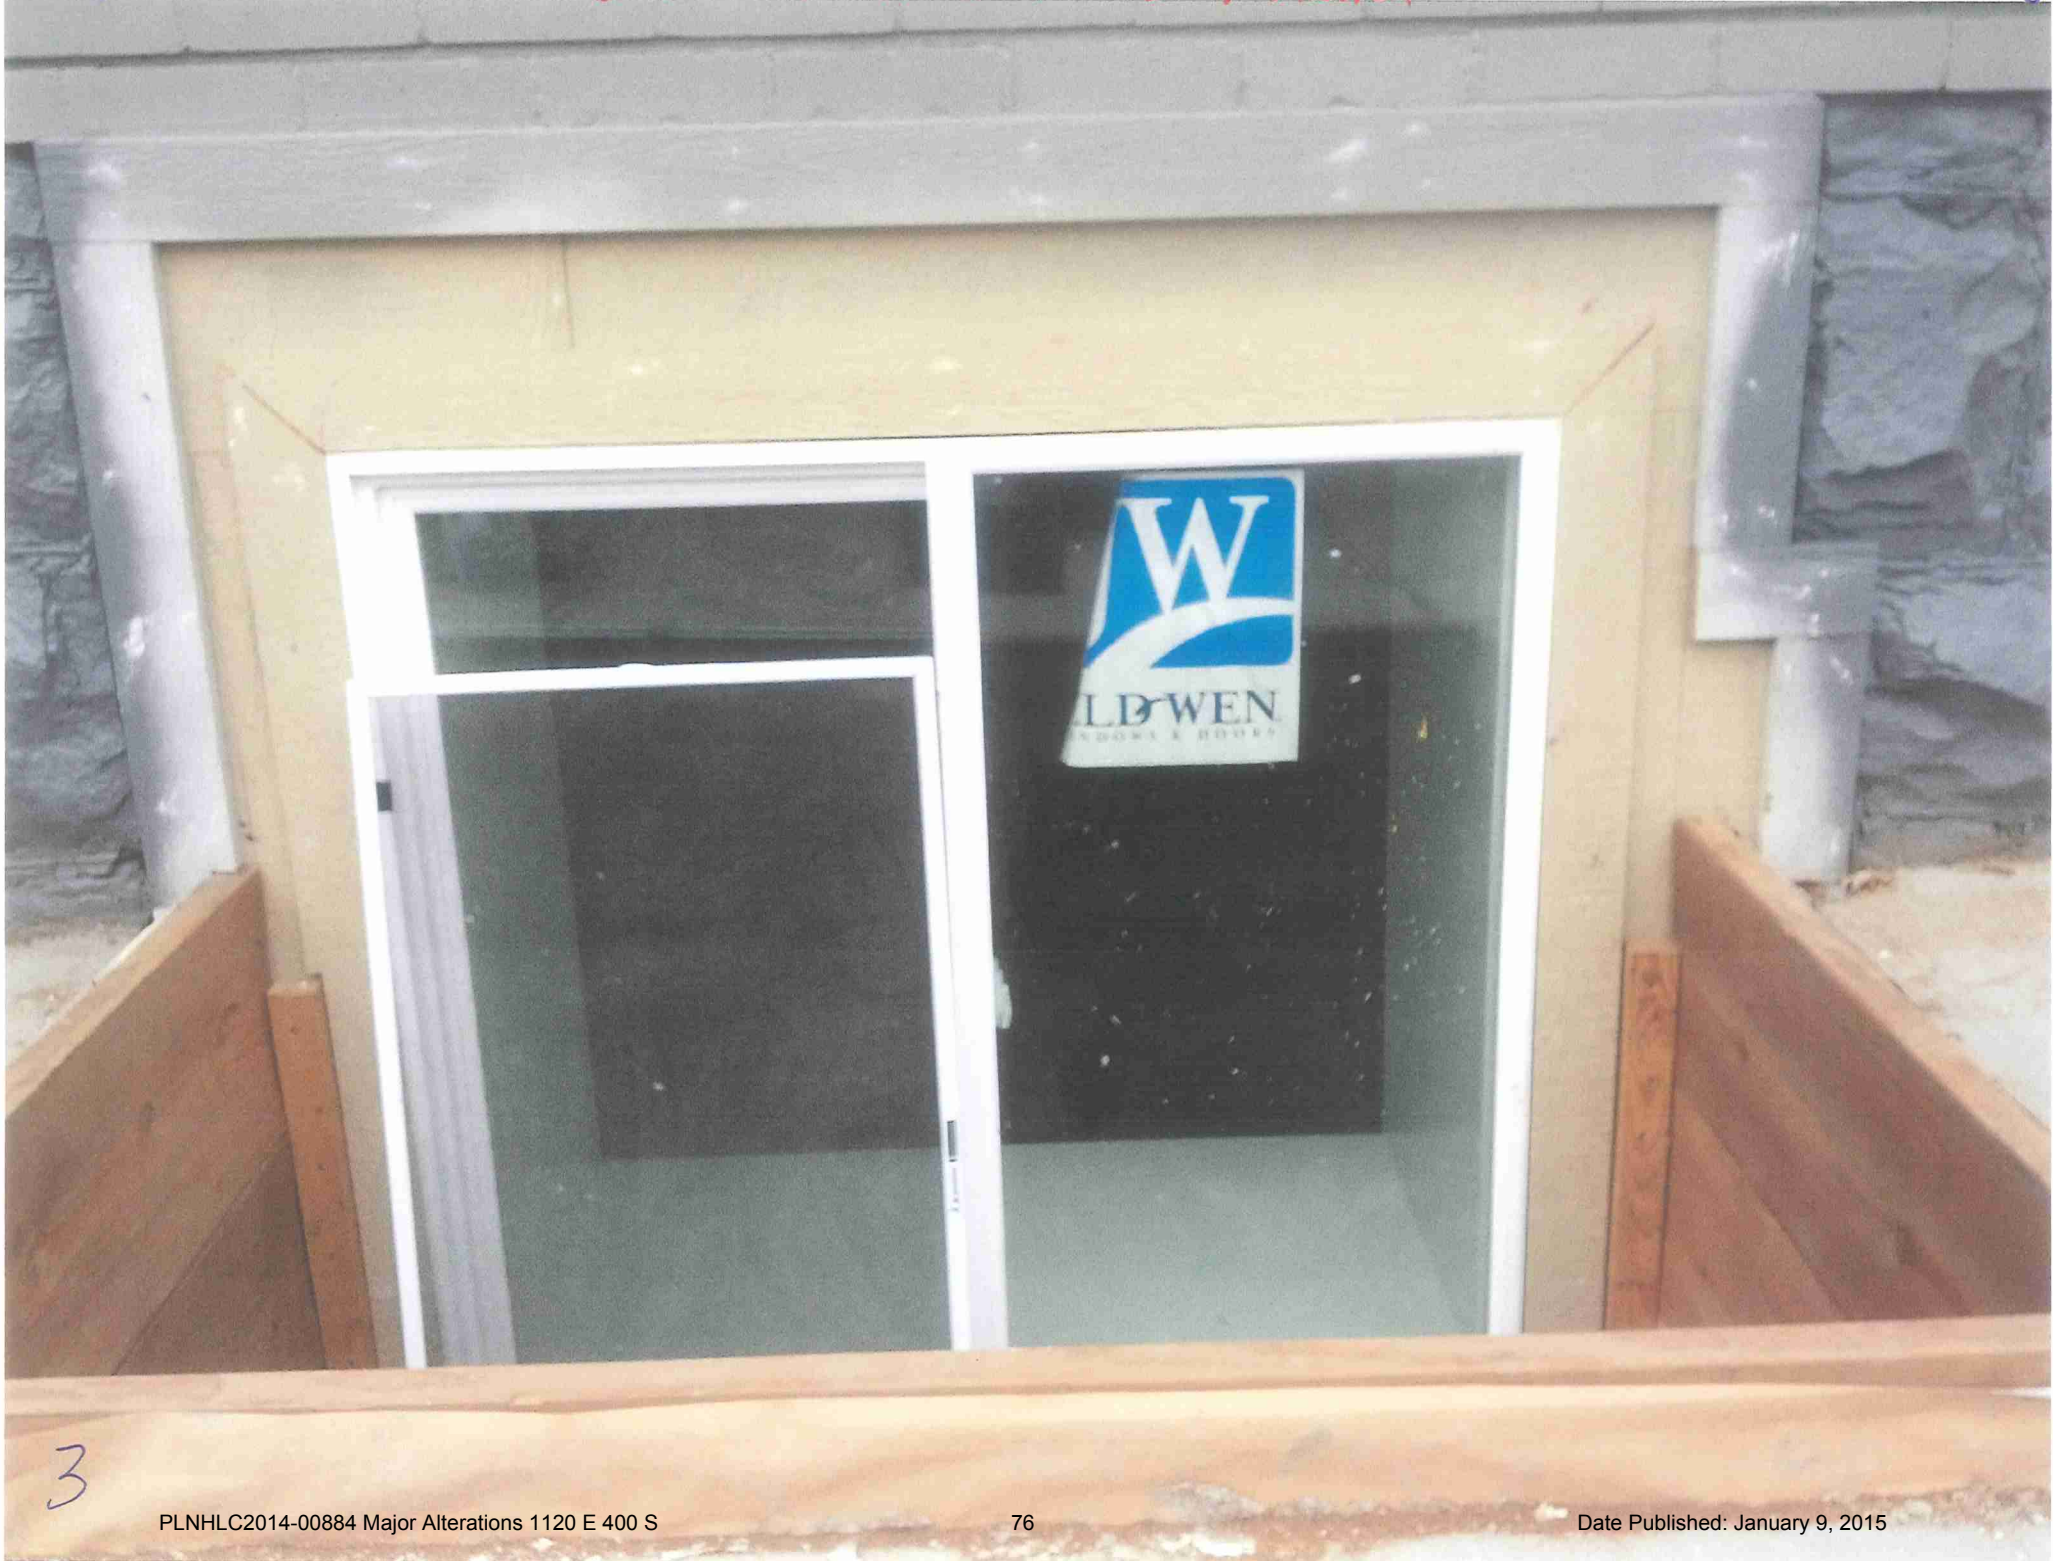
Picture 4

(old) window in basement previously

· Please show a drawing or example of how the area around the windows will be designed with the proposed materials when they are re-done. Show how the windows will be recessed (not flush with the building wall as the egress windows are constructed.) Provide a drawing of the profiles of the basement windows showing how much they will be recessed from the exterior wall. See [Basement Window Crossection Sketch and Picture 4](#)

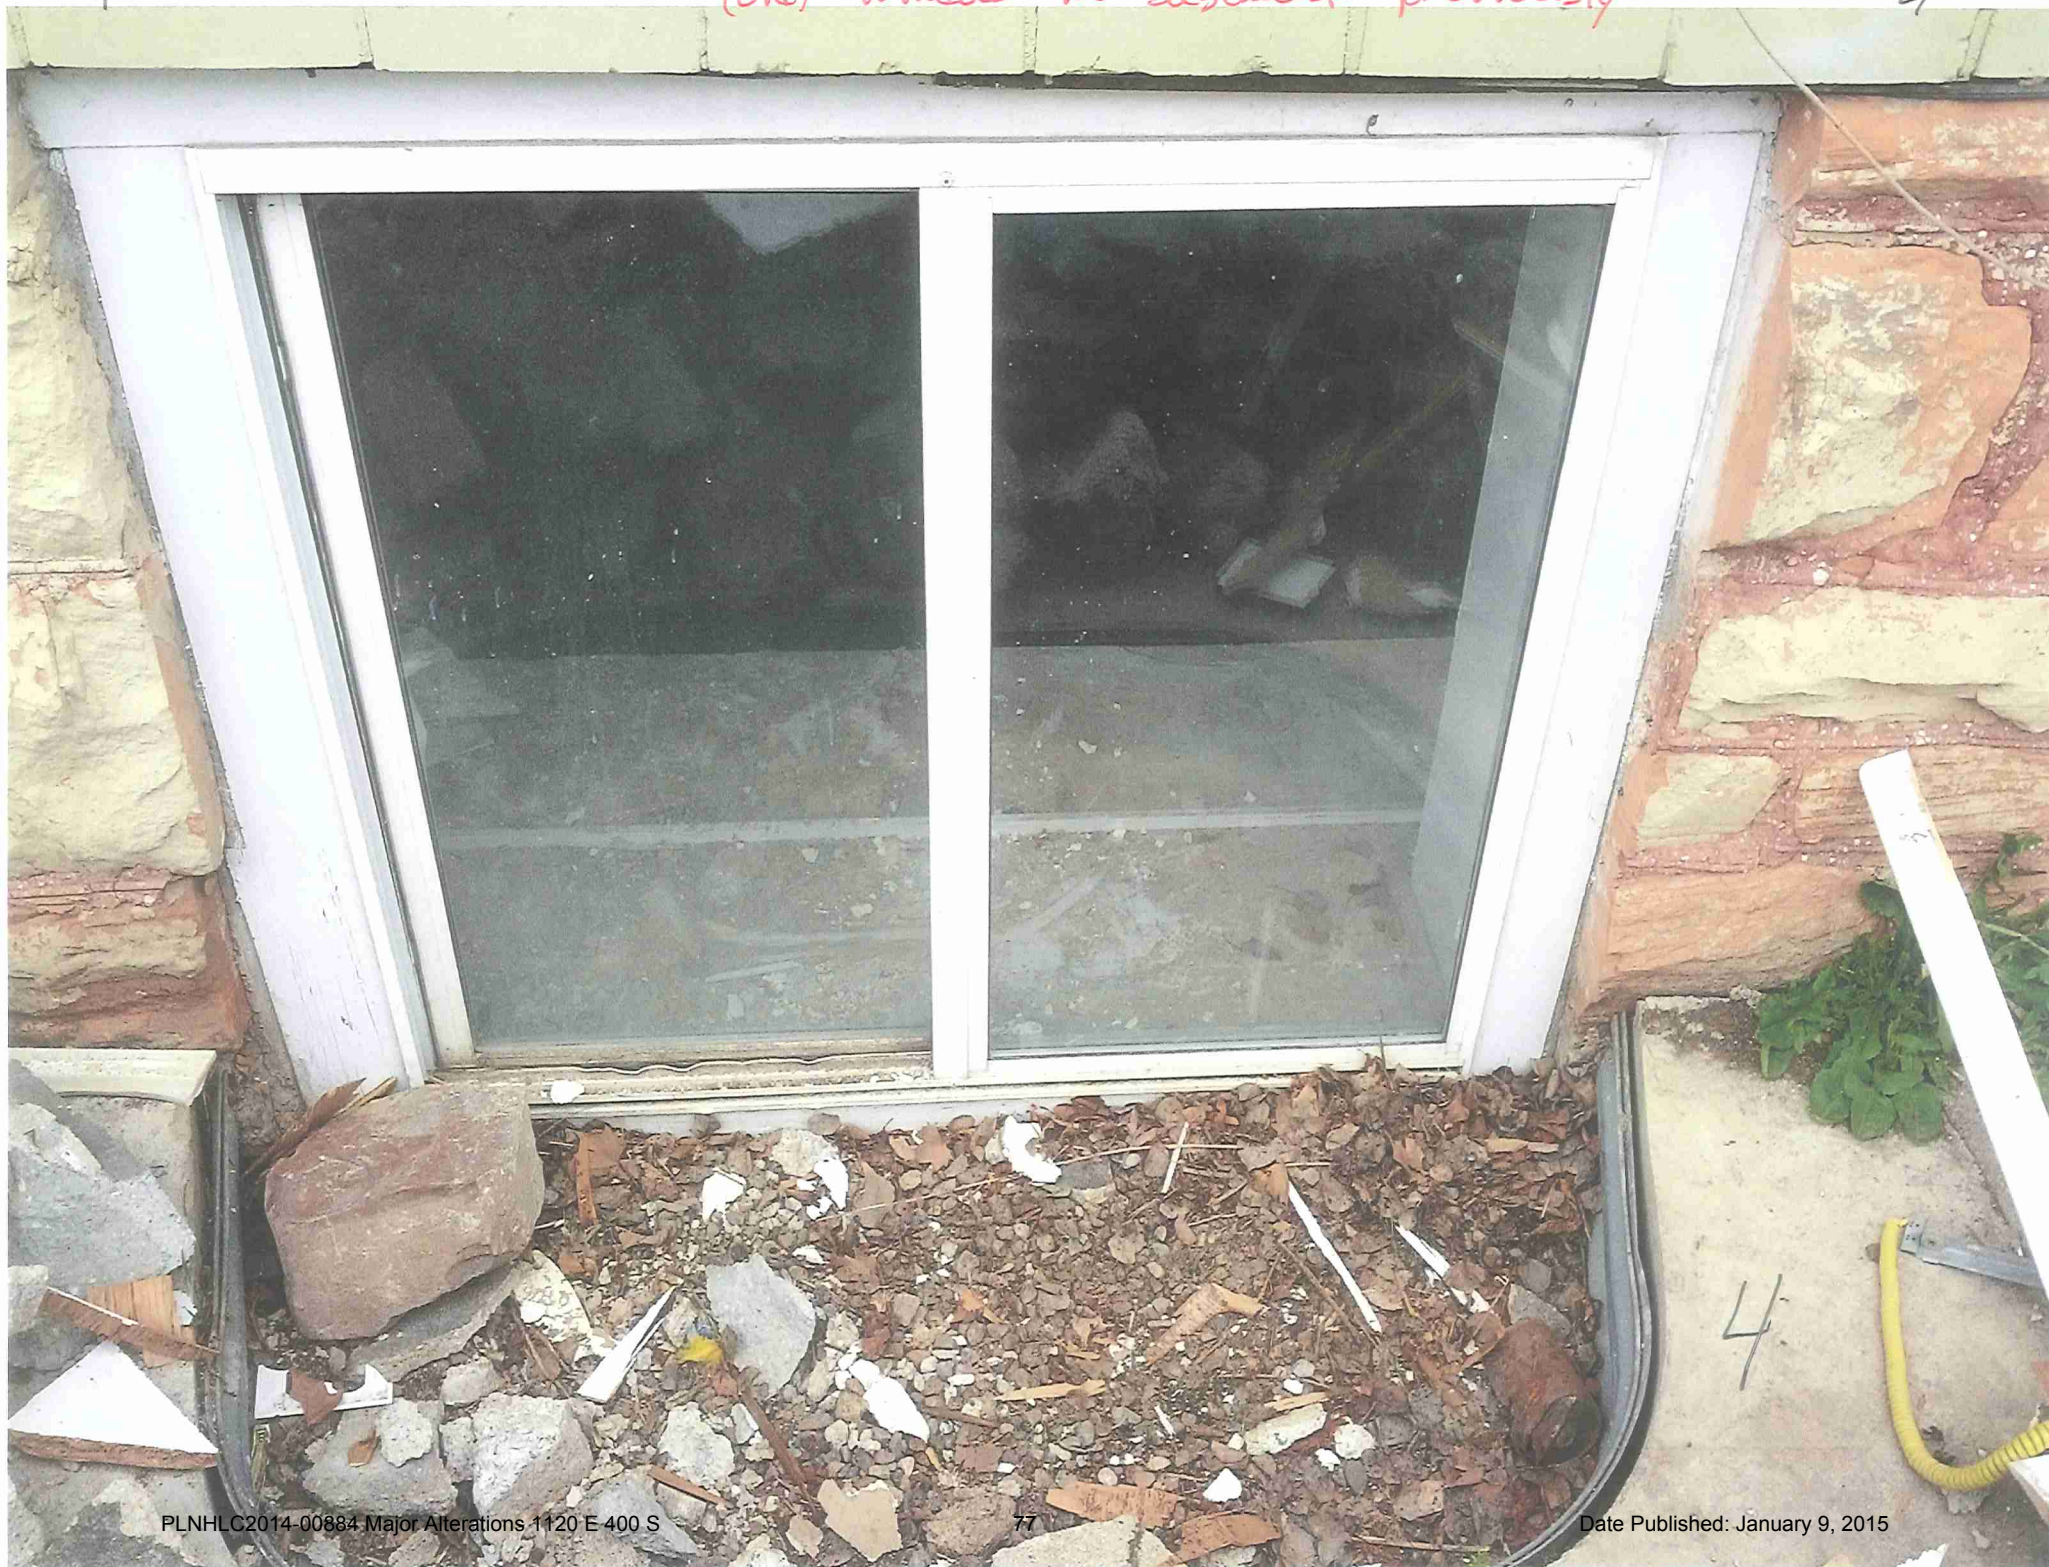
Picture 5

· Identify windows that were covered up, are original windows still there? The window that was covered up is still there (see picture 5). Plans for the windows? The plan is to remove the cover and to refurbish the window remaining inside if necessary and replace the glass if it is broken.

Covering to
be removed

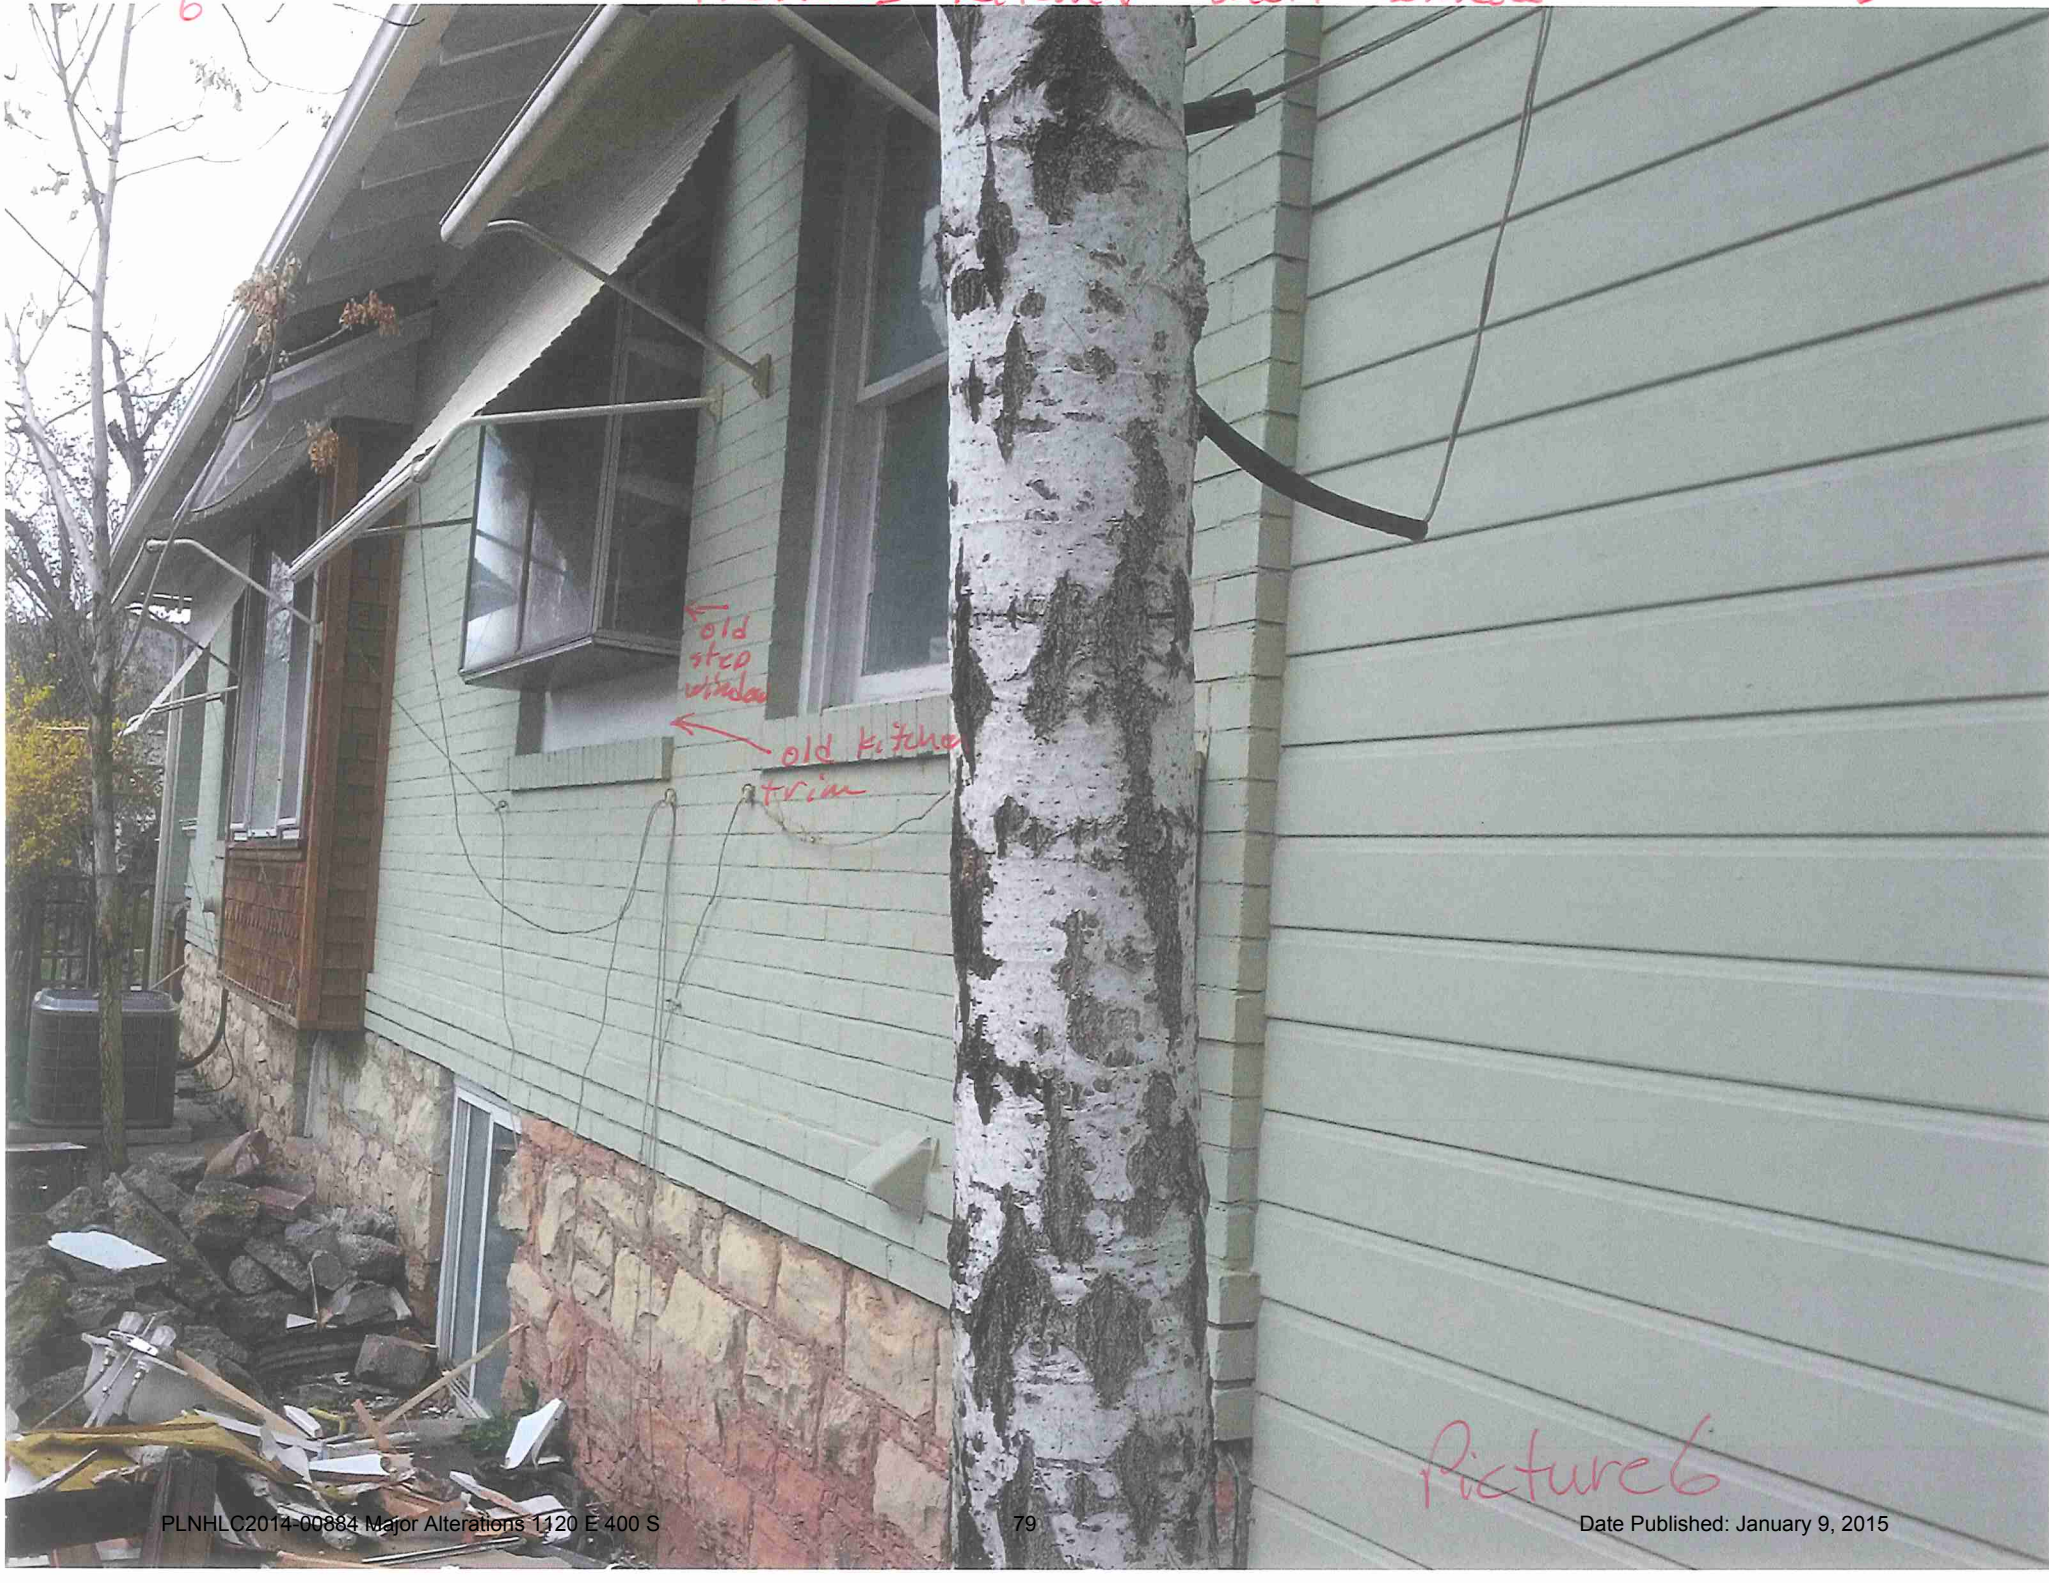
Picture 6

Previous Kitchen shelf window

← old kitchen trim

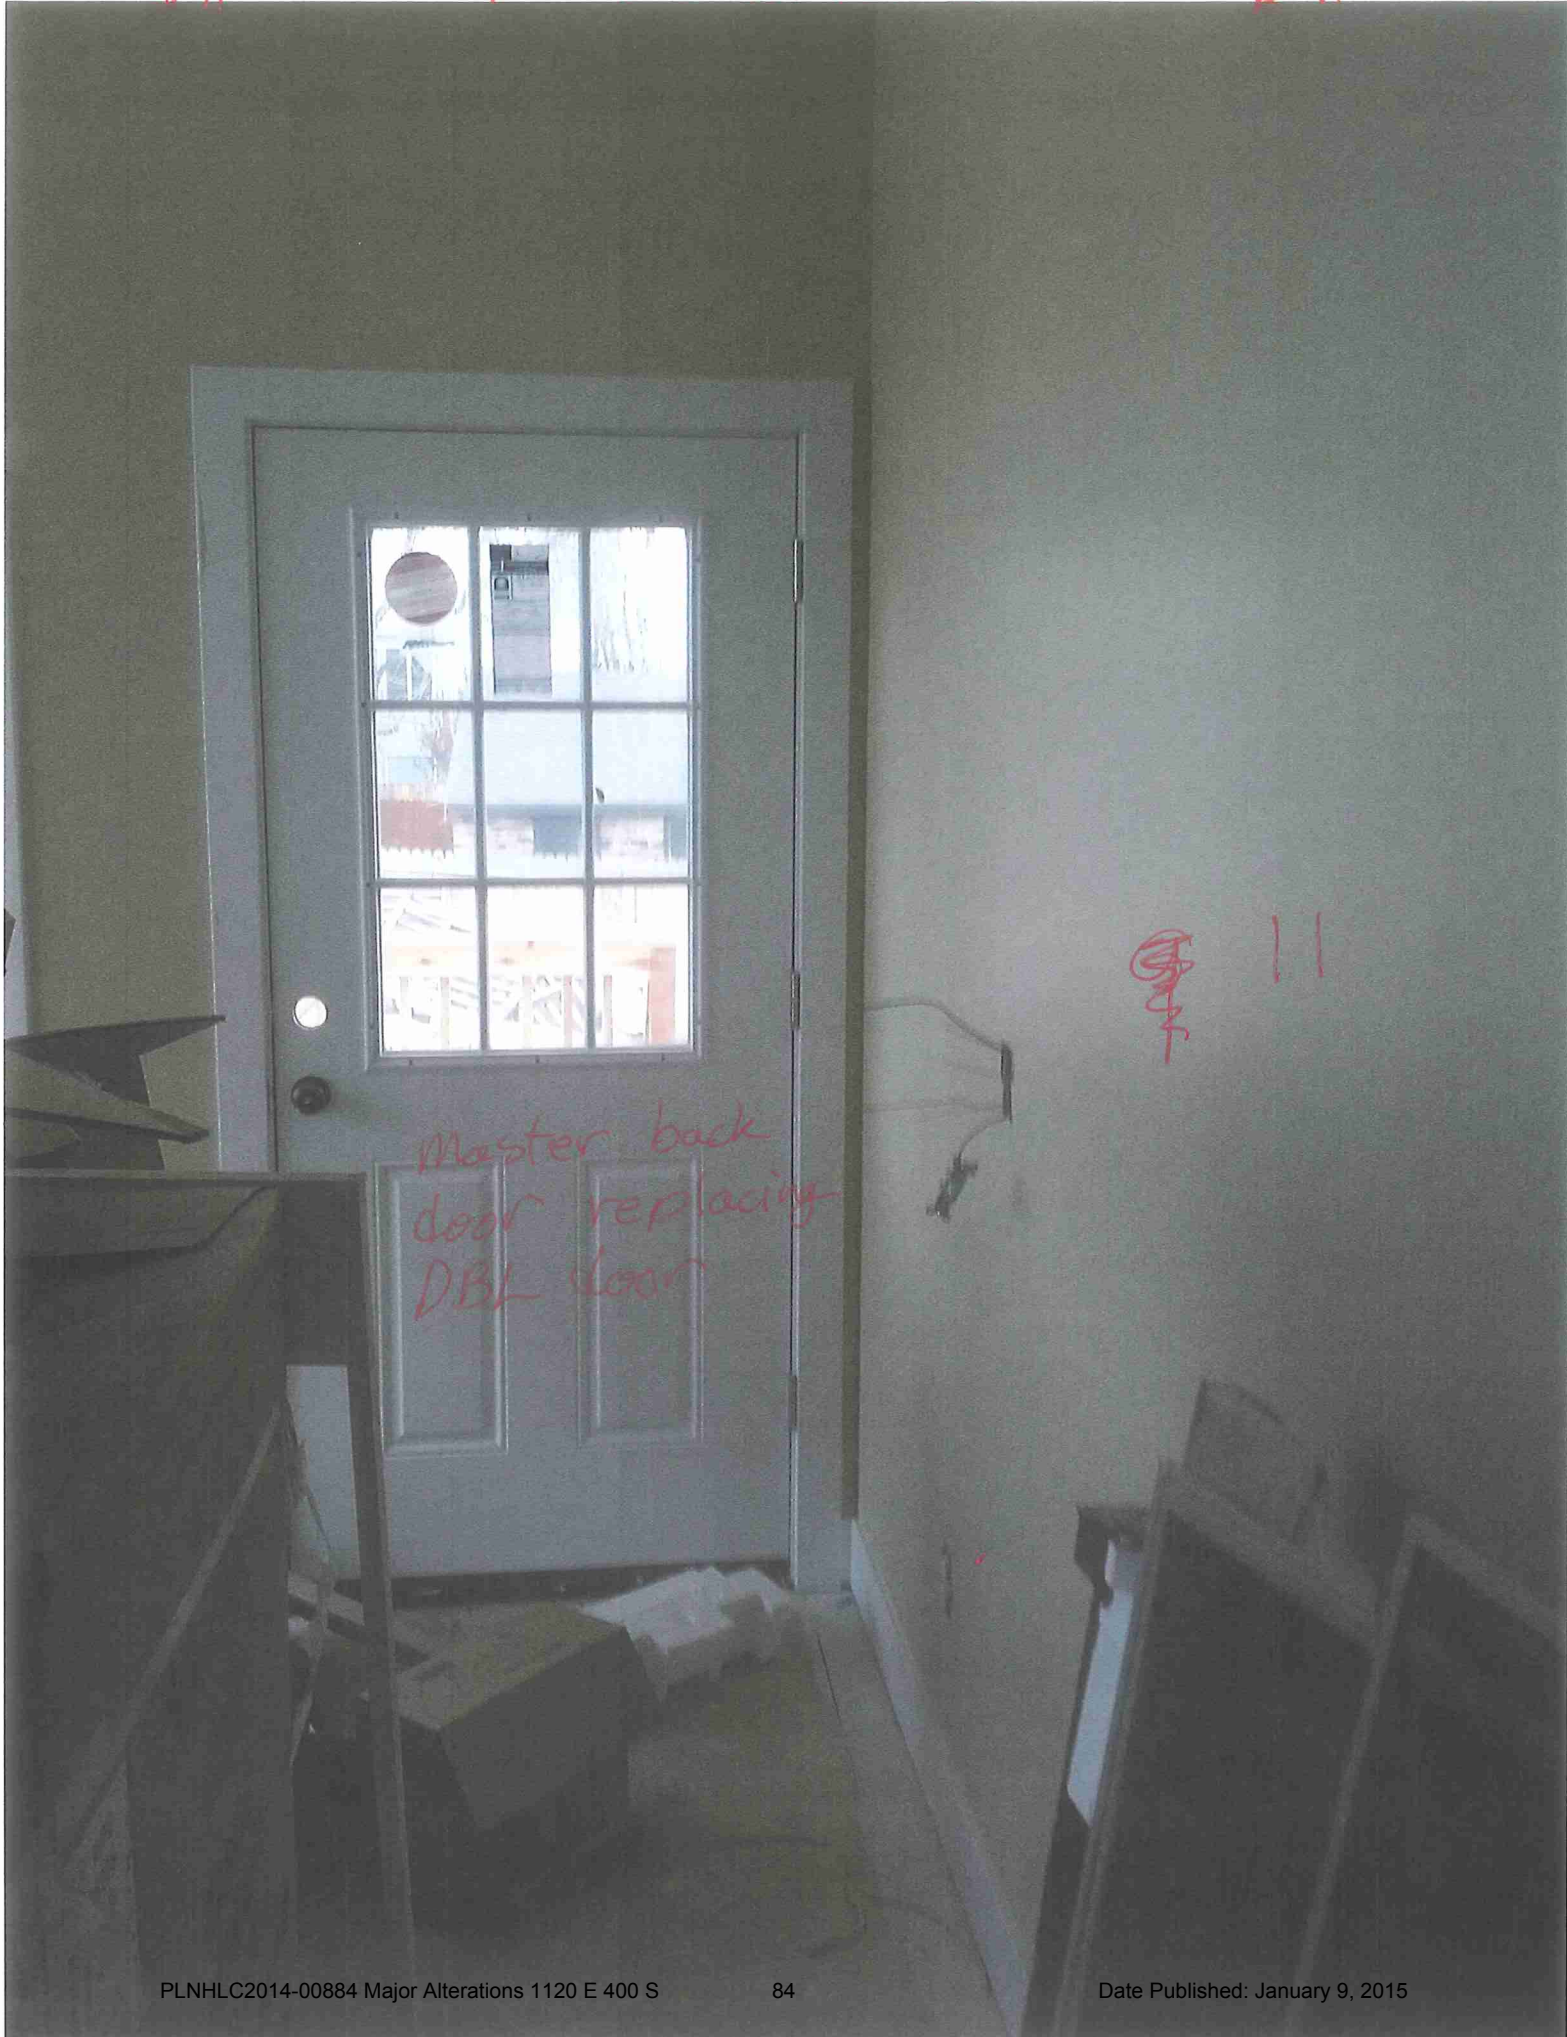
Master back
door replacing
DBL door

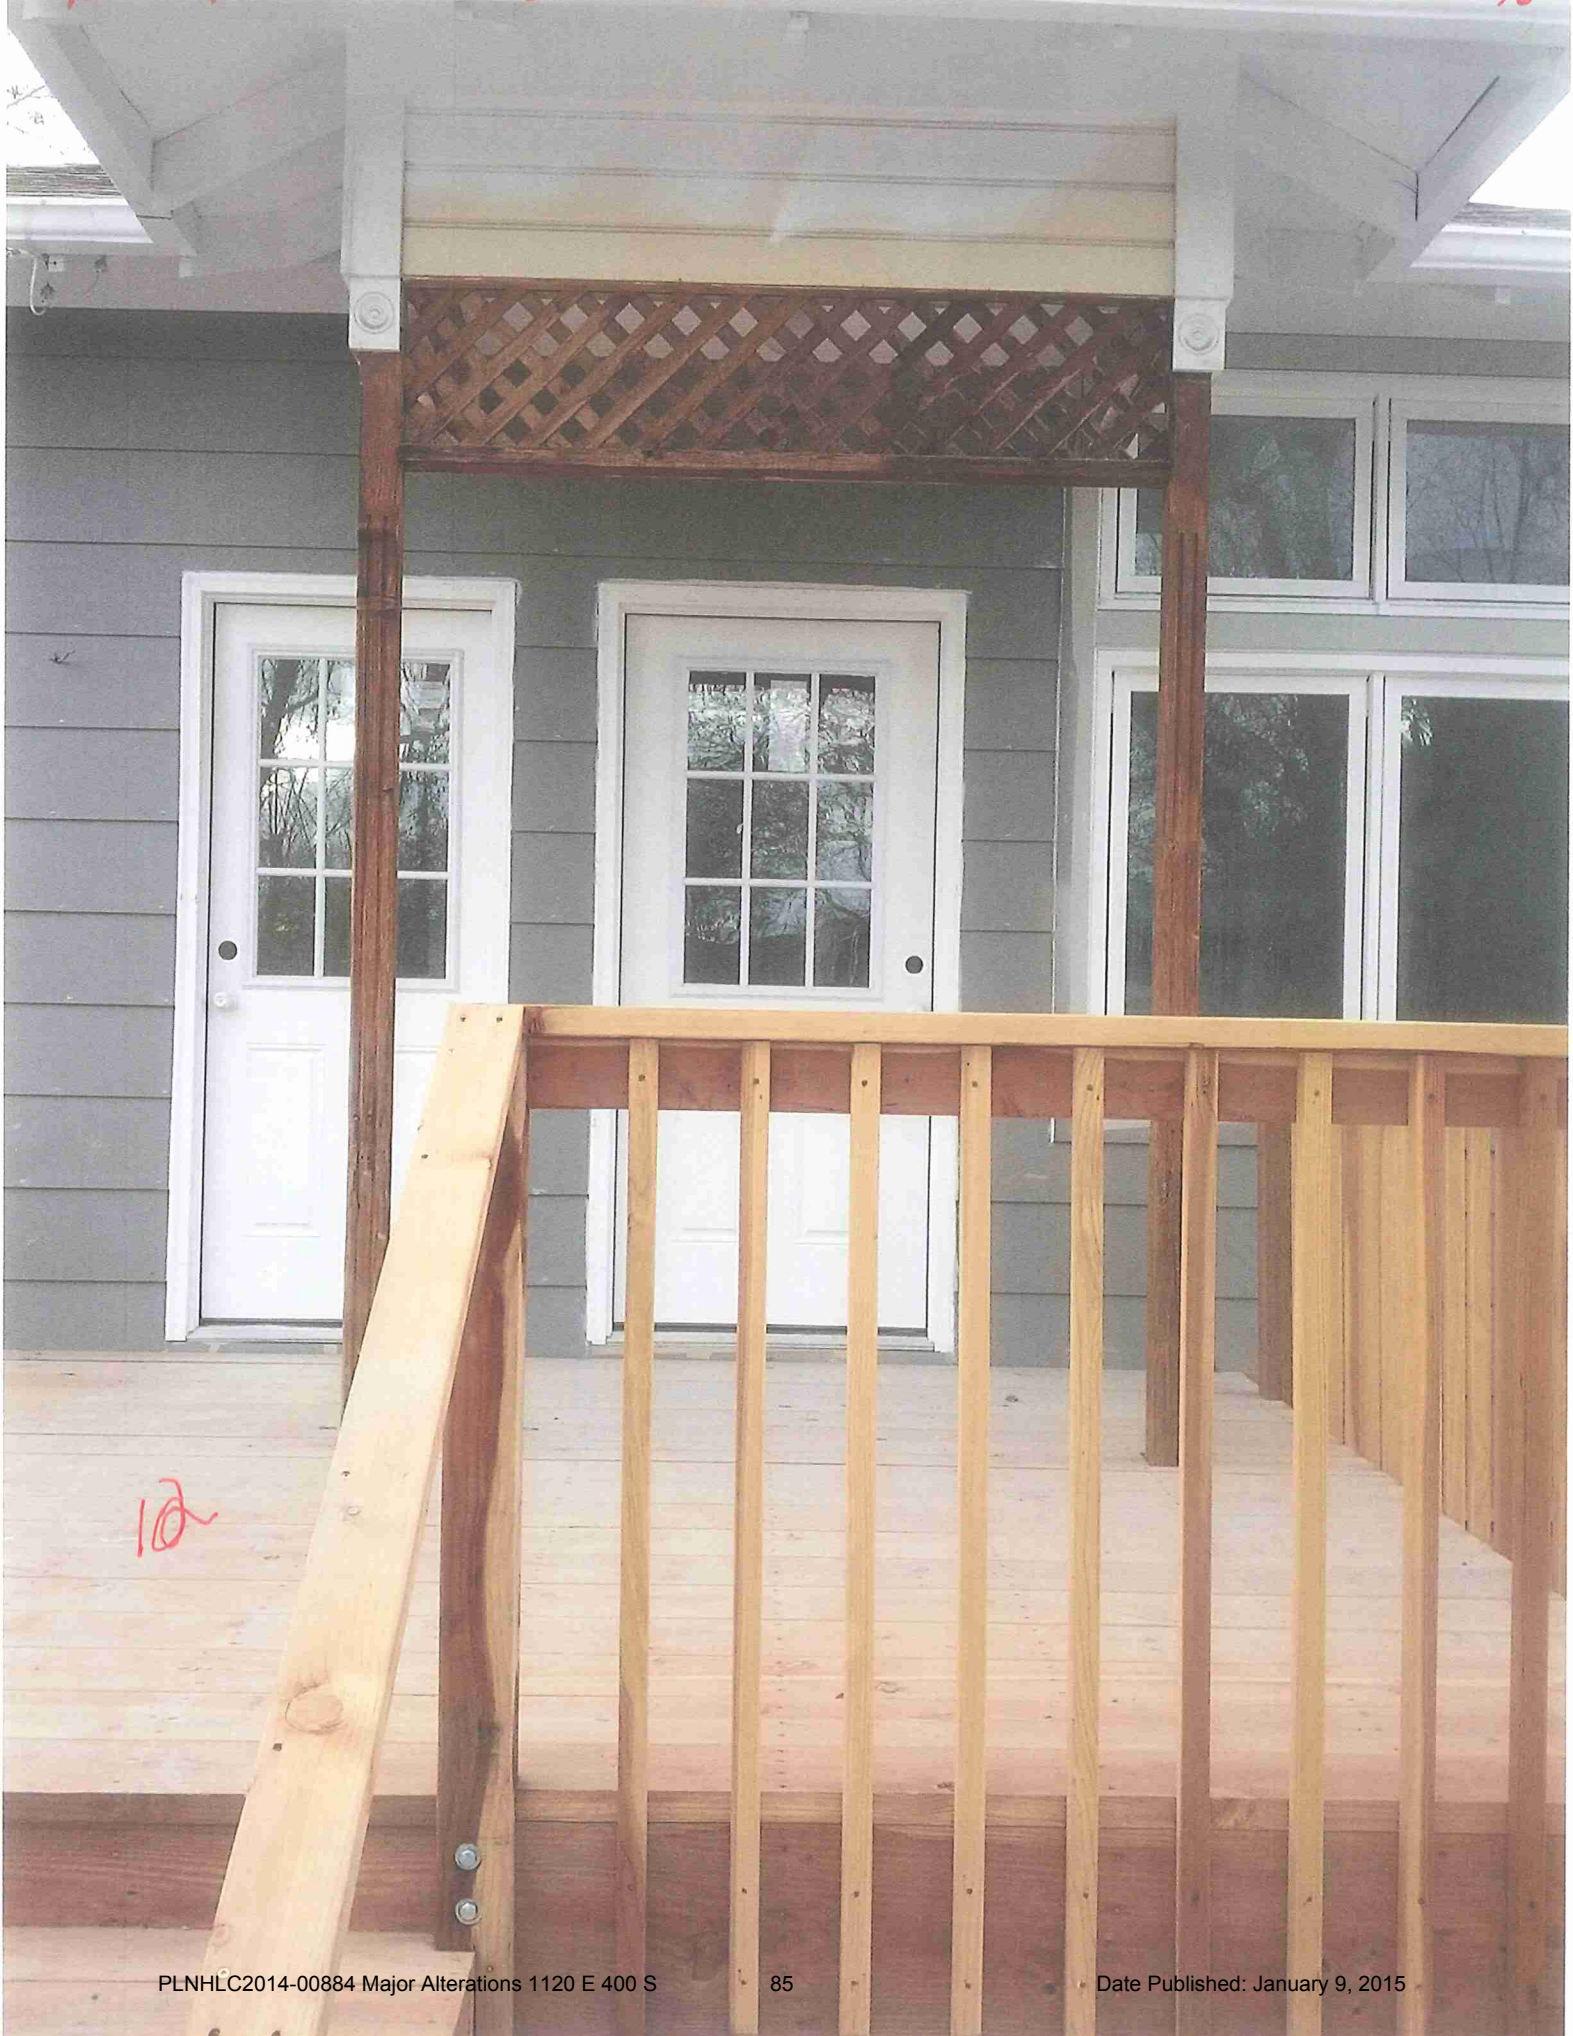
12 Replaced DBL door, New insulated metal door matches other door, 2
