HISTORIC LANDMARK COMMISSION STAFF REPORT

1120 E 400 S Major Alterations PLNHLC2014-00884 University Historic District 1120 E 400 South January 15, 2014

This is a request by Andrew Nielson for major alterations to the property located at approximately 1120 E. 400 South, in the University Historic District, and within the R-2 (Single and Two Family Residential) zoning district.

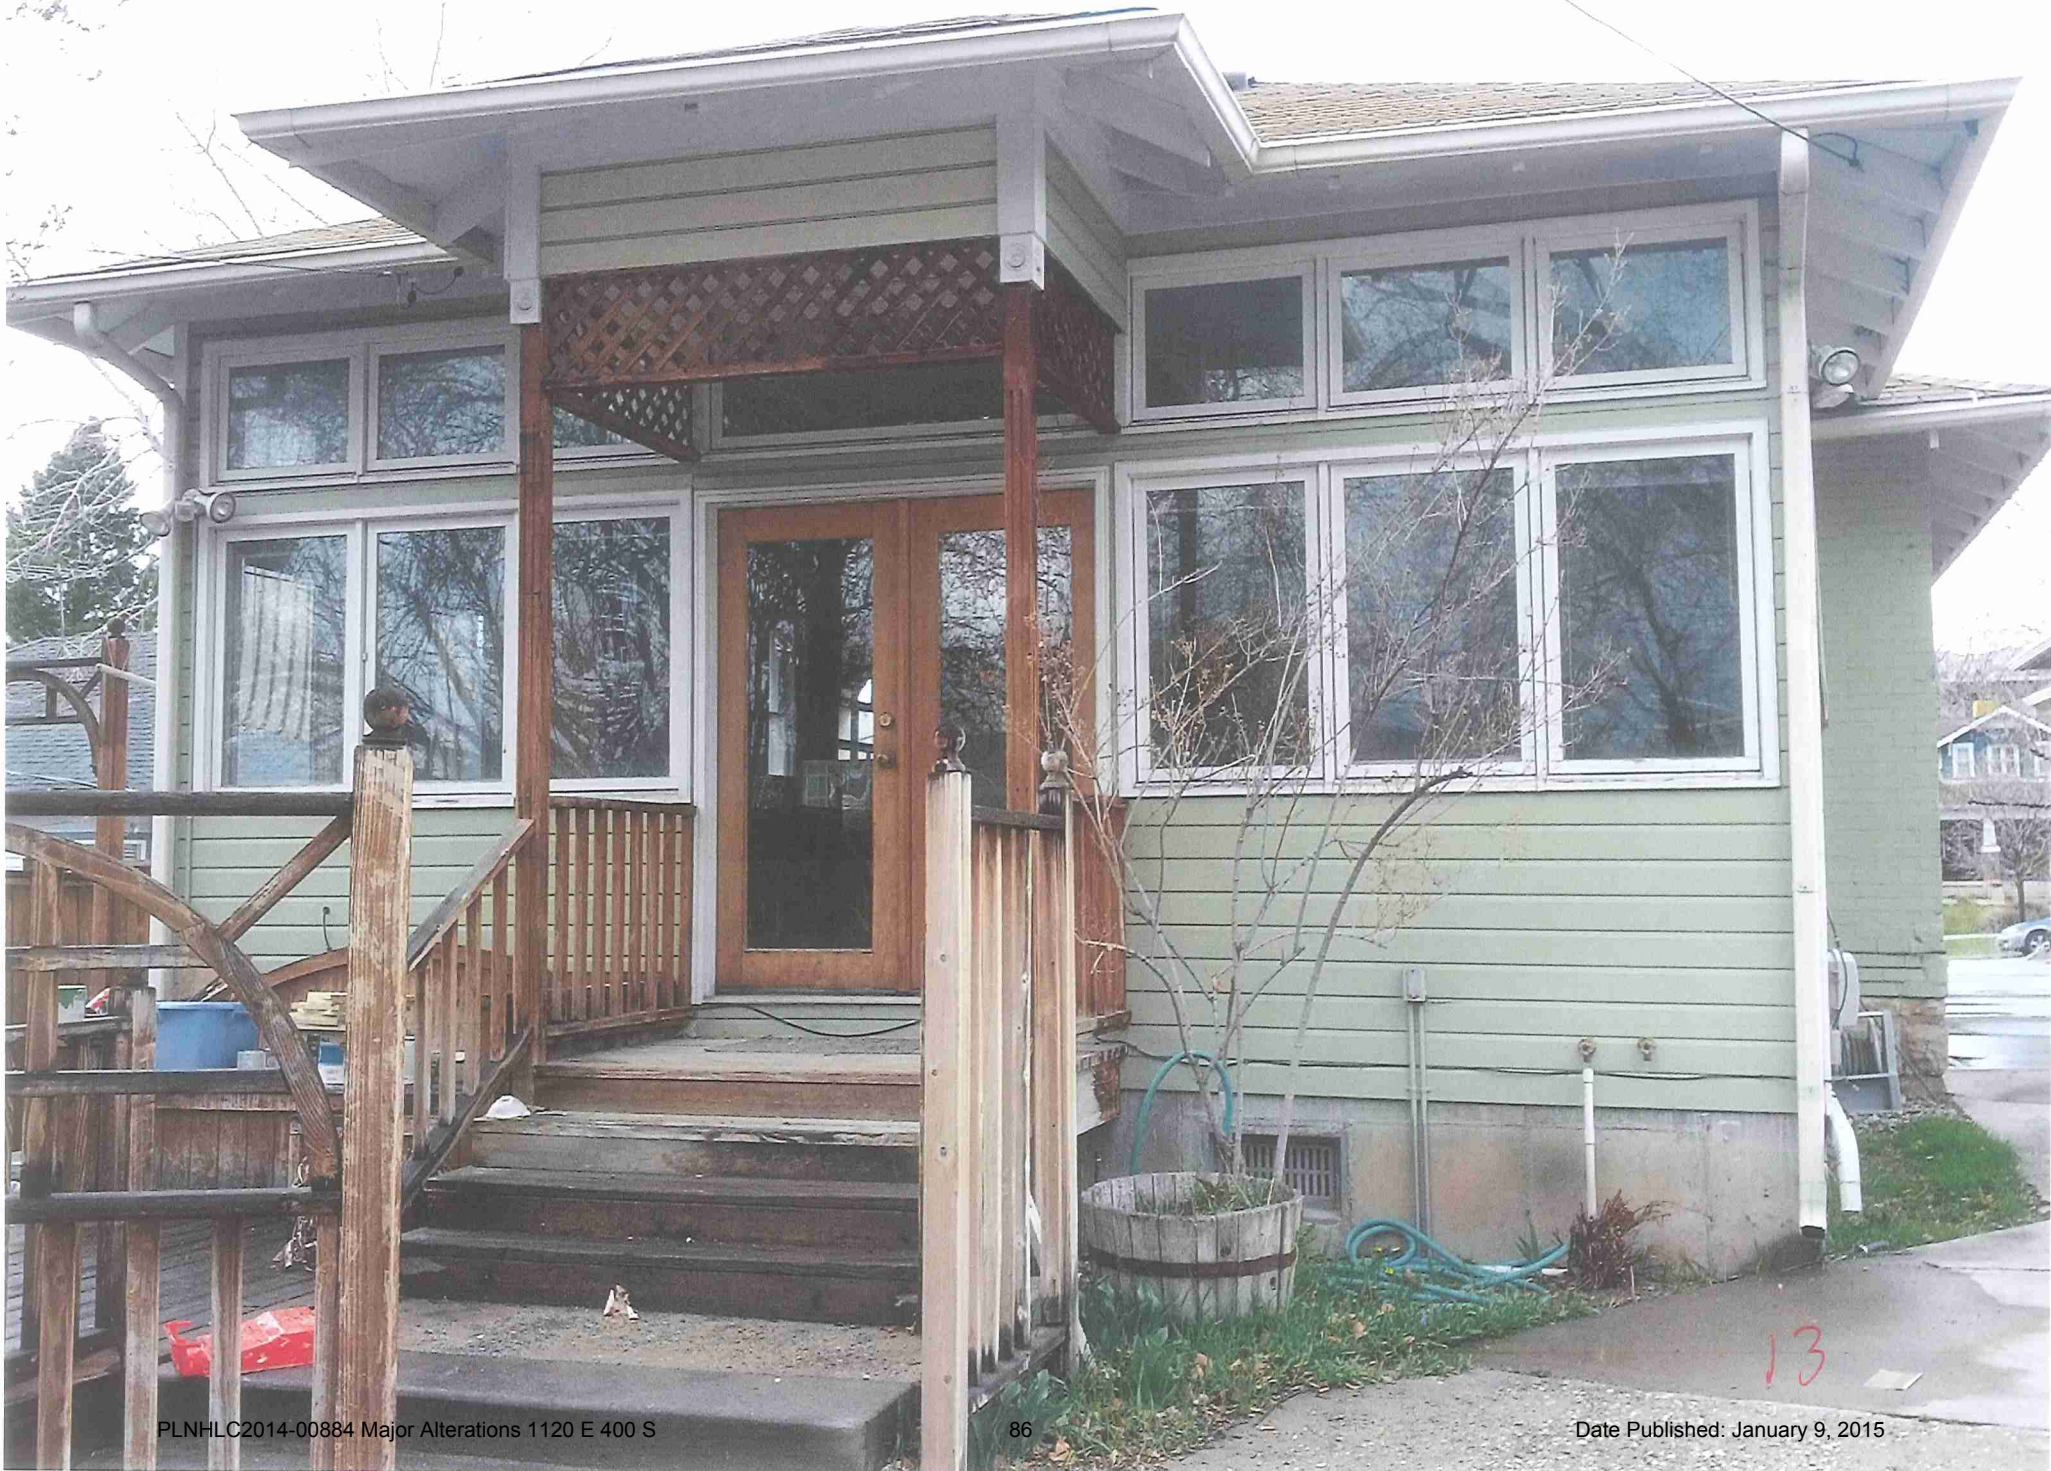
old DBL Door and Deck / Stairway and siding 13

10" lap siding

11. Even though the back wall of the house addition changed less than anticipated, the original 6" tongue and groove siding could not be located to patch into the wall where changes were made. It is proposed that we replace all of the siding that covers the addition with the smooth 10" lap siding

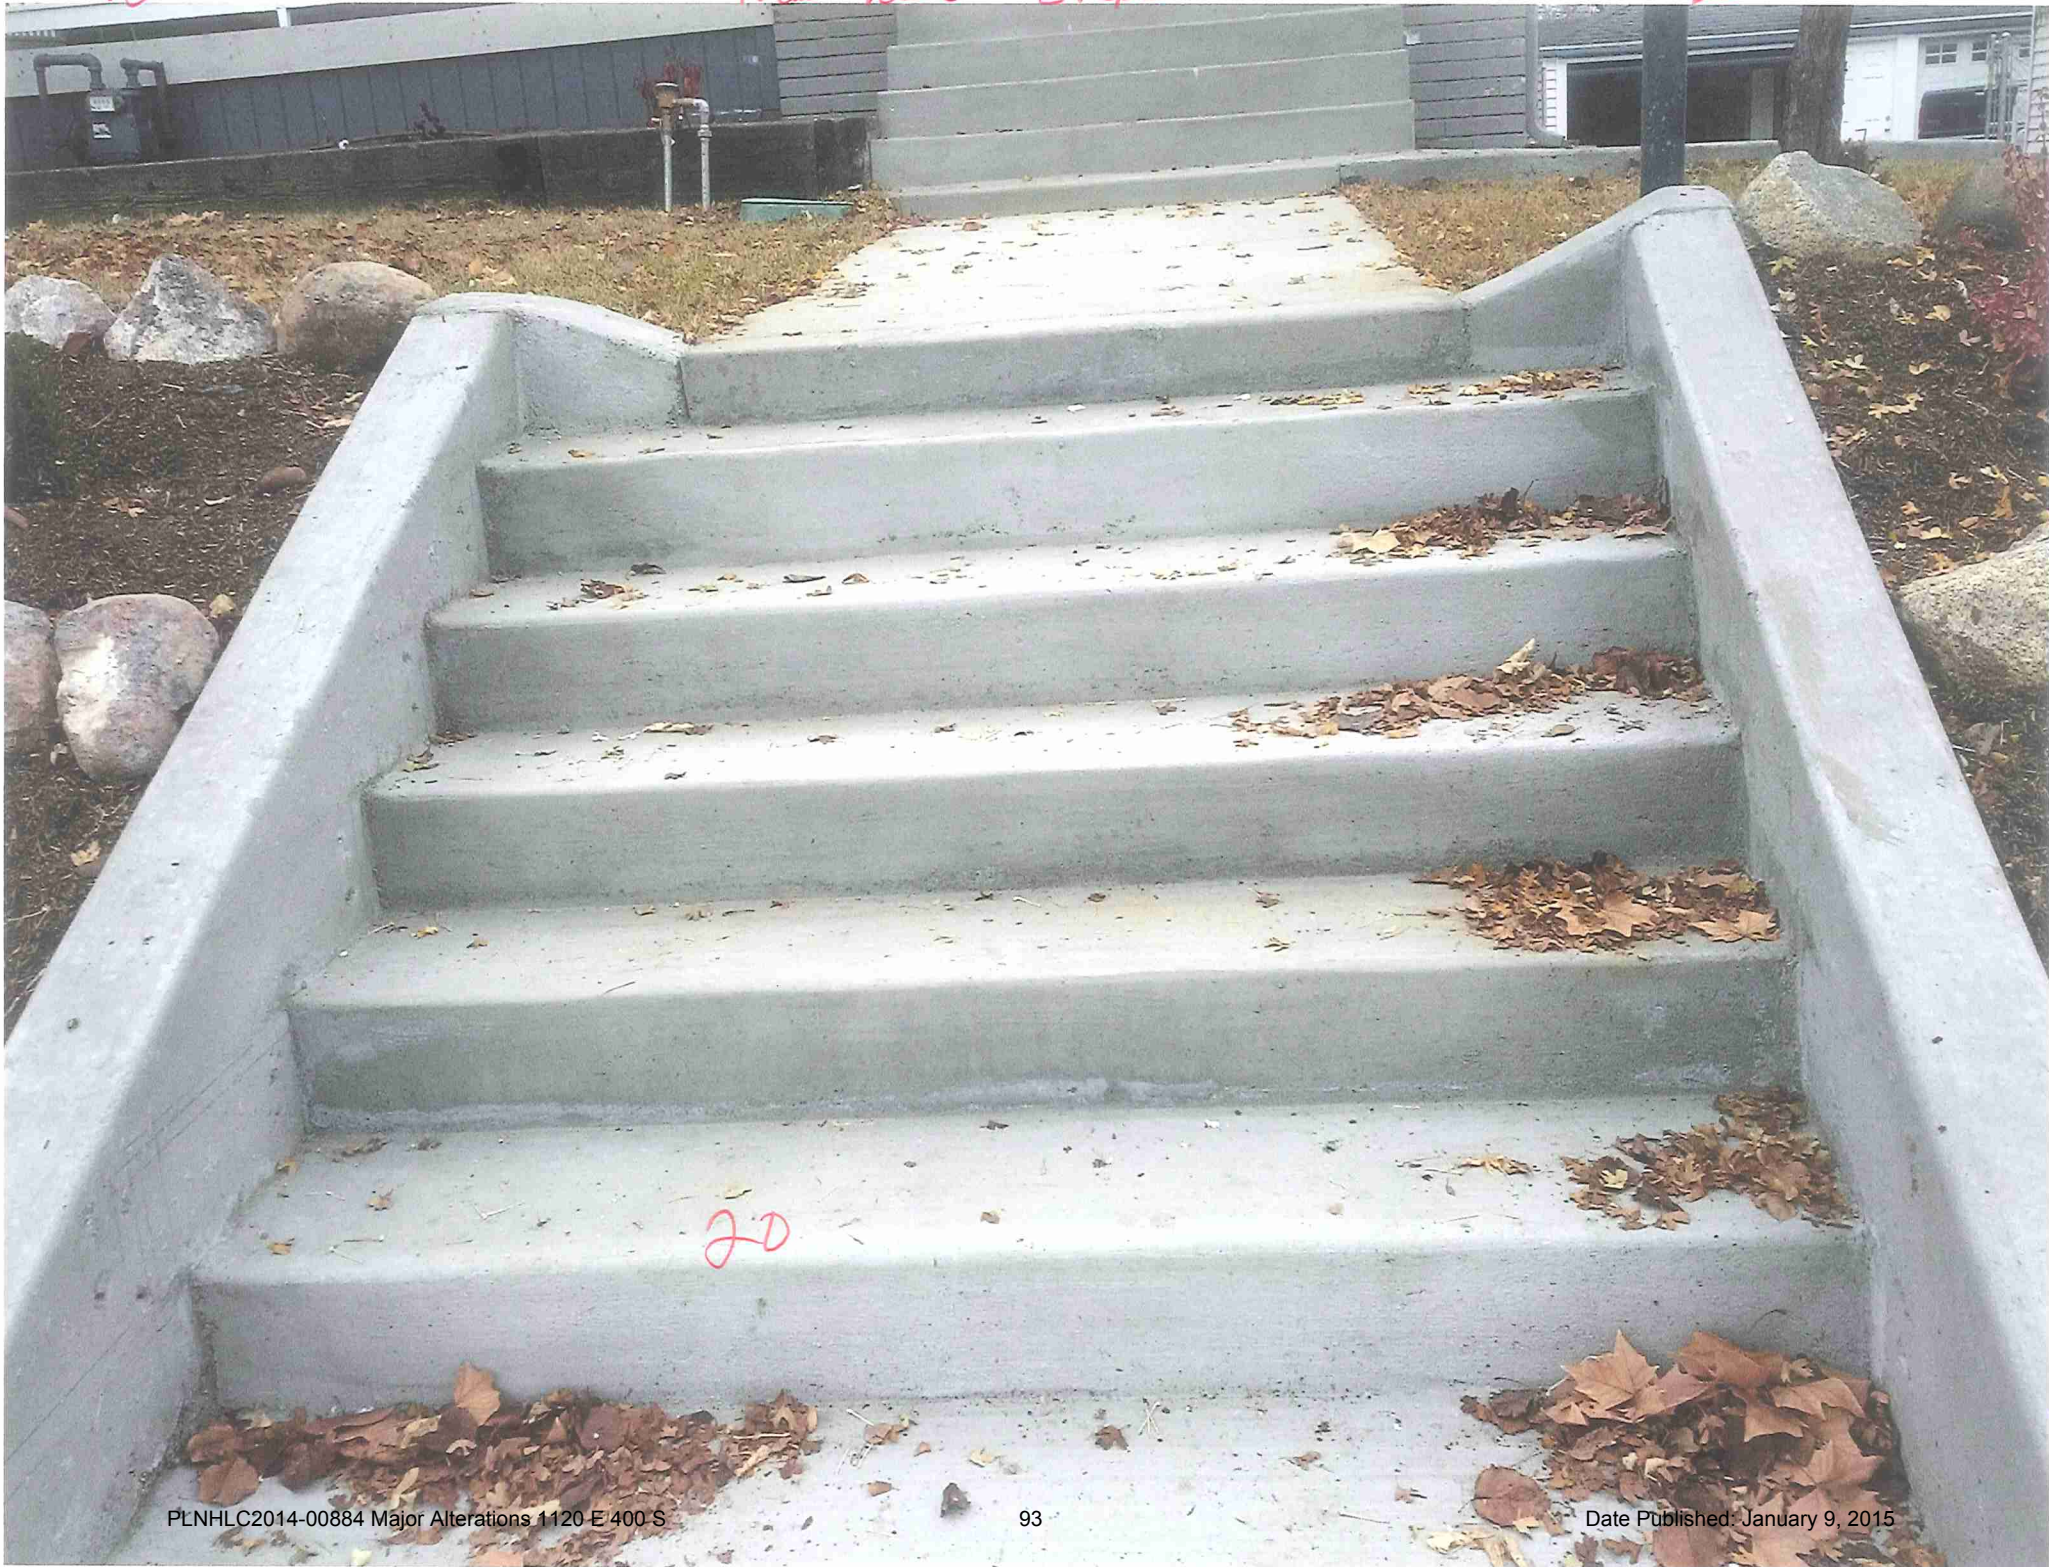
12. Both sets of existing front steps were repaired and the weathered black wrought iron railings will be replaced. The lower steps were changed to have straight edges as opposed to being curved and flared out.

Repaired porch steps

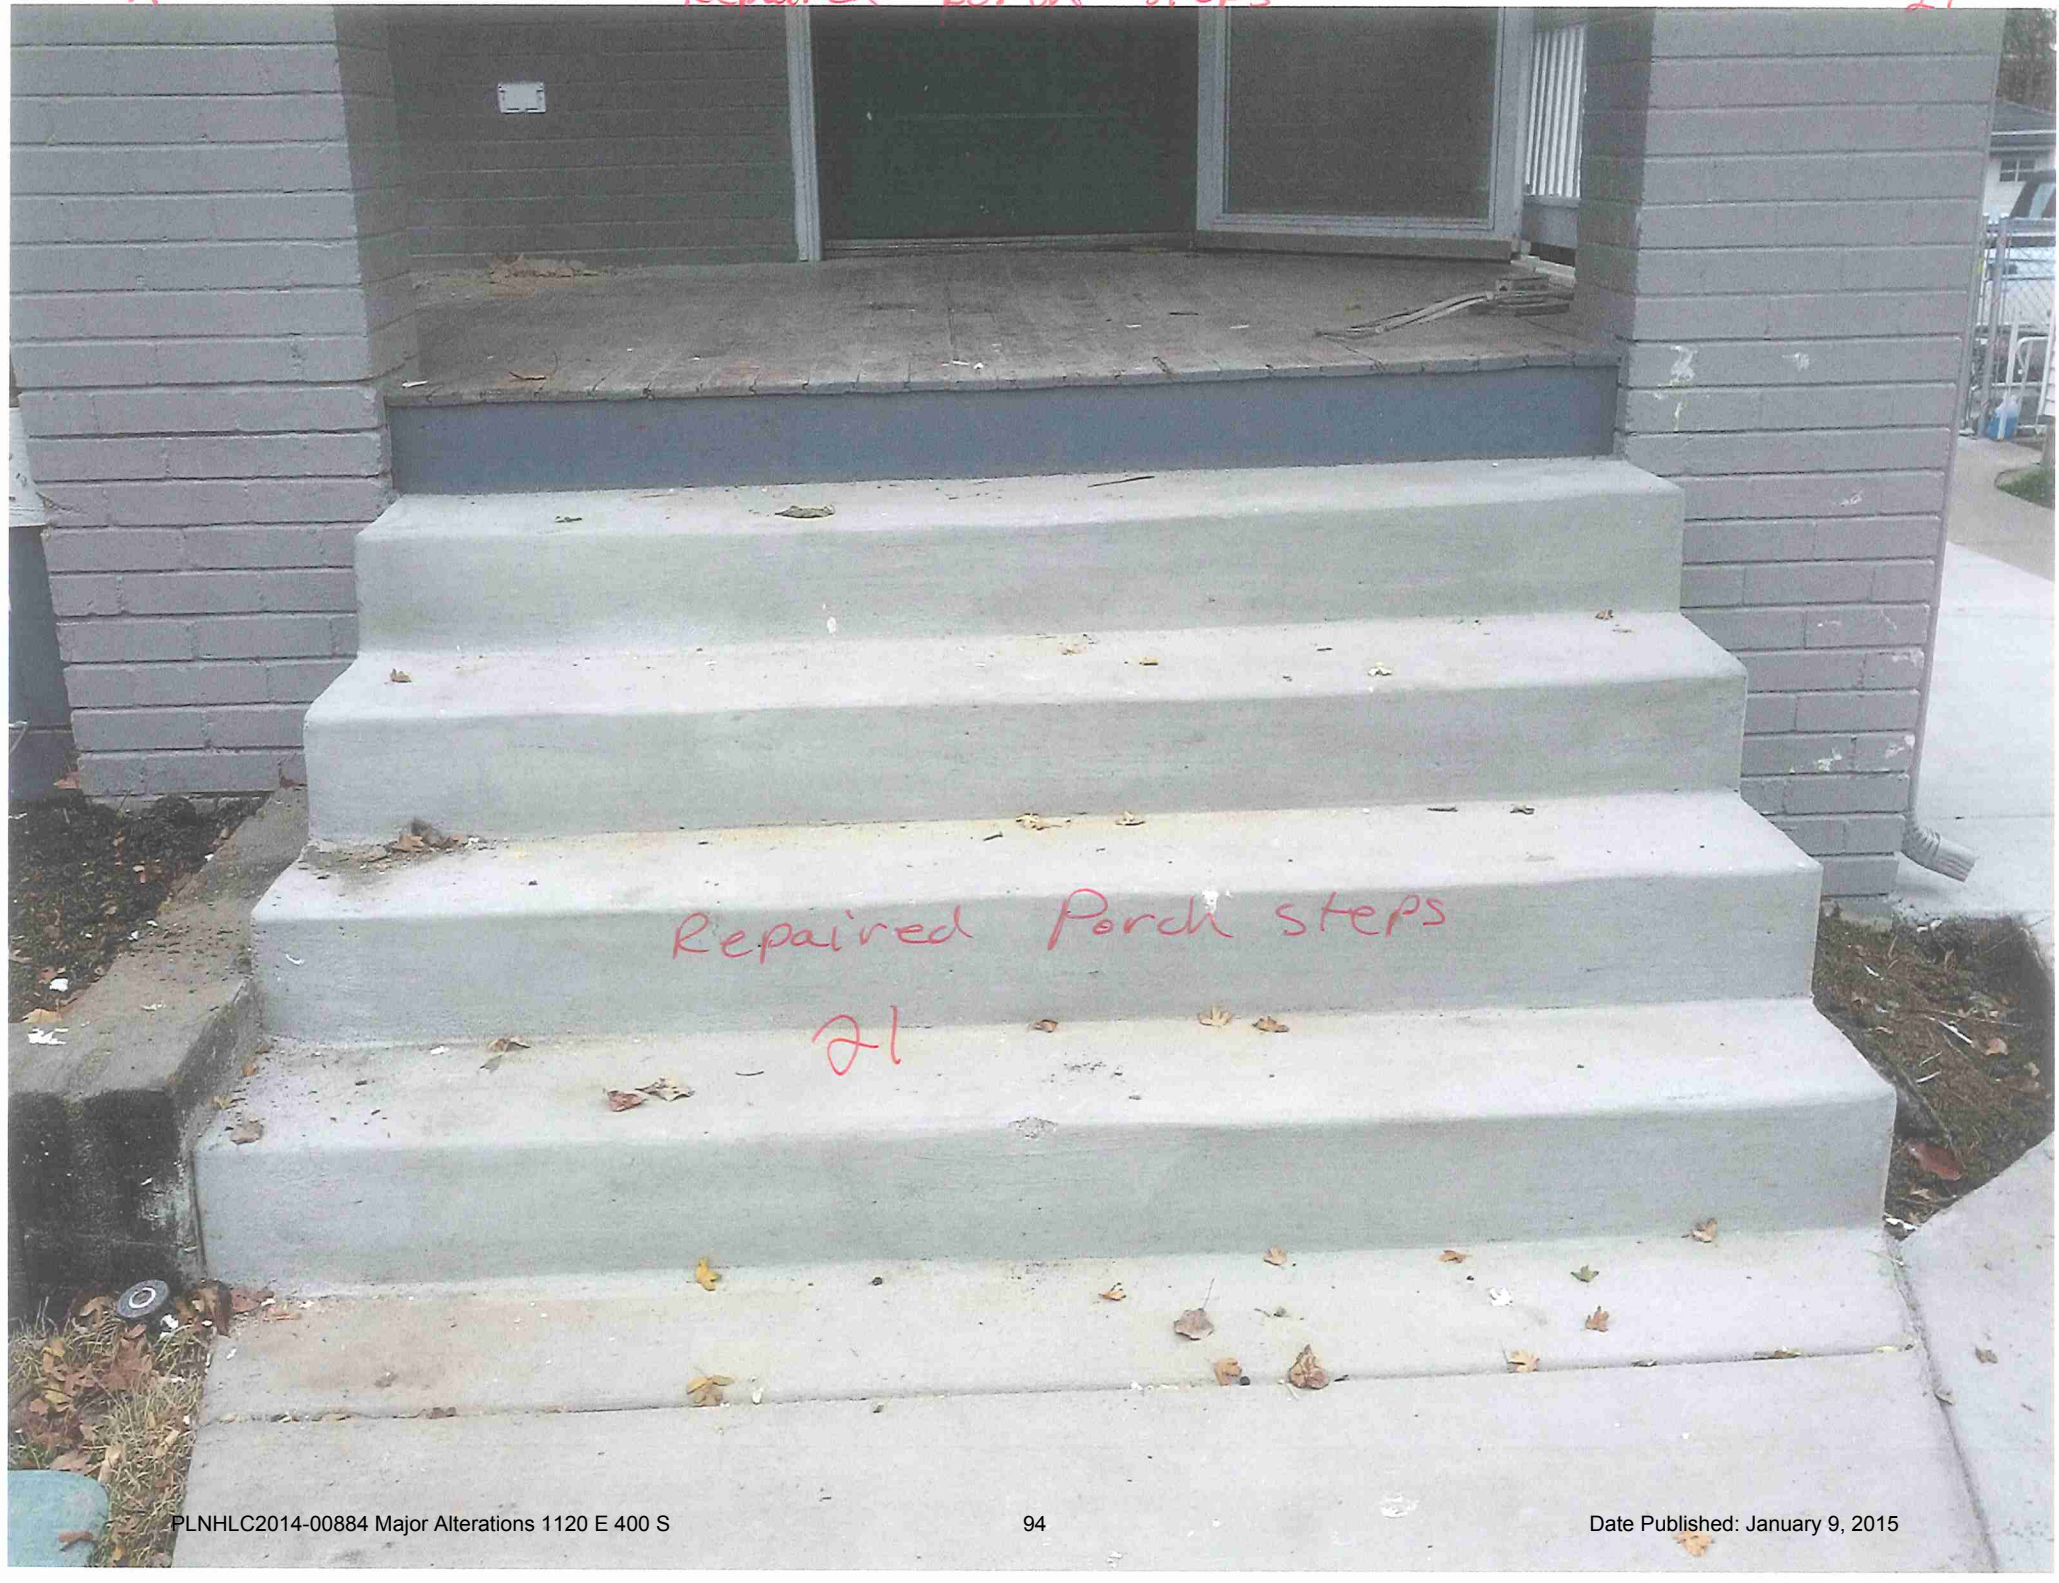
Repaired Porch steps
